Murray Ranch Arborist Report

Hall Lane
Stockton, CA

June 26, 2024

by
Ps1 Landscape Architecture
816 Hampshire Court
Modesto, CA 95350
209.840.2246 cell

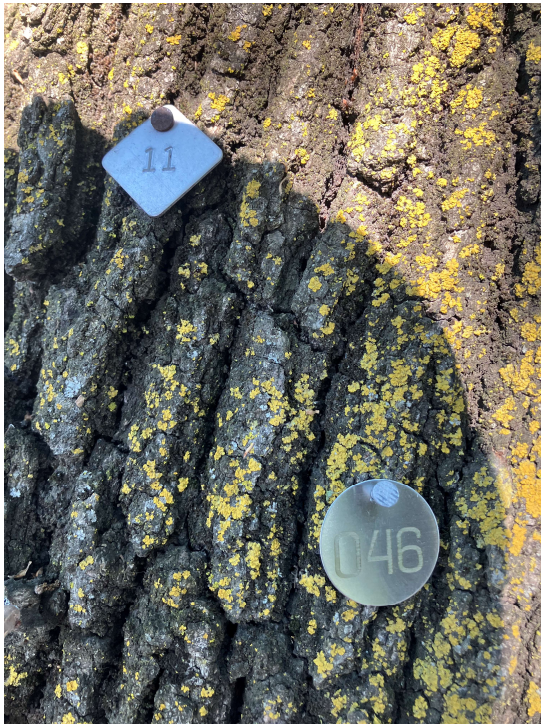
Photo 2: Tree tags. Diamond shaped tags were found on several trees from a previous tree survey. This survey used round tags.

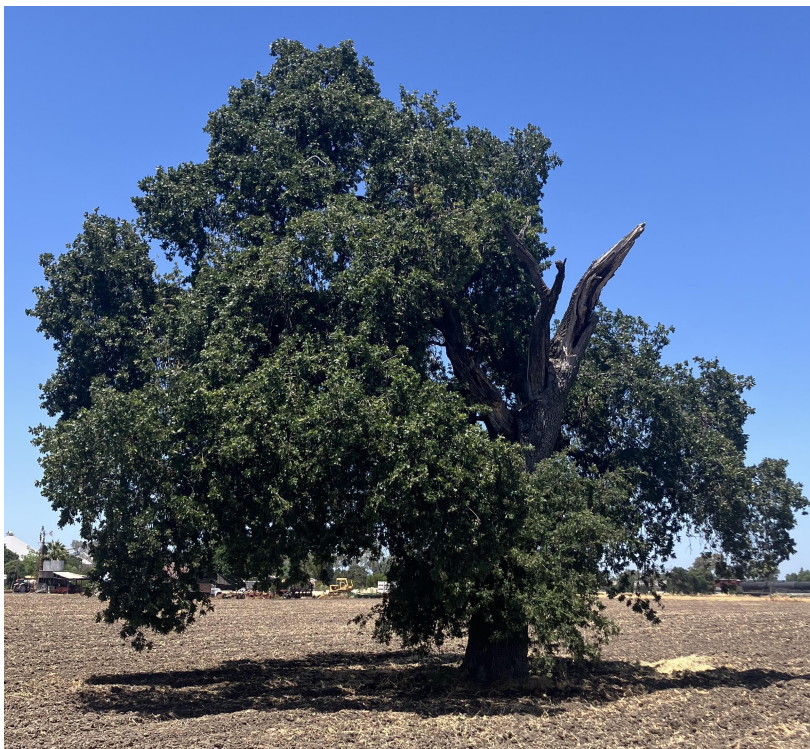
Photo 3: Tree #28 is severely injured and diseased and is not a candidate for preservation or remedial work.

28	47"	65'	Quercus lobata	Valley Oak	Very Poor	Heritage
----	-----	-----	----------------	------------	-----------	----------
