Martin Garcia Villanueva

ISA Certified Arborist WE-348844A

January 13, 2026

Arborist Tree Report

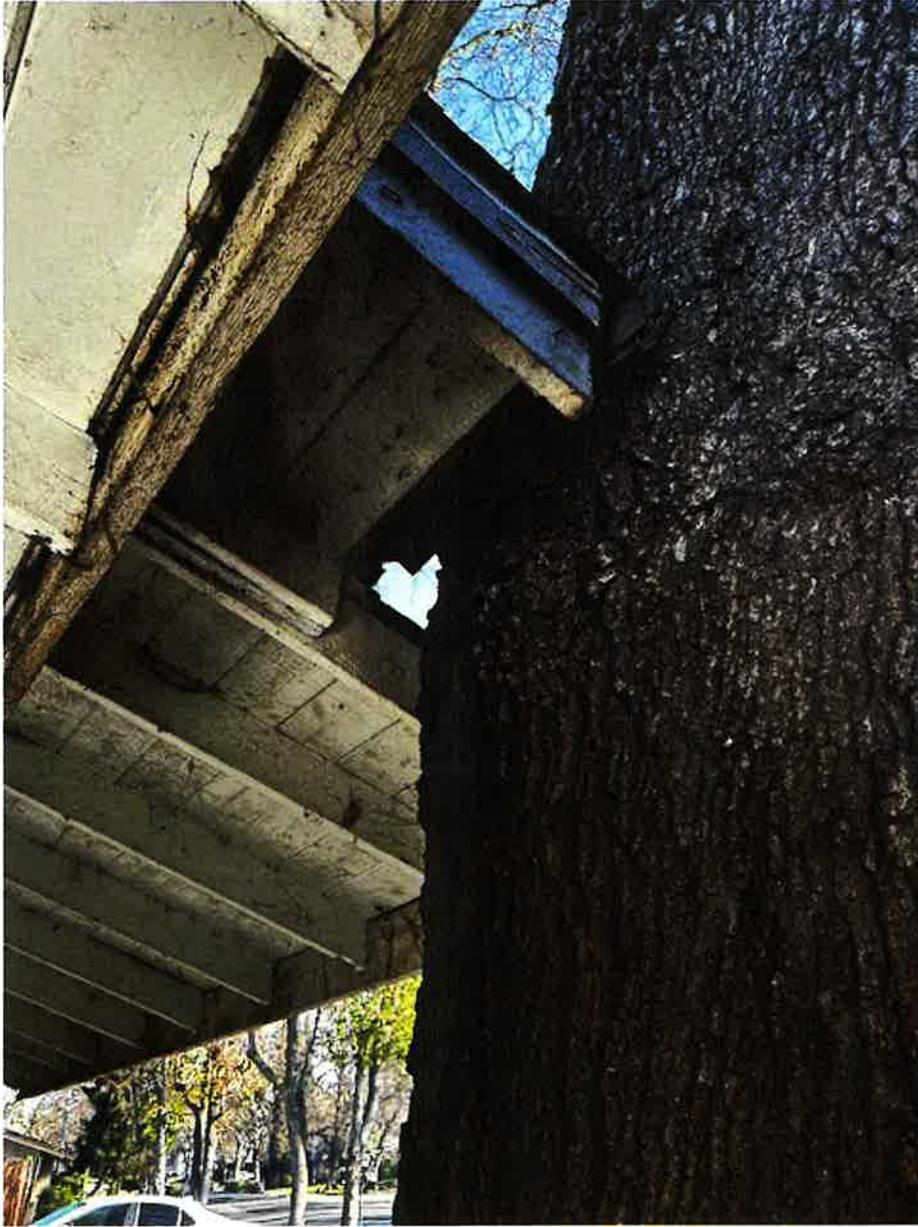
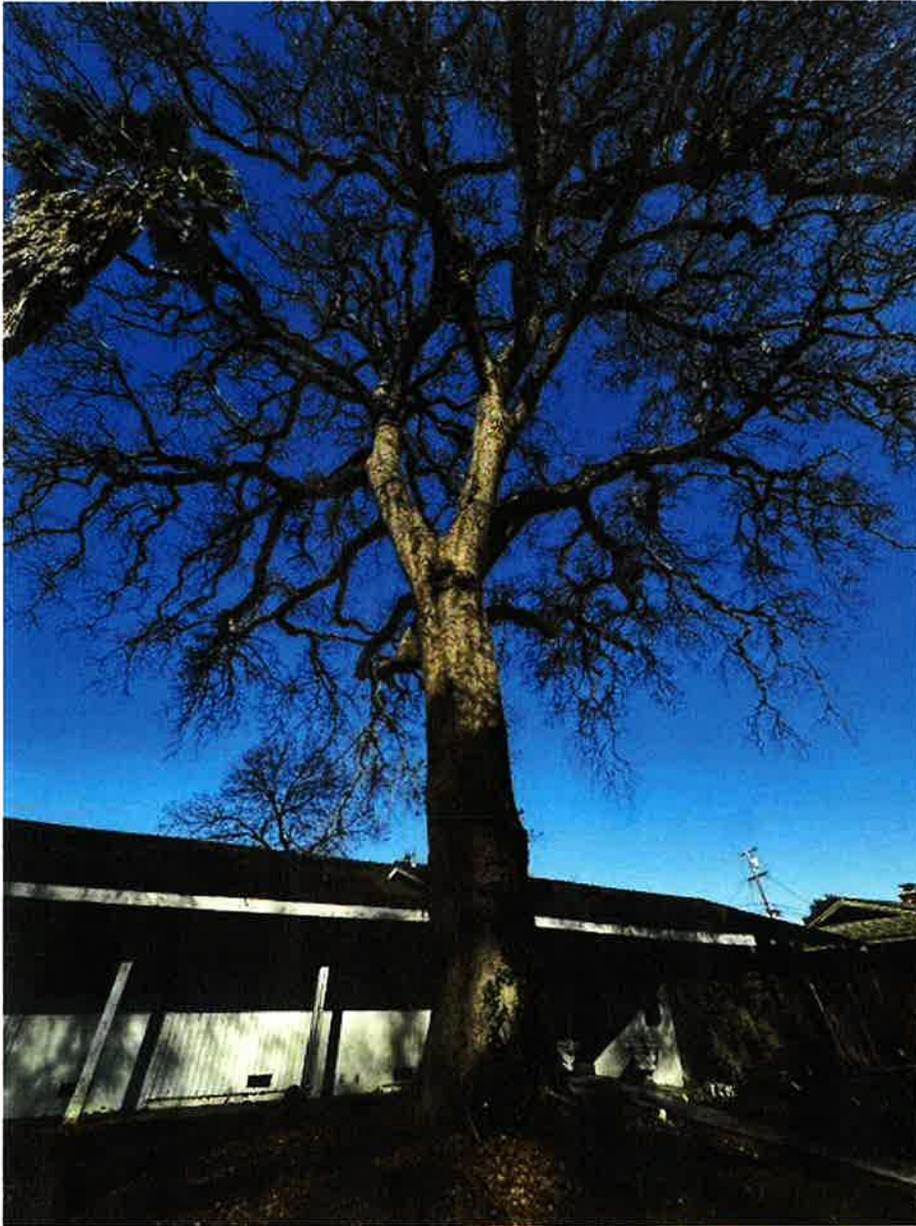
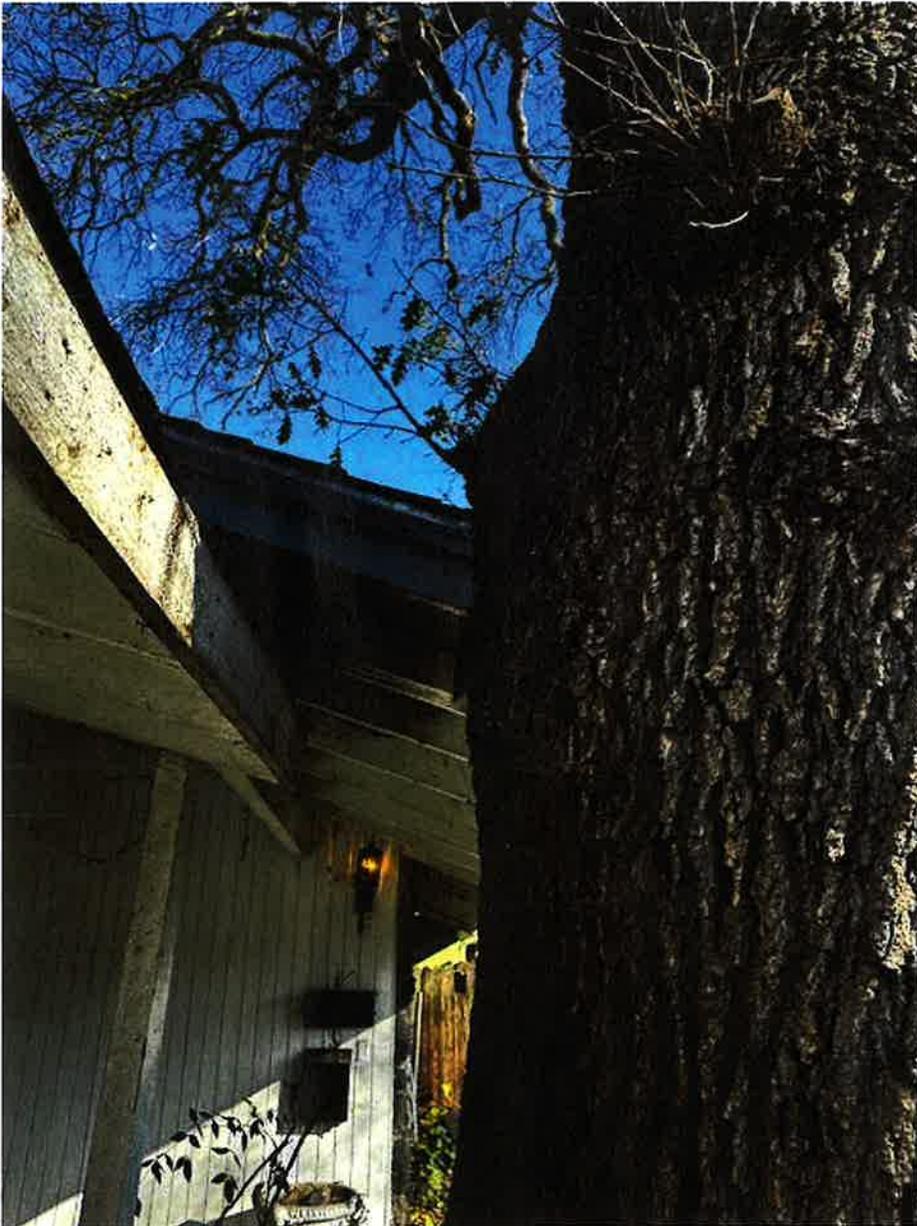
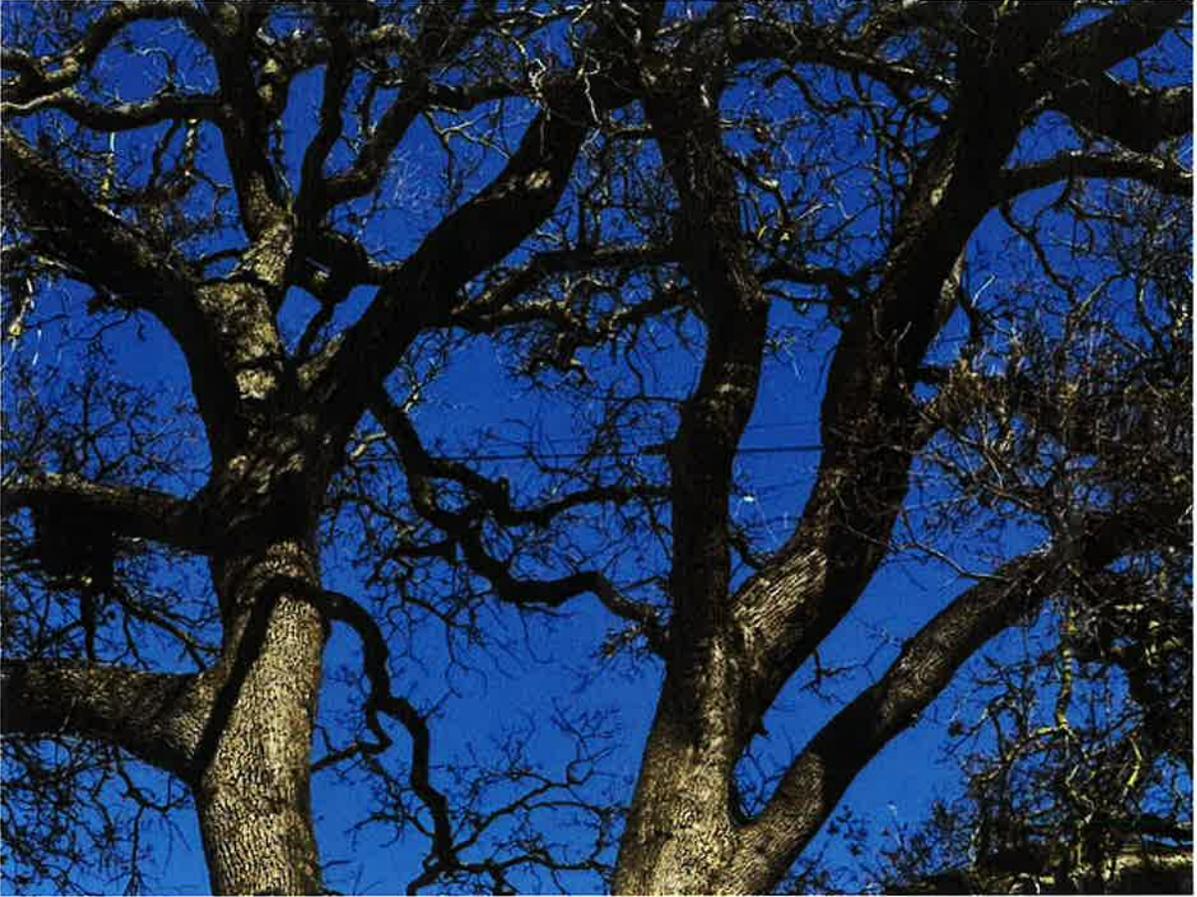
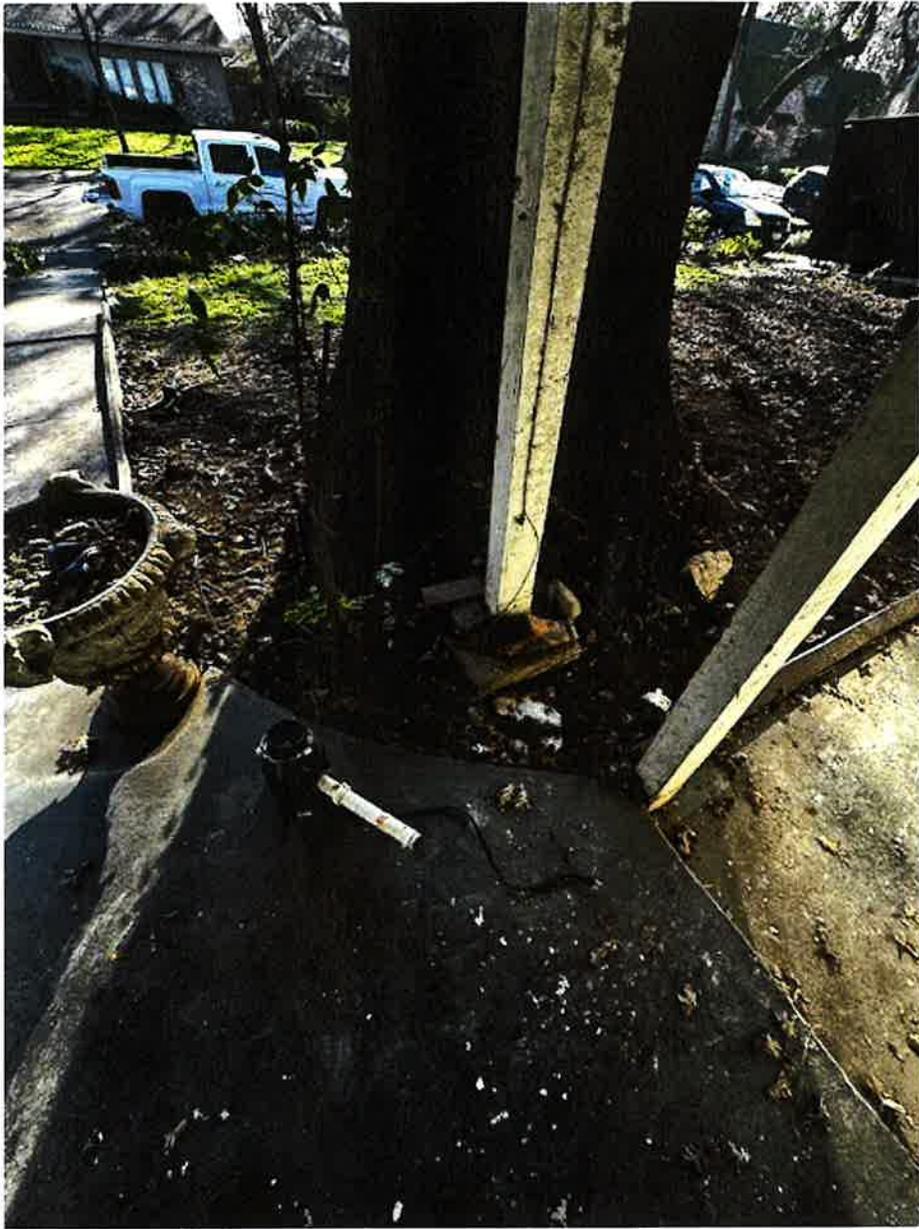
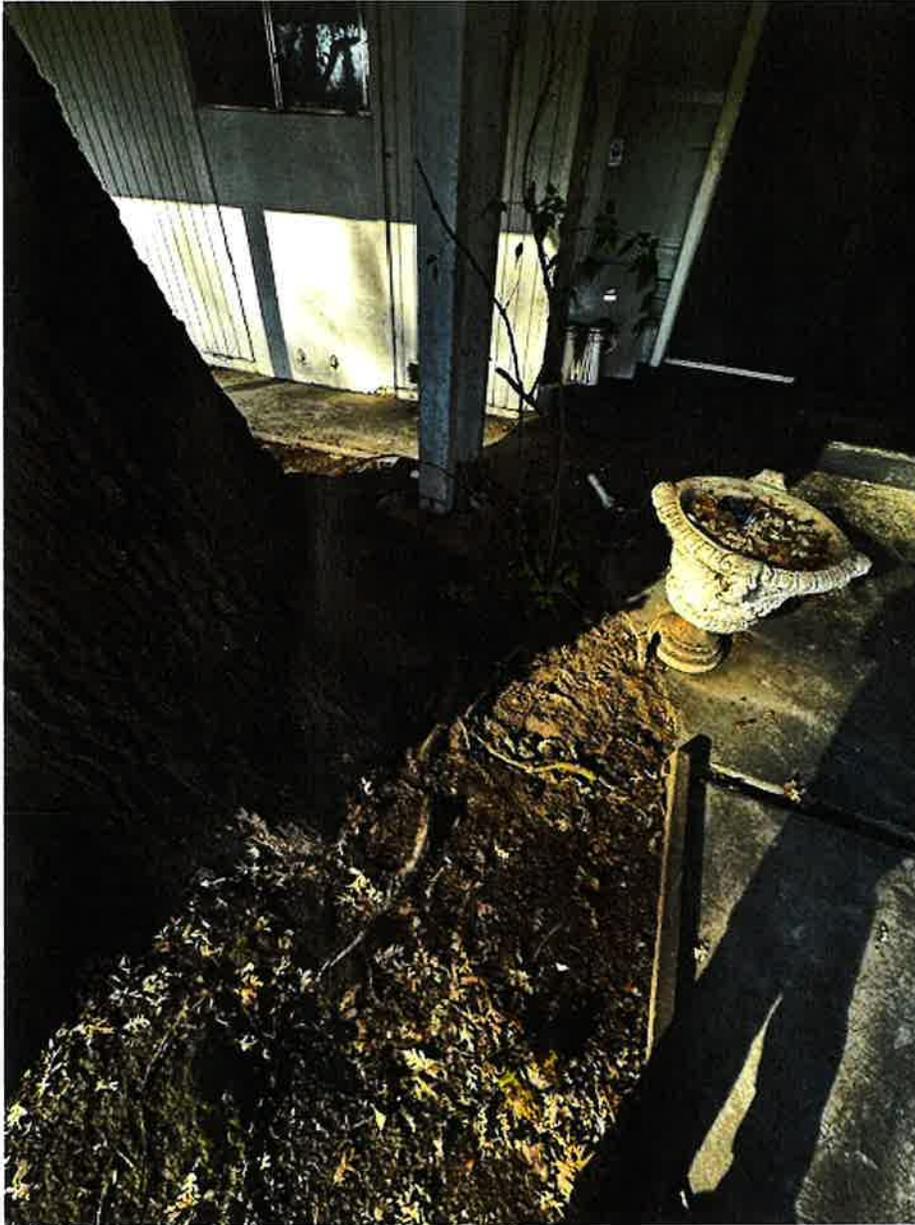
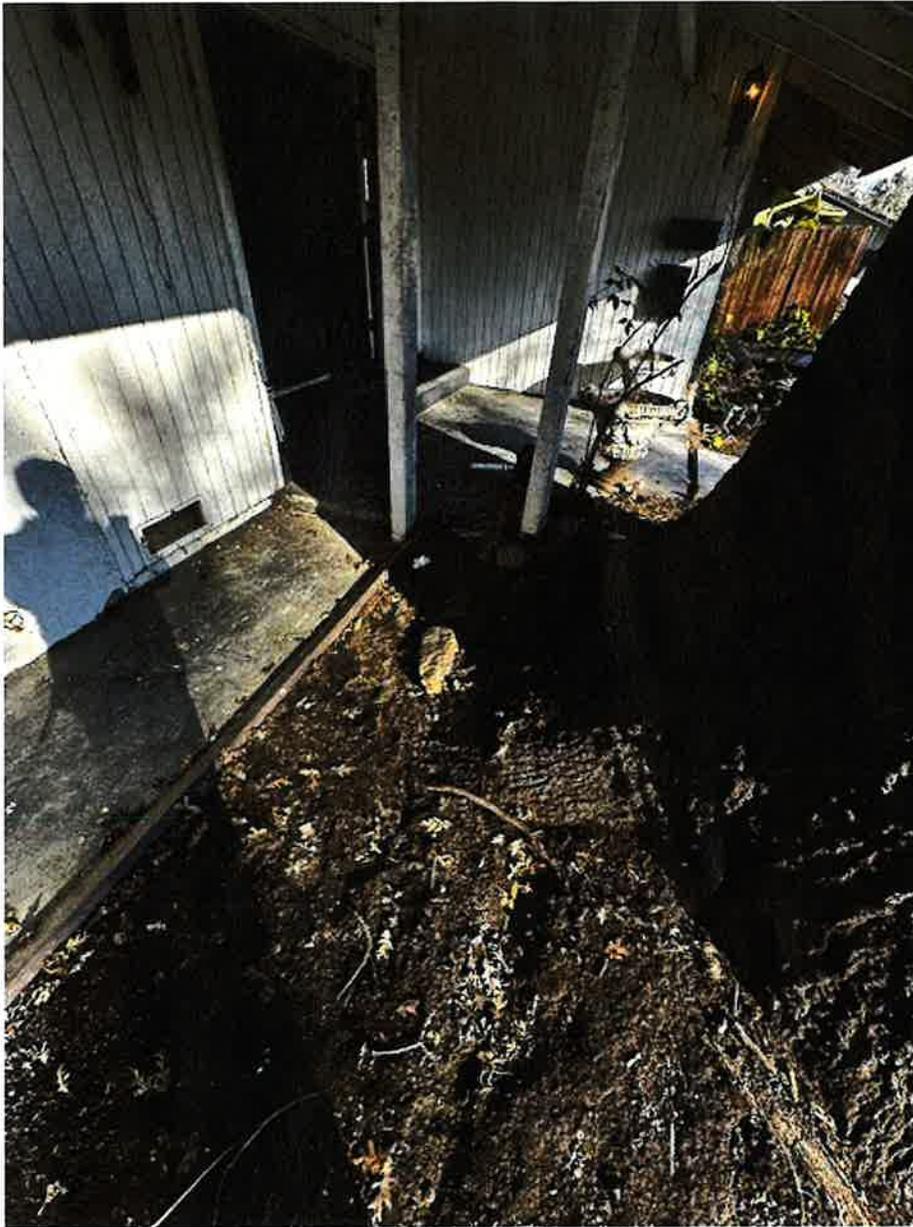
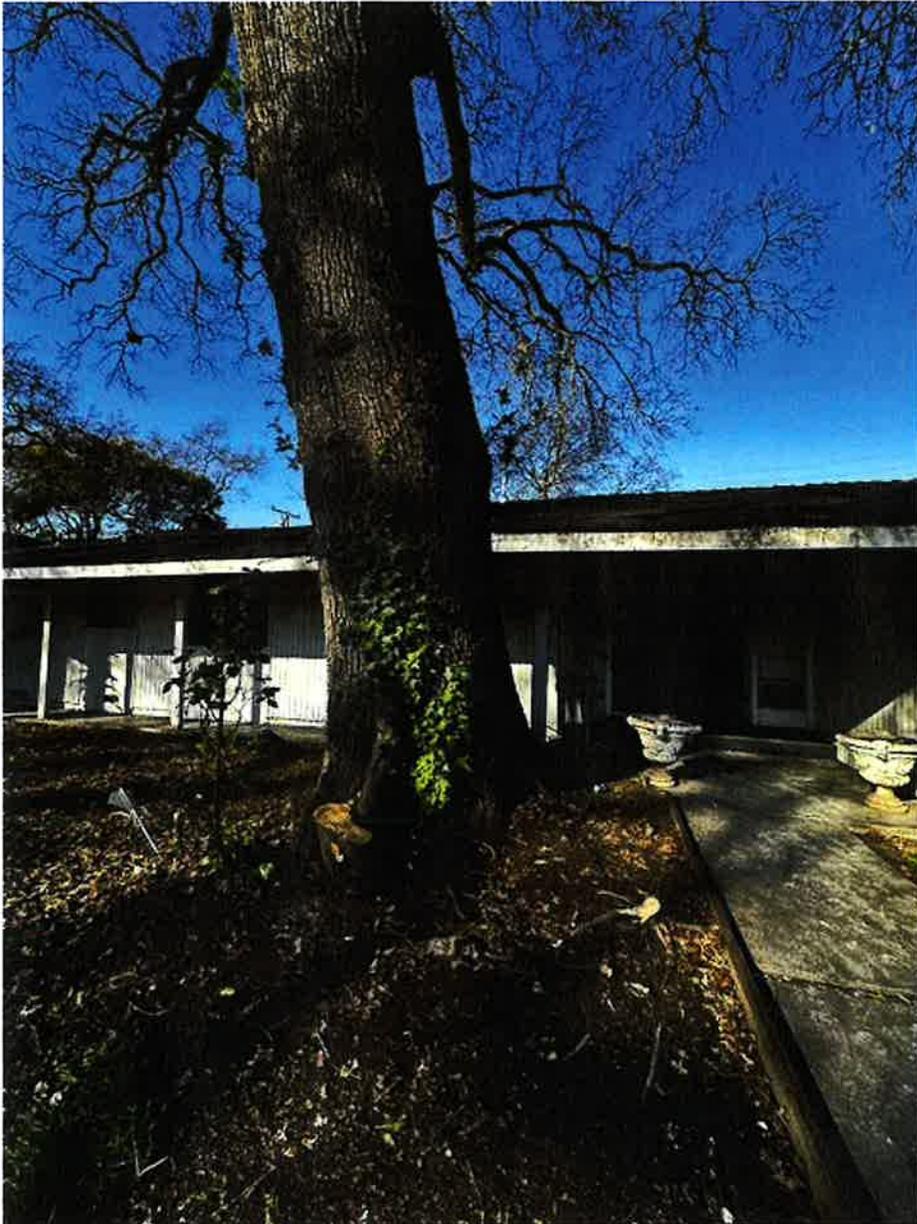
The tree located at 7517 Park Woods Dr. Stockton, CA 95207 is a *Quercus lobata* (commonly known as "Valley Oak"). The tree's diameter measures 59.524 inches at the required height (24 inches above actual grade). The tree's condition looks to be in order at first glance. However upon closer inspection the canopy shows multiple significant signs of future potential danger and hazards. The first being naturally sheared off limbs due to excessive limb weight and neglect. Sheared off limbs are a pathway to decay and pathogens that decreases a tree's lifetime and increases the likelihood of failure. Lack of maintenance overloads limbs which if left untreated poses a threat to buildings and/or individuals. In the Canopy there is also an attempt to "cable" the tree for support. Adding a cable to a tree for support is a practice commonly done by experienced arborists in order to reduce the load and support the cabled limb. The existing cable (seen in pictures below) is installed incorrectly for it is not using the appropriate hardware or practice recommended. In this case the cable is wrapped around two limbs which have overgrown the cable and can be seen "choking" both limbs. Having wires, cables, ropes or other objects wrapped around a trunk or any part of a tree reduces the flow of nutrients to the rest of the limb, reducing its food source and increasing the likelihood of failure.

The first reason for the removal of this Oak is the damage that it has caused and will cause because of its location. The tree is planted close to no centimeters next to the roof line. In compliance with the city of Stockton a valid reason for a removal of a Heritage Oak is the “proximity to existing or proposed structures” and “constructions of proposed improvements”. A tree's root system can extend 2-3 times the size of its canopy which jeopardizes the well being of the building's foundation, existing pipes and if existing underground utilities. Having such a wide and uncared, neglected canopy that overhangs the structure poses clear and present danger.
