Silver Lake Campground Facility Condition Assessment

Final Report

August 16, 2024

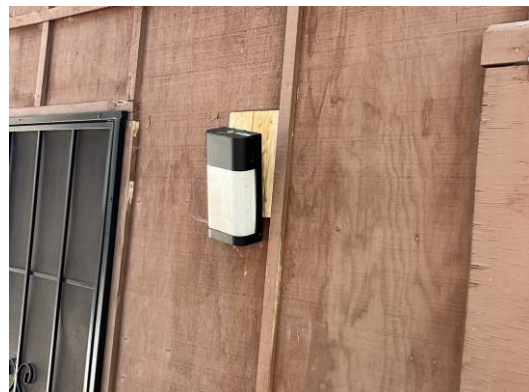
Record ID: 169
System: D5040 - LIGHTING
Item No.: D5040.50.420
Priority: Immediate (0-1 Years)
Quantity/Unit of Measure: 3/EA
Total Deficiency Cost: \$7,460
Deficiency Description: *The exterior wall mounted fixture is past its expected useful life.*
Description of Work: *Replace the existing wall mounted lighting fixture with an LED lighting fixture.*
Comments:

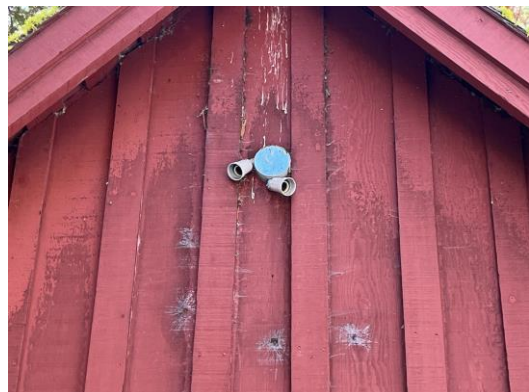
Record ID: 407
System: D5040 - LIGHTING
Item No.: D5040.50.420
Priority: Immediate (0-1 Years)
Quantity/Unit of Measure: 1/EA
Total Deficiency Cost: \$2,500
Deficiency Description: *The exterior wall mounted fixture is past its expected useful life.*
Description of Work: *Replace the existing wall mounted lighting fixture with an LED lighting fixture.*
Comments:

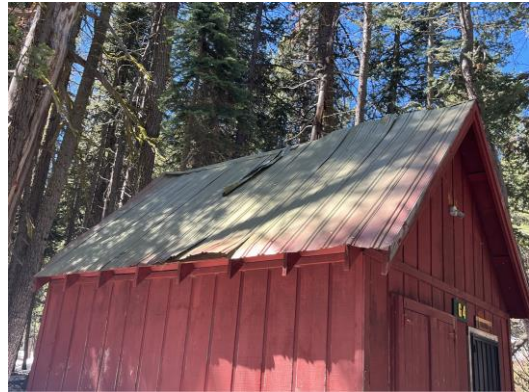
Record ID: 181
System: B3010 - ROOFING
Item No.: B3010.10.002
Priority: Immediate (0-1 Years)
Quantity/Unit of Measure: 200/SF
Total Deficiency Cost: \$7,720
Deficiency Description: *Metal Roofing is at or approaching end of expected useful service life.*
Description of Work: *Remove and replace metal roofing.*
Comments:

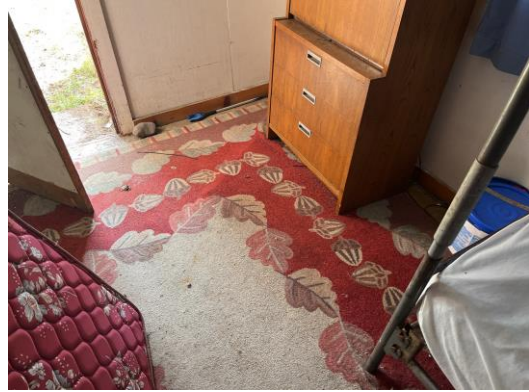
Comments: *Concrete floor slab is severely damaged from uplift caused from roots of nearby tree.*

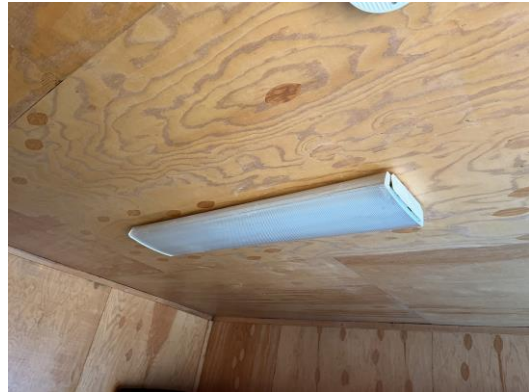
Record ID: 65
System: D5040 - LIGHTING
Item No.: D5040.50.421
Priority: Immediate (0-1 Years)
Quantity/Unit of Measure: 1/EA
Total Deficiency Cost: \$1,260
Deficiency Description: *The light fixture is past its expected useful life.*
Description of Work: *Replace existing incandescent fixtures with LED fixtures.*
Comments:

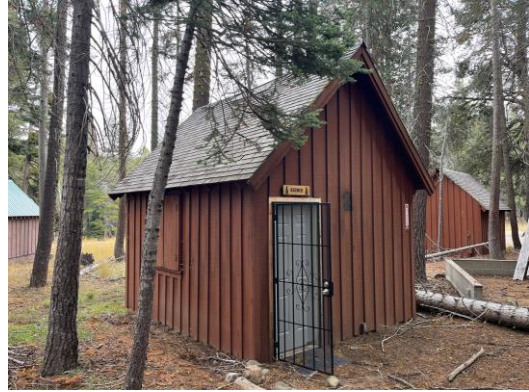
Comments: *Shake Roof*

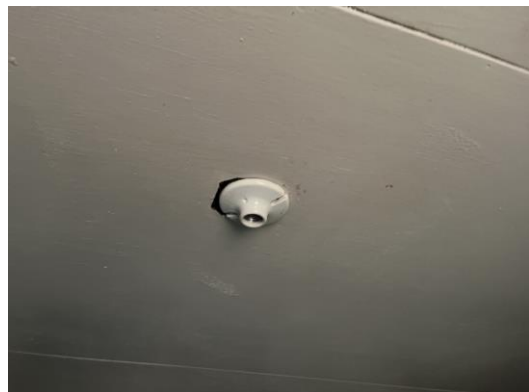
Record ID: 85
System: D5040 - LIGHTING
Item No.: D5040.50.421
Priority: Immediate (0-1 Years)
Quantity/Unit of Measure: 1/EA
Total Deficiency Cost: \$1,260
Deficiency Description: *The light fixture is past its expected useful life.*

Description of Work: *Replace existing incandescent fixtures with LED fixtures.*

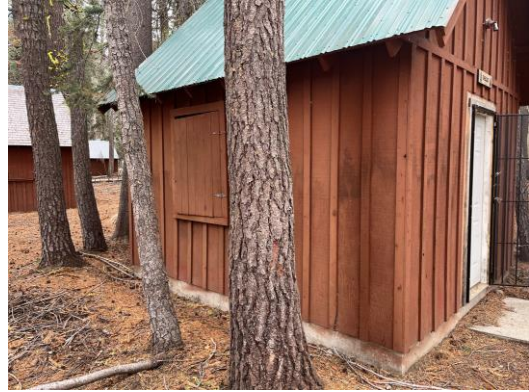
Record ID: 103
System: B2010 - EXTERIOR WALLS
Item No.: B2010.10.016
Priority: Immediate (0-1 Years)
Quantity/Unit of Measure: 700/SF
Total Deficiency Cost: \$17,640
Deficiency Description: *The exterior wood board siding is showing signs of age and wear.*
Description of Work: *Power wash and repaint existing wood board siding.*
Comments:

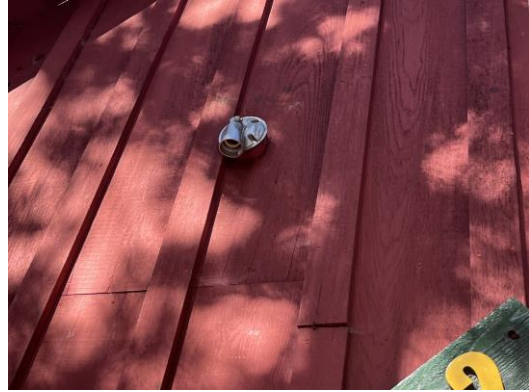
Record ID: 468
System: D5040 - LIGHTING
Item No.: D5040.50.420
Priority: Immediate (0-1 Years)
Quantity/Unit of Measure: 1/EA
Total Deficiency Cost: \$2,500
Deficiency Description: *The exterior wall mounted fixture is past its expected useful life.*
Description of Work: *Replace the existing wall mounted lighting fixture with an LED lighting fixture.*
Comments:

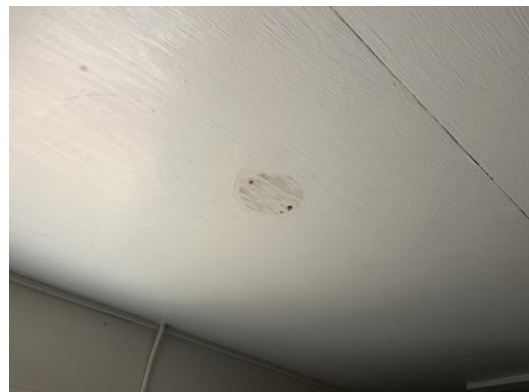
Comments: *Smoke detector is missing.*

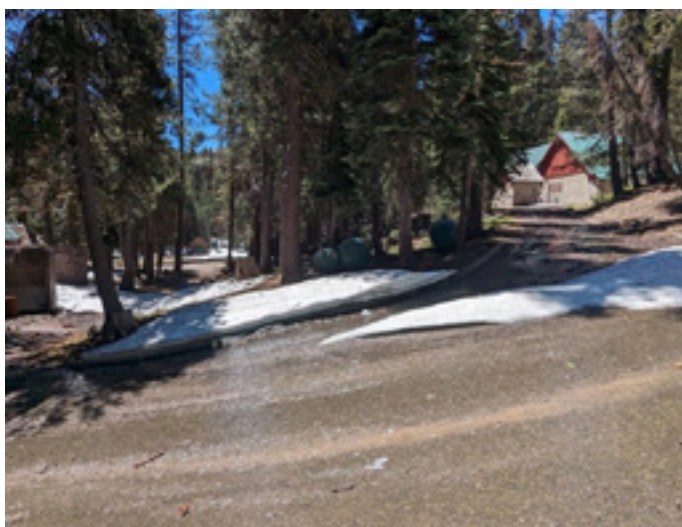
Figure 1: Lodge Approach Roadway Cross Slope

The parking lot provides the only means of public access to the site. For the approximately 49 stalls provided in the lot, a minimum of two accessible parking stalls should be provided – one for van accessible and the other for standard accessible use. Only one accessible stall is provided, but it has faded striping and no marked access aisle. An International Symbol of Accessibility (ISA) symbol on the pavement is undersized and in an inappropriate location. Posted sign marking the stalls is also not provided. The pavement slopes in the direction of the stall length are more than the standards. Regarding and repaving a portion of the parking lot for one van and one standard accessible stall and access aisle along with compliant pavement markings and posted signs is recommended.

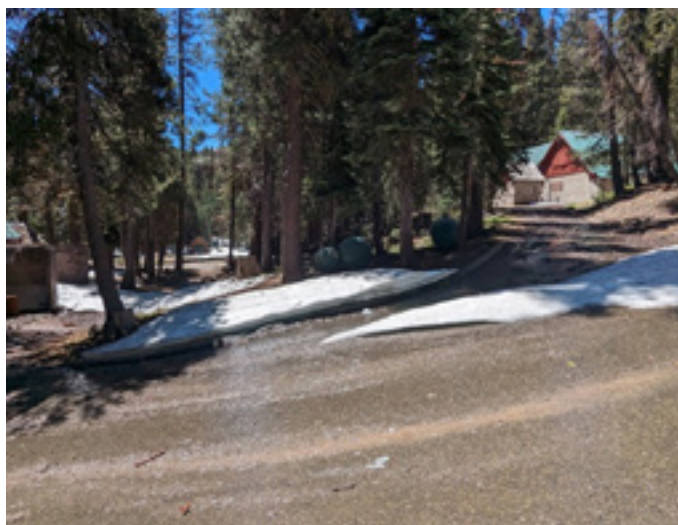
Figure 4: Manager's Office Exterior Building

Access to the front door and registration desk has significant barriers for entry with exterior steps and raised door thresholds. Within the building, the transaction desk height exceeds the standards. As a recommendation, demolish the steps and provide a compliant concrete ramp and landing, door thresholds, and alter the registration desk to provide a surface not more than 34" above the finish floor.

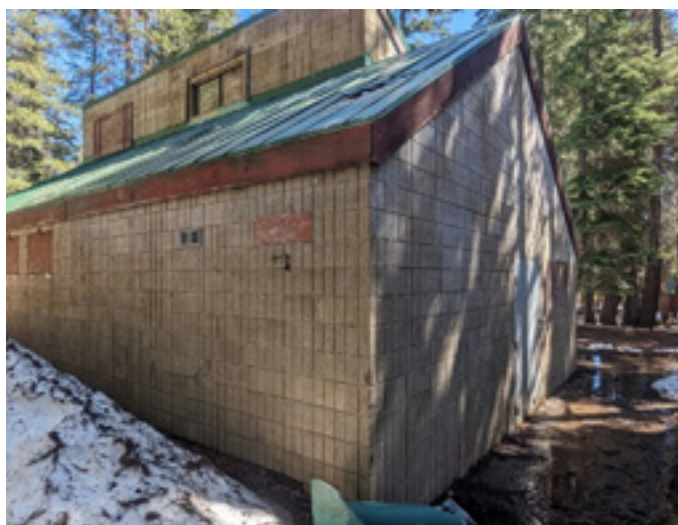
Figure 6: Restroom and Showers West Exterior View

Access to the facility was limited to the women's restroom due to snow accumulation on the other side of the building. The accessible women's restroom toilet is stall mounted, and the size of the stall and location of the toilet does not comply with the standards in the reference standard noted above. An accessible shower stall is not provided in the restroom. Lavatories in the restroom do comply with the standards. It is assumed that the men's restroom has similar deficiencies. Alterations of the Restroom and Showers building are recommended for compliance.

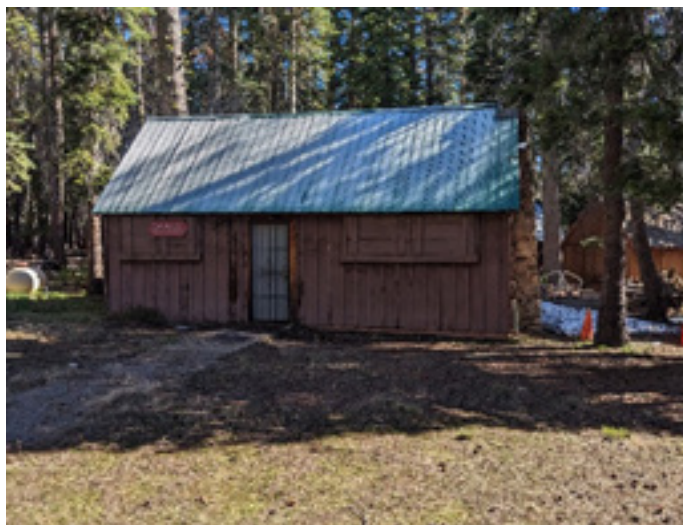
Figure 7: Nurse Cabin Exterior

A barrier is present at the entrance as the door width is inadequate and the threshold is raised at the door opening. All interior doors from the entrance to the triage room, bedroom, and bathroom lack the required minimum width for room access, and the bathroom does not have an access compliant shower or toilet for use. In view of significant barriers present in the Nurse cabin, a replacement building with compliant triage, bedroom, and bathroom is recommended for compliance.

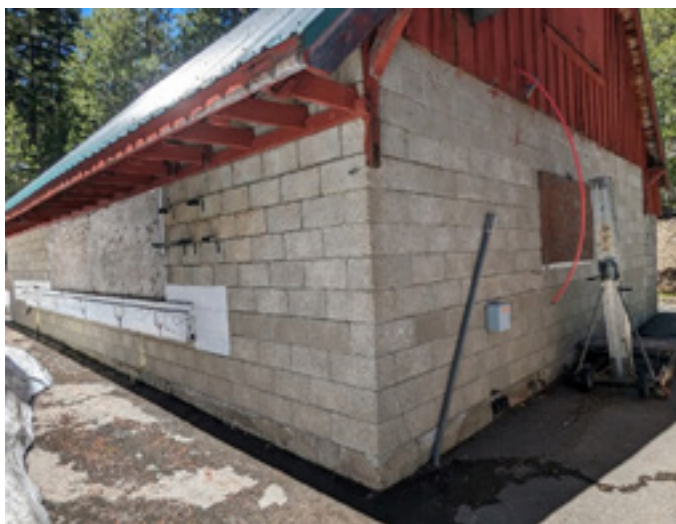
Figure 10: Exterior Southeast Corner of Kitchen

The food serving line is at an enlarged wall opening on the building's south face. The surface slope of the asphalt at the line exceeds 2.5% and is not compliant for access. The service counter was not in place for review to determine if it met the accessibility standards. Interior portions of the Kitchen are for staff use and accessibility within is not a requirement. Compliant pavement slopes at the serving line are recommended for compliance with the requirements.

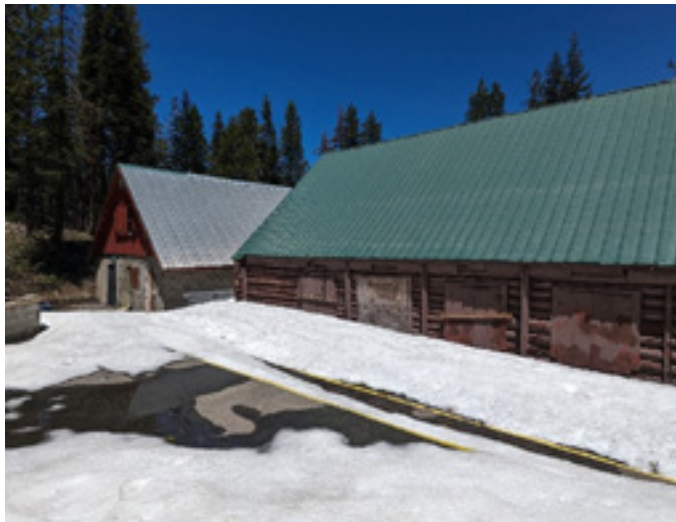
Figure 11: West Side of Lodge with Raised Deck and BBQ on Left of View. Shown Beyond Lodge is the Kitchen

Kitchell could not evaluate the accessibility of the Lodge as the approach to the Lodge entrance and accommodations was restricted by snowbanks. The patio at the Lodge's rear is higher than the building floor, and no ramp is provided for access to the patio or the BBQ. Access to the multiple levels of the rear patio by ramps is recommended.
