415 E POPLAR STREET SITE PHOTOS

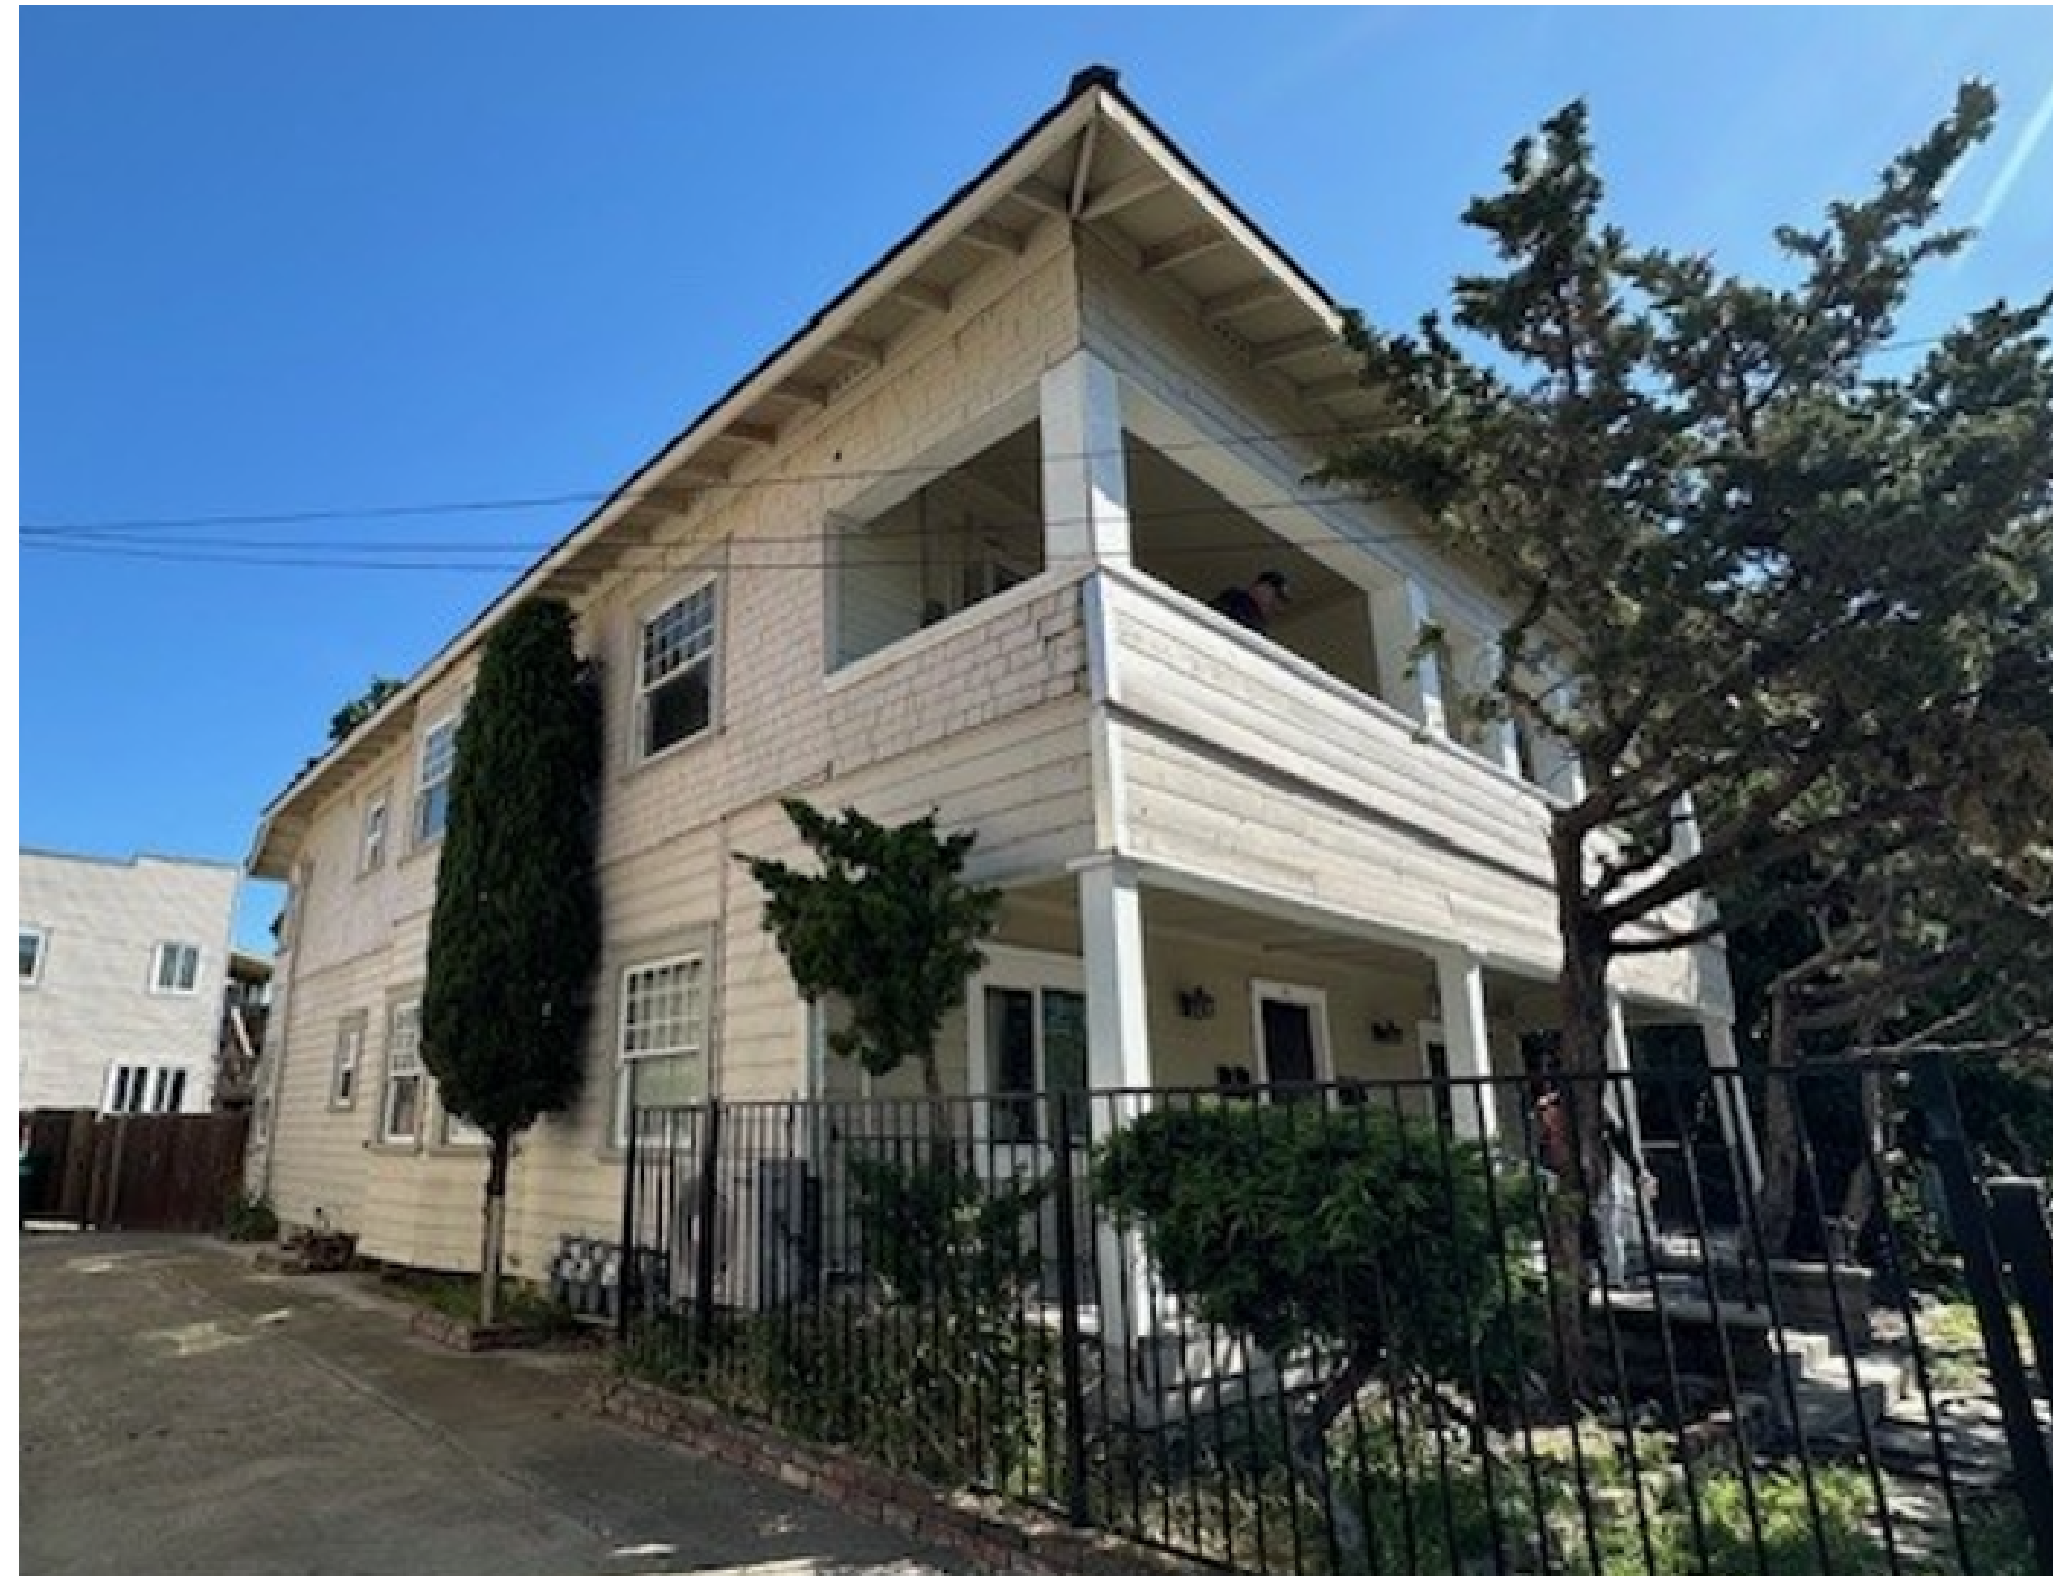
Current Condition photo of the southwest corner of the building showing the original shake siding and windows and trims that remains on the west elevation, and the replacement siding and windows on the front (south) elevation.

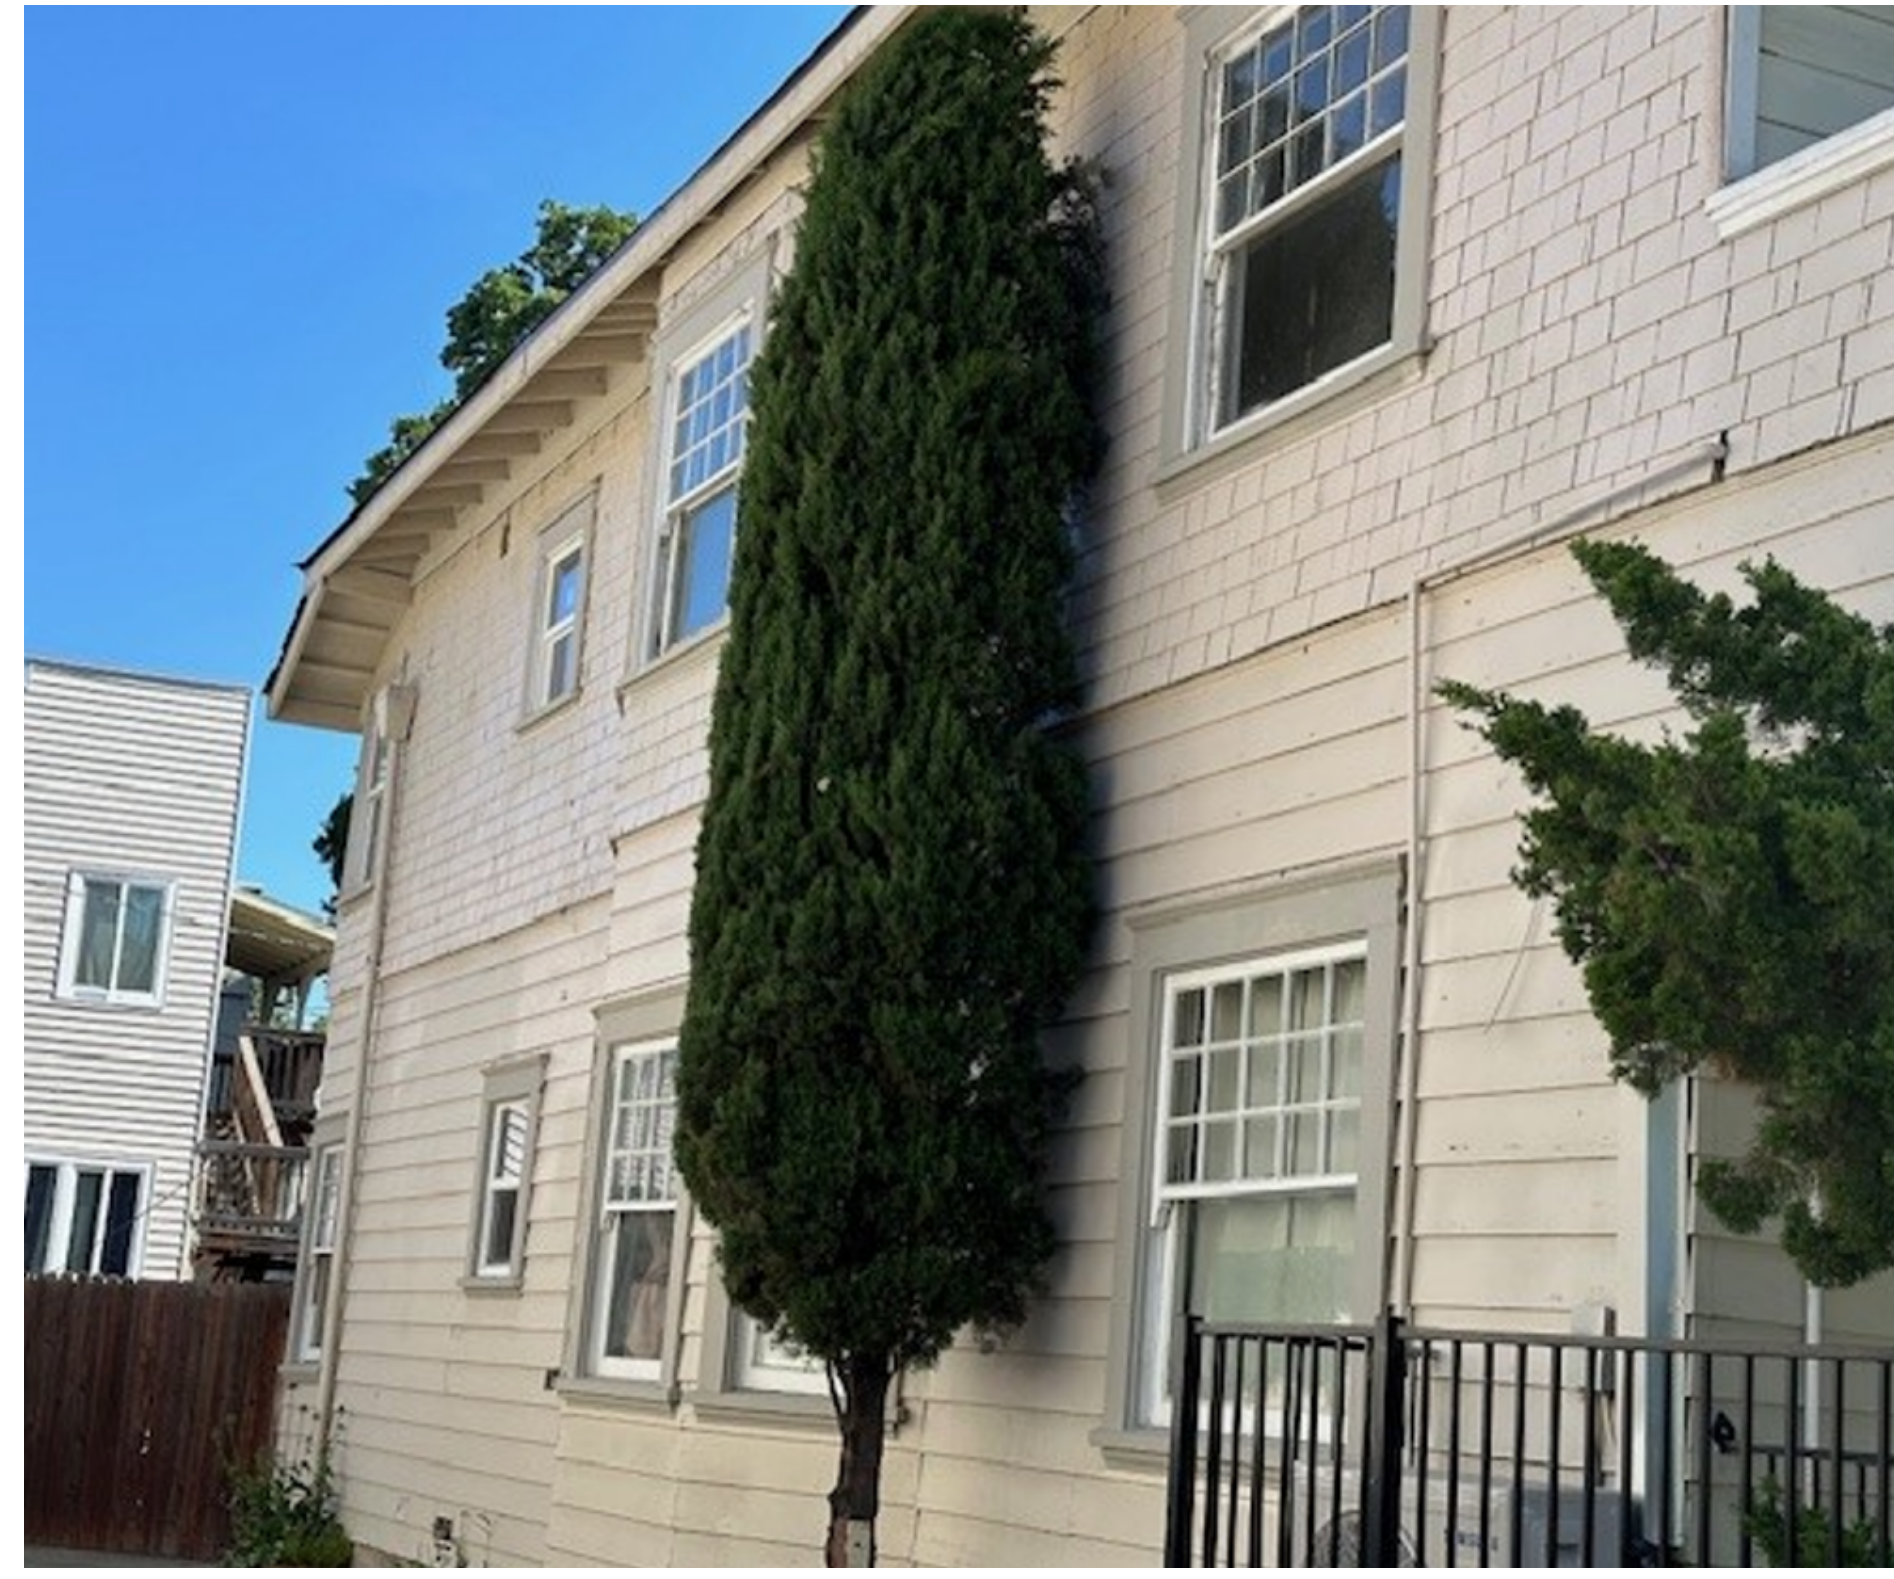
Closer view of west elevation existing conditions.

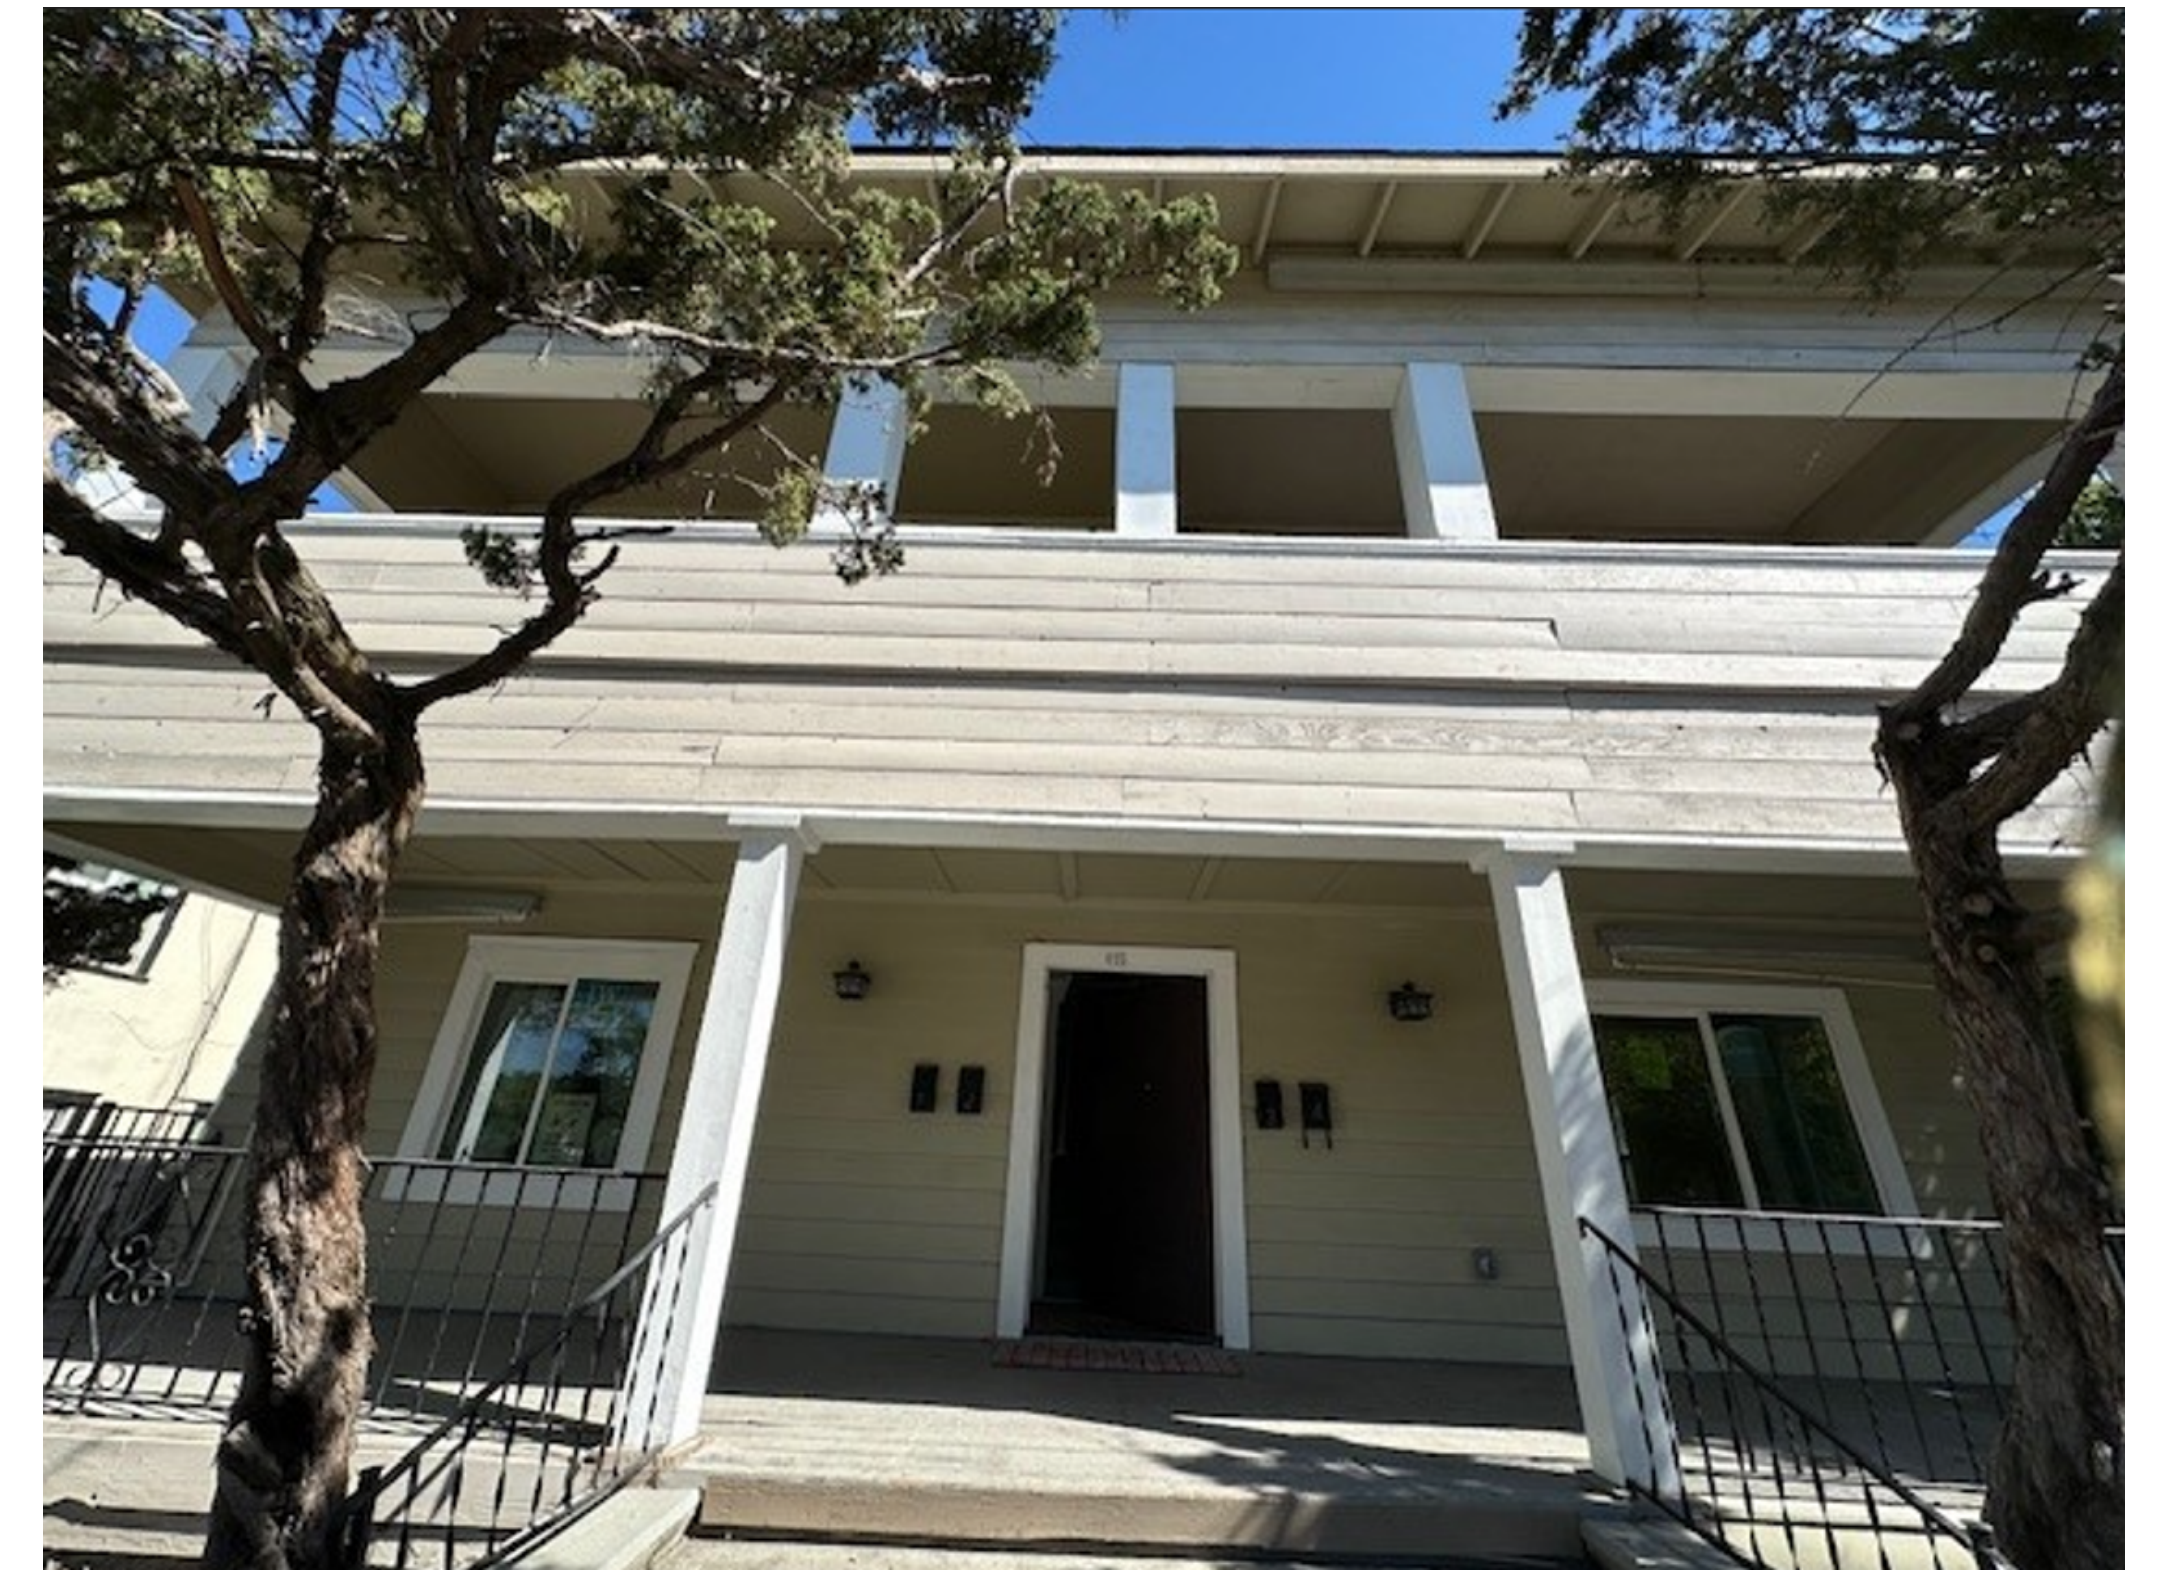
Closer view of south elevation existing conditions.

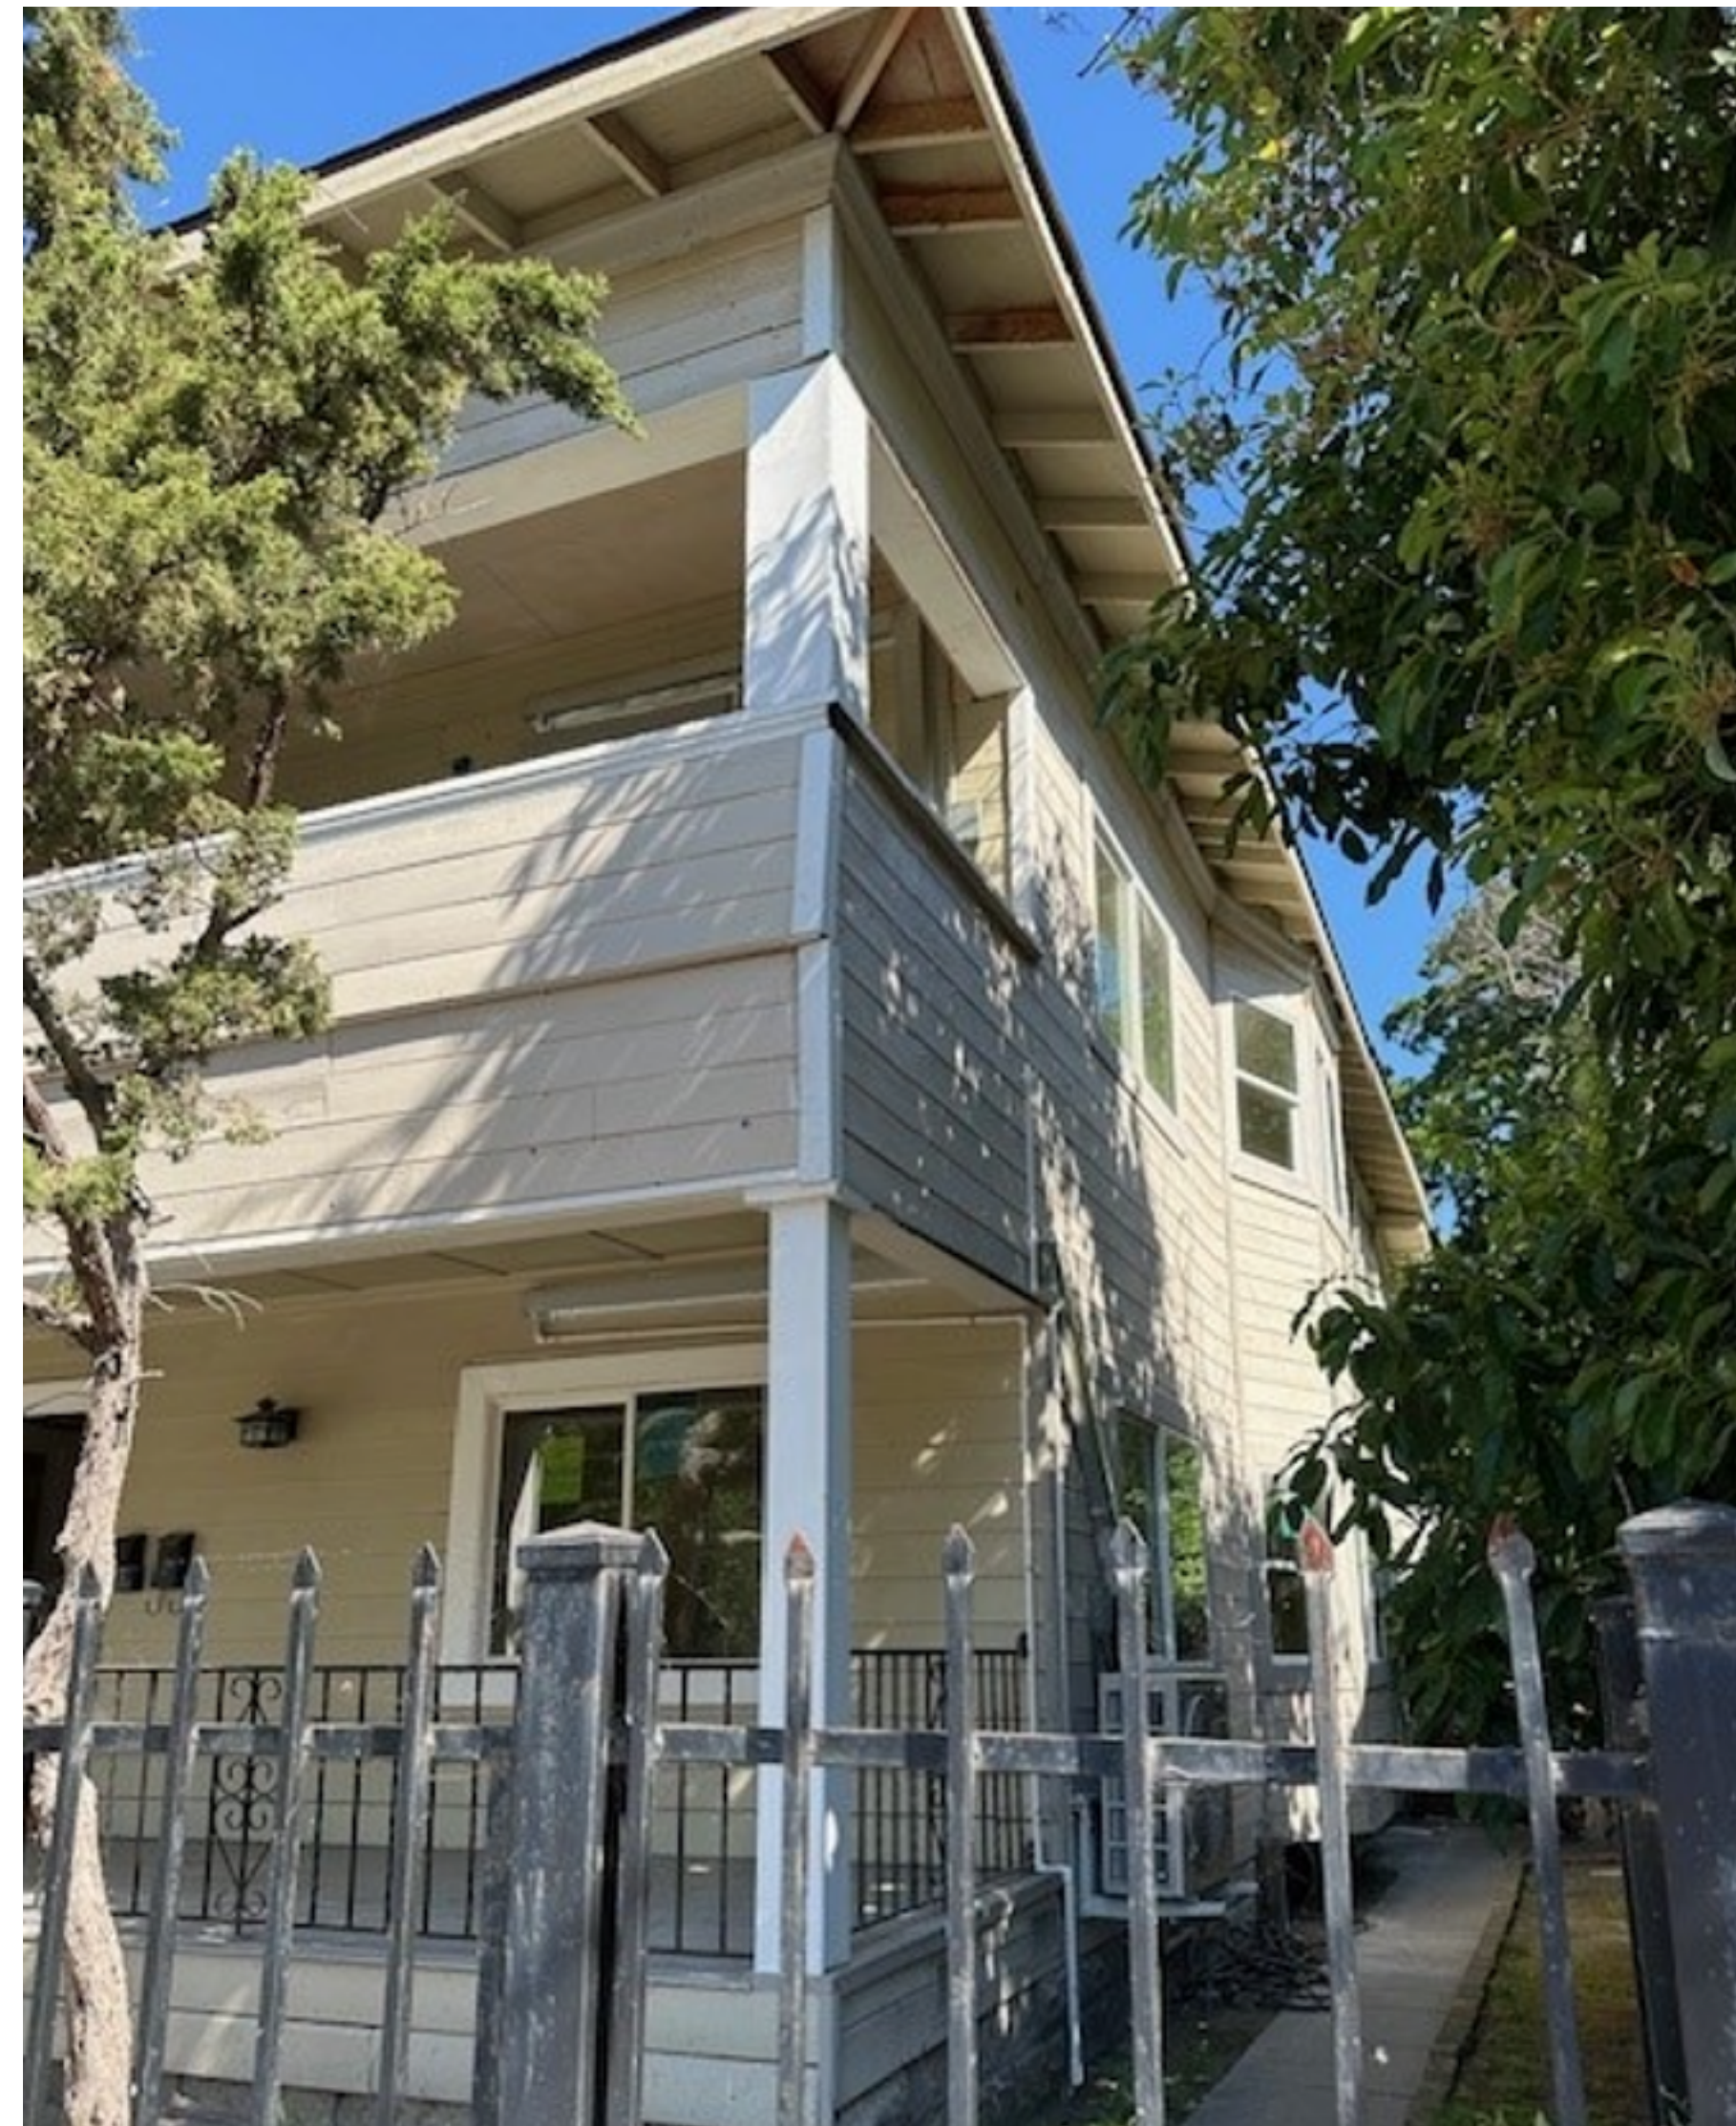
Current Condition photo of the southeast elevation showing new siding and window and trim replacements.

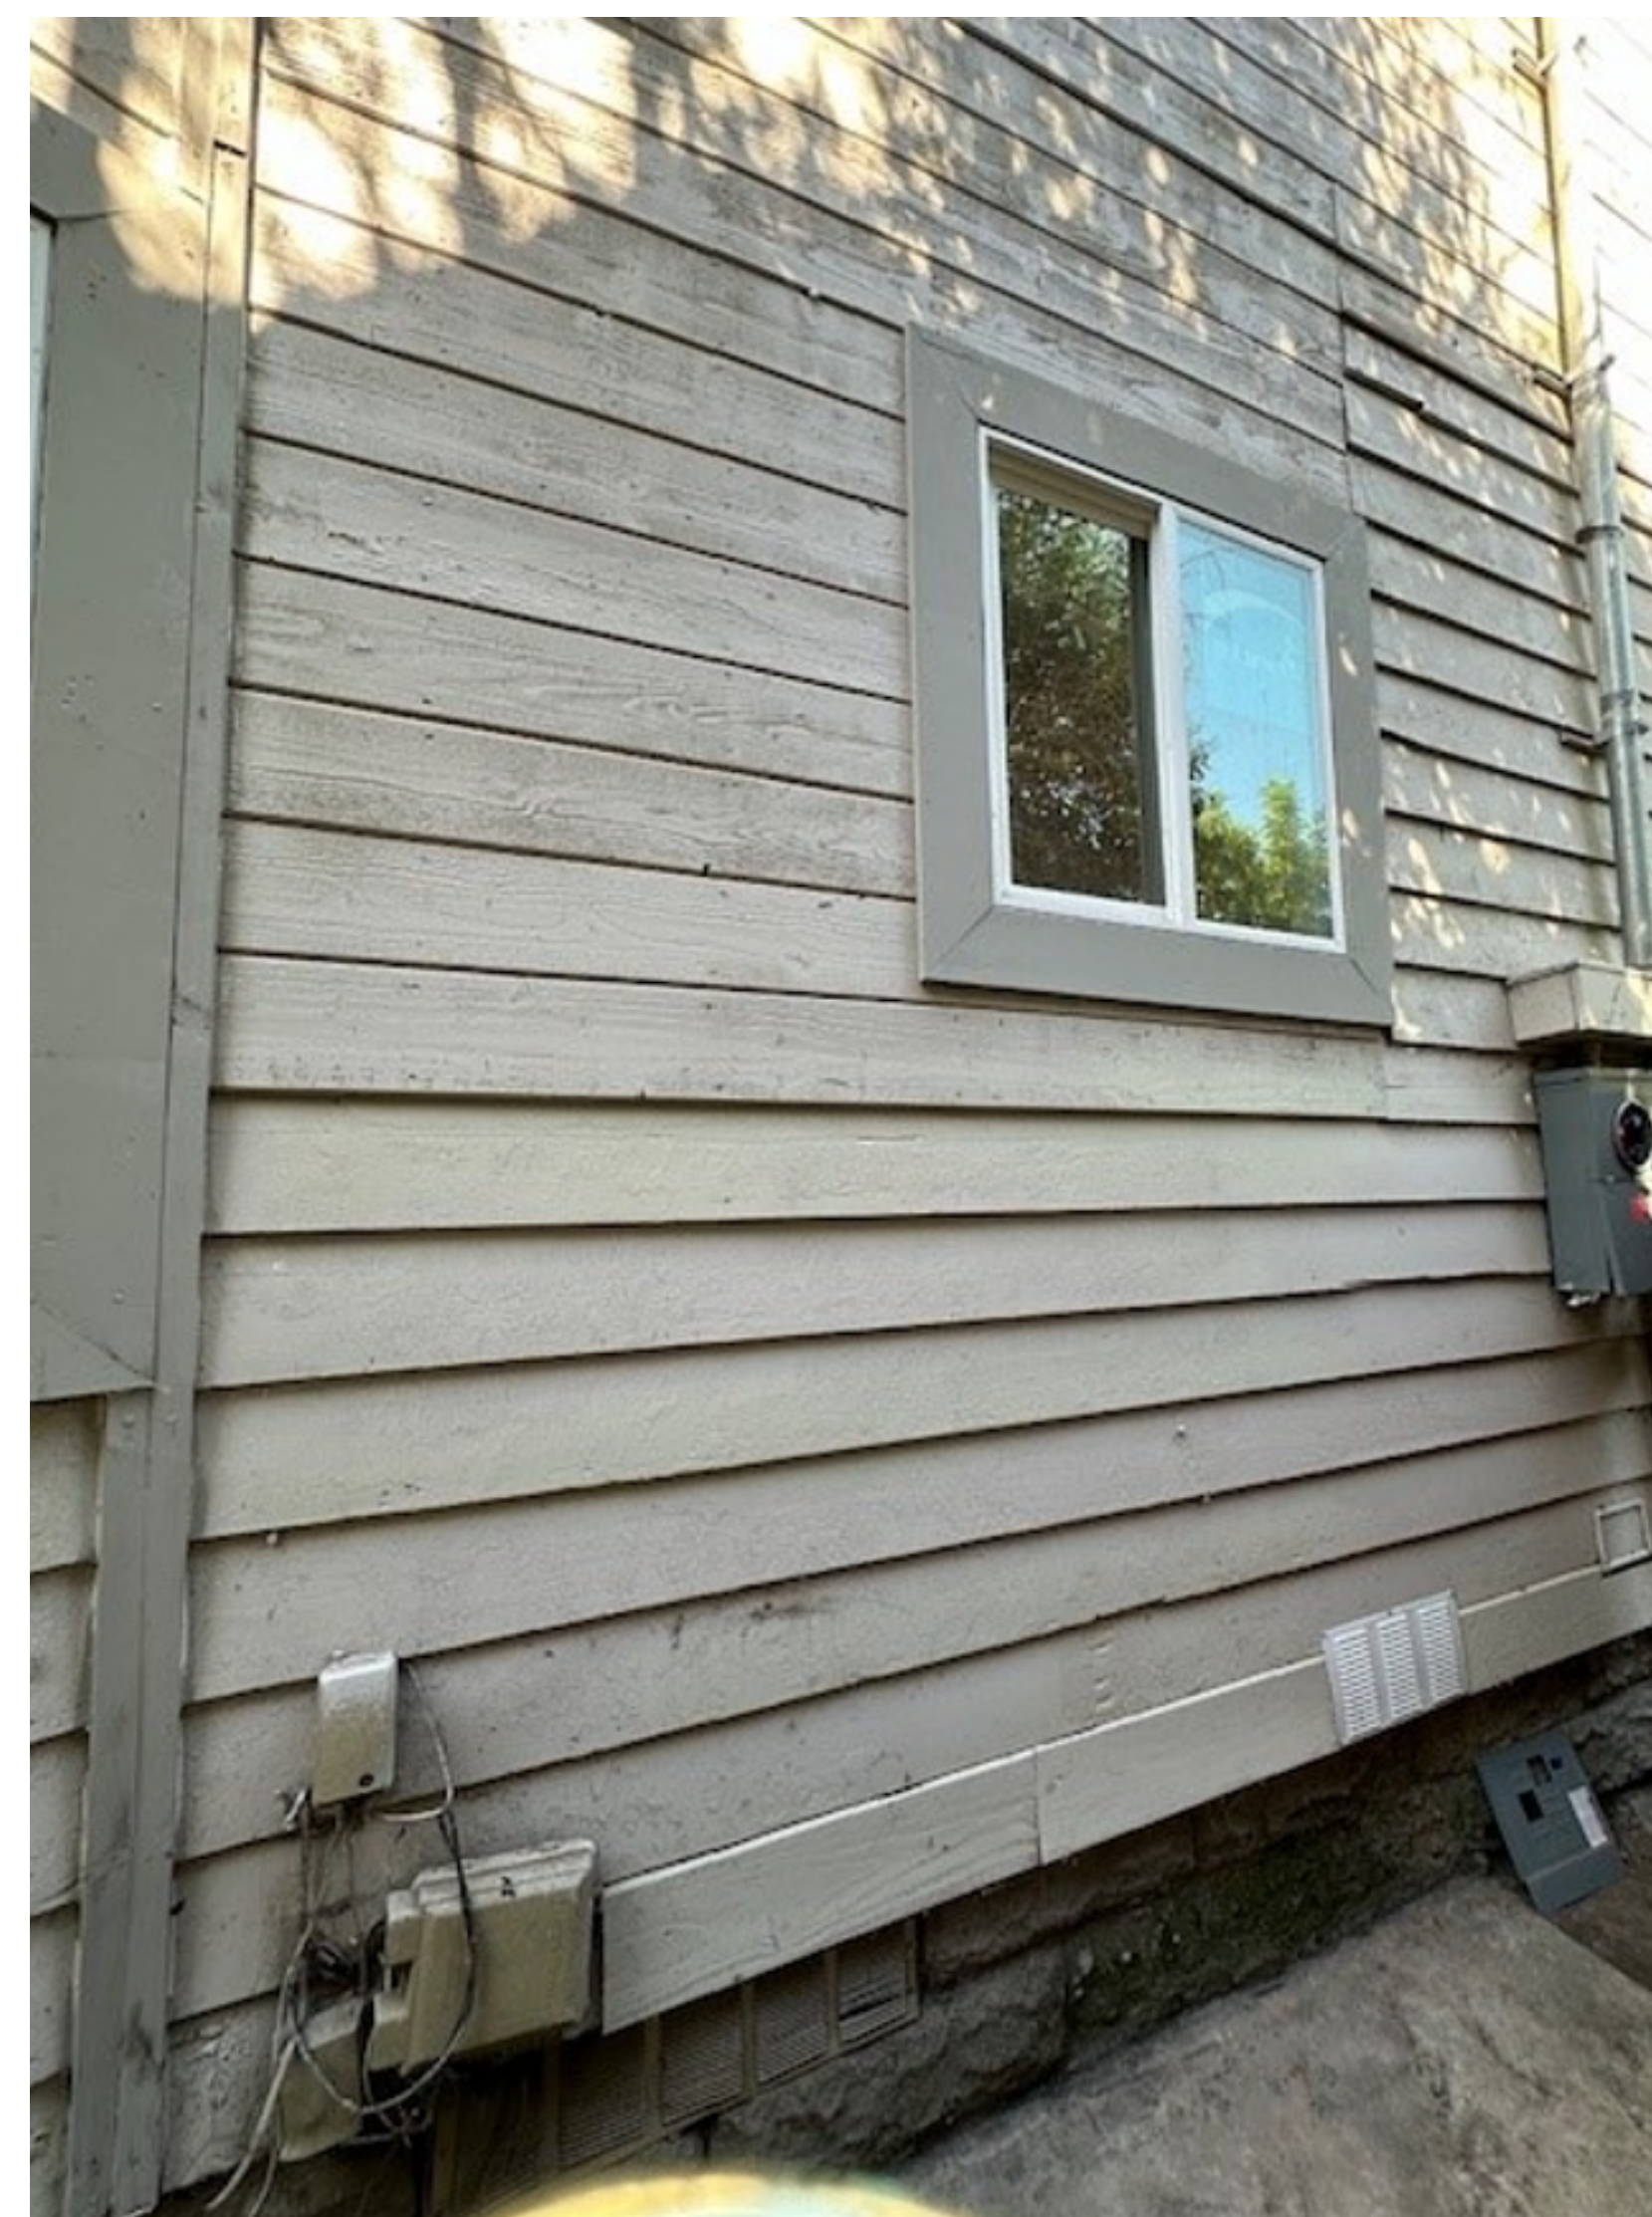
Current Condition photo of the east elevation showing areas where application of new siding and existing siding occur. Image also shows new window and trim types

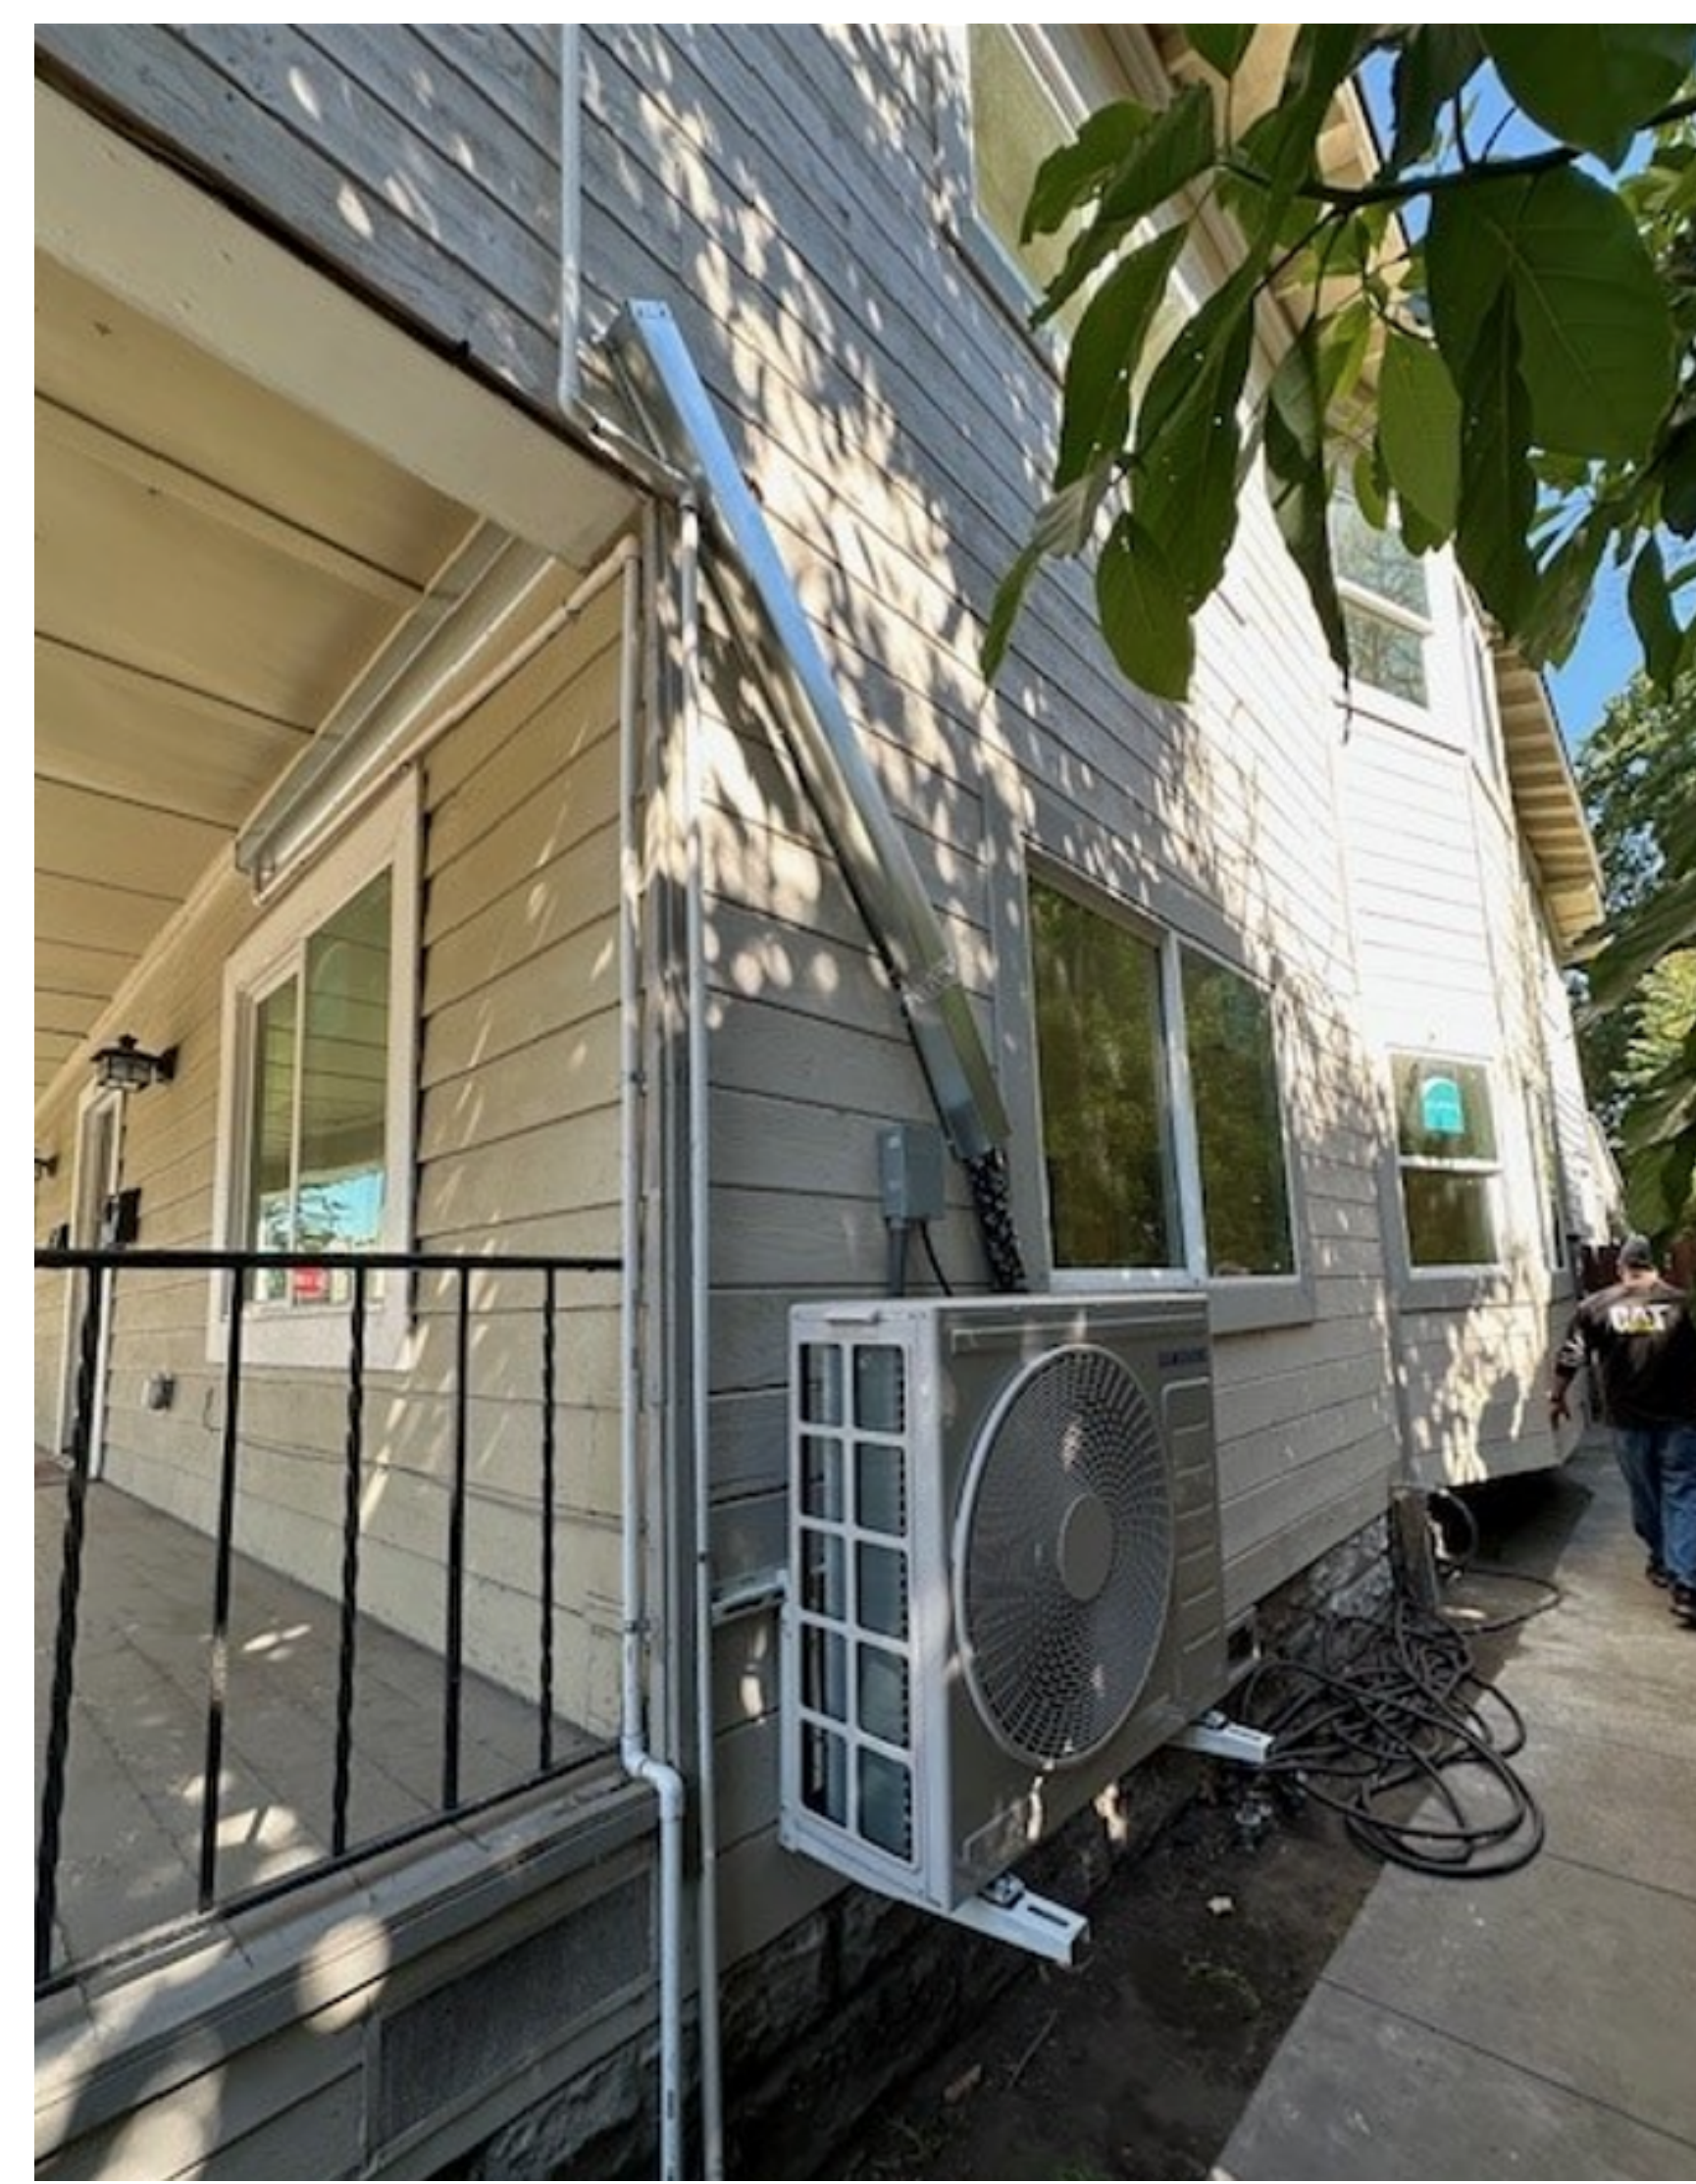
Current Condition photo of the east elevation showing areas where application of new siding. Image also shows new window and trim types.
