415 E POPLAR STREET SITE PHOTOS

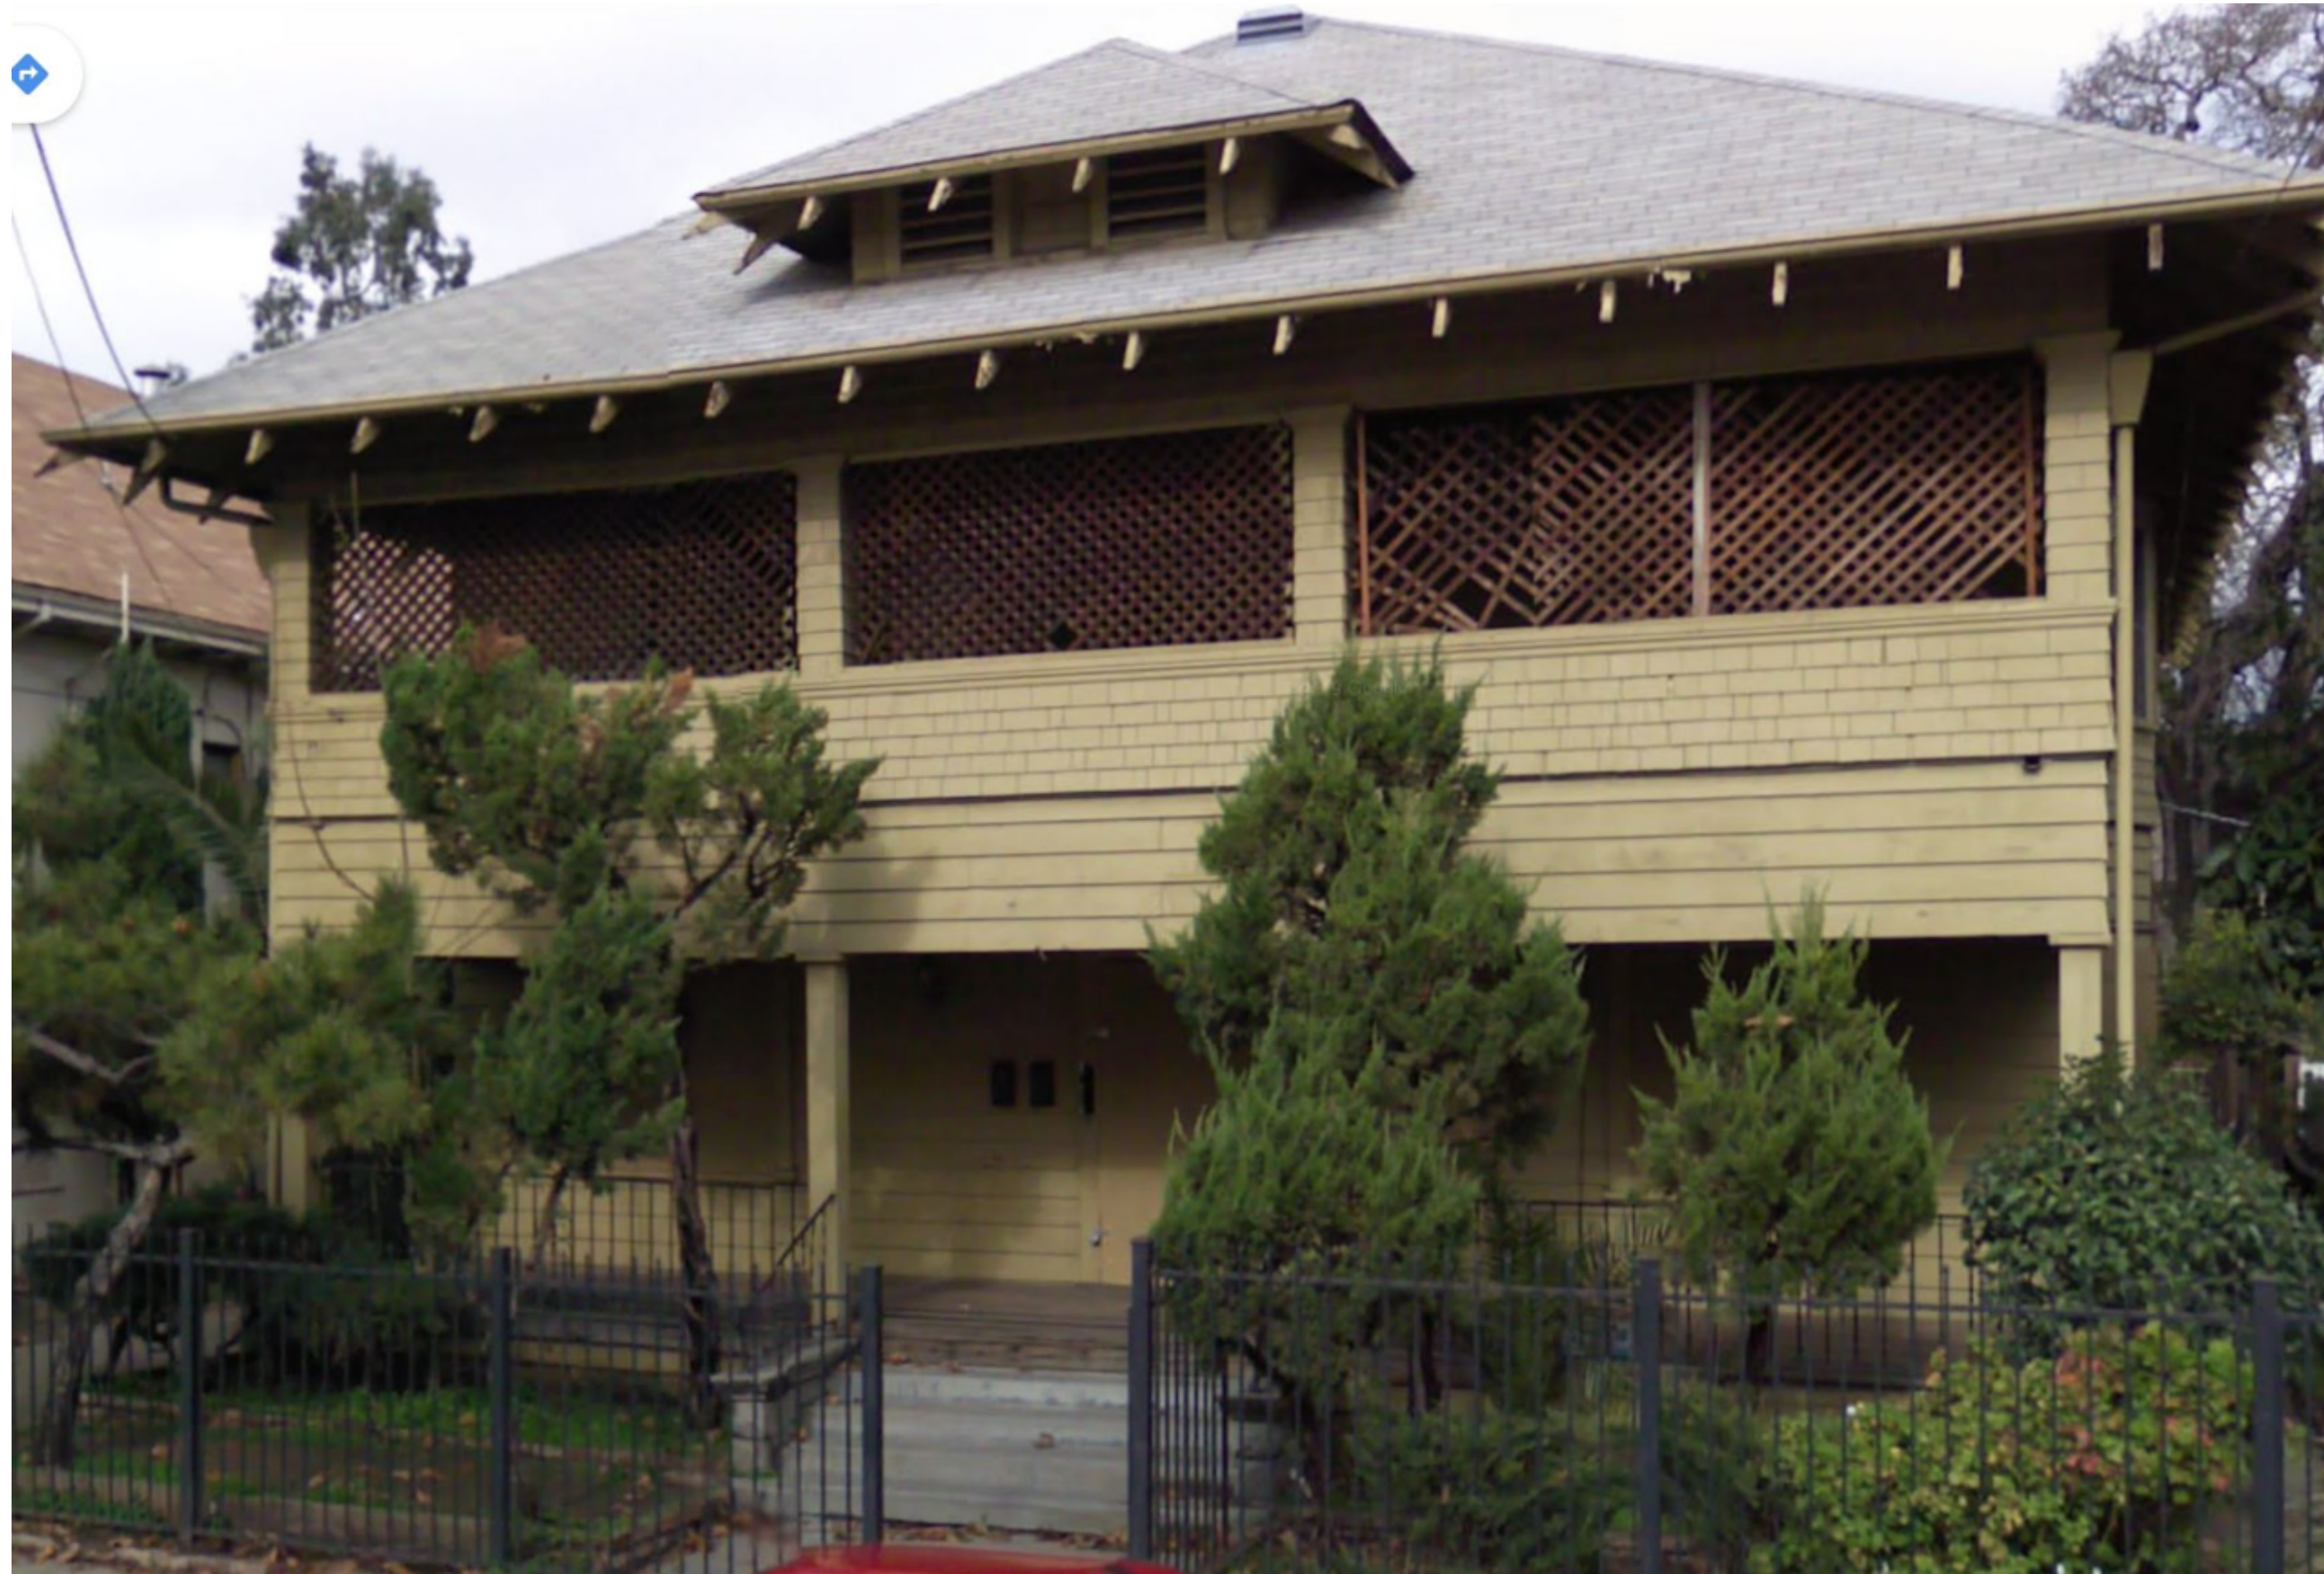
Front (south) elevation. Source: Google Street View, 2009.

Images show the building showing the shake and stacked lap siding on the south (front) and west elevations.
Older west elevation view is unavailable due to vegetation.
