**SUBJECT: REQUEST FOR BUDGET AMENDMENT FOR COMPREHENSIVE  
WELL EVALUATION WATER OF WELL NO. 33 - PROJECT NO. UH22005**

## **Well No. 33 Evaluation Work Plan**

### **City of Stockton**

# WATER WELL VIDEO REPORT

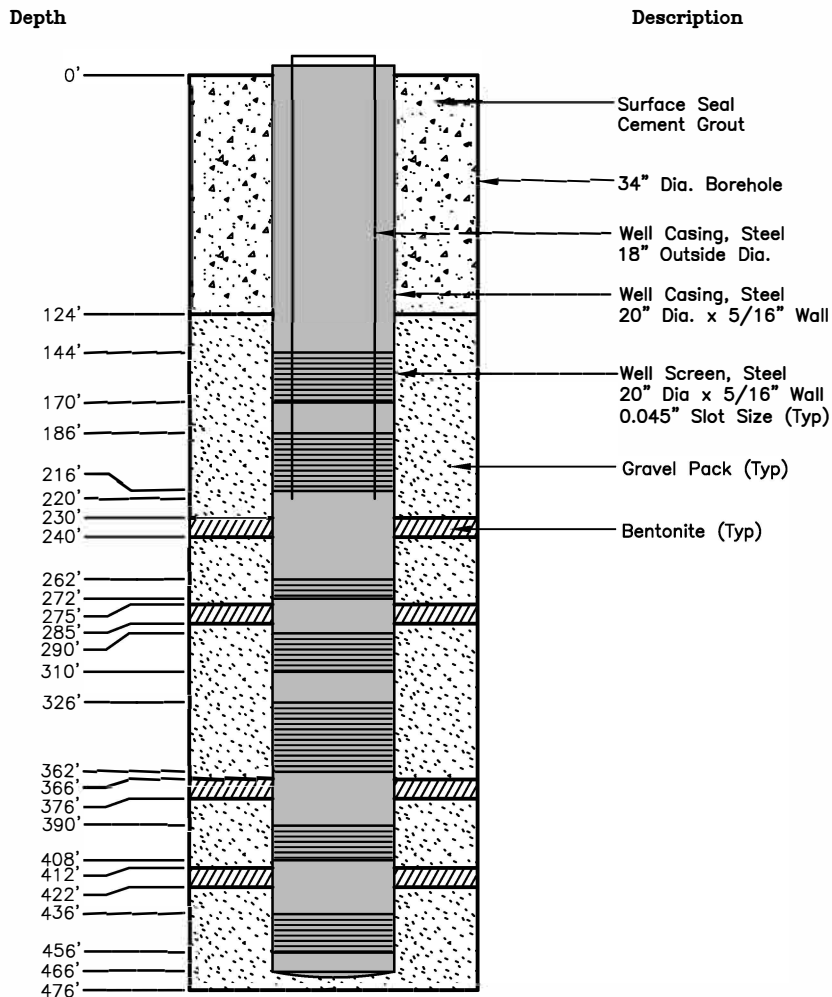
Figure 1. City of Stockton Well No. 33 Profile

During the video survey, the upper two screen sections (144' – 170' and 186' – 216') were not visible due to the installation of an inner, 18-inch diameter, steel casing set within the well to a depth of 220 feet (**Figure 1**). The presence of the inner casing was not known about at the start of the video survey. Ken Worster (Brown and Caldwell), who worked on the Well No. 33 project in 2009, communicated to the City that the inner casing was installed after the 2009 well construction and testing to mitigate cascading water conditions originating from the two uppermost screen intervals.

- The inner, 18-inch casing in the well shall be removed in order to provide access to the upper screened zones for brushing and inspection. The inner casing shall be removed in such a manner that will allow for its reinstallation at the conclusion of pump testing.

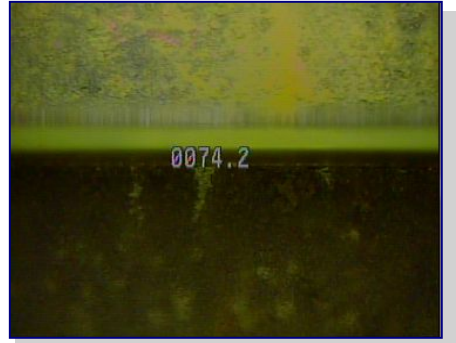
Depth: 74.2 Feet

WELLBORE SNAPSHOTS	DEPTHS (SideScan-Feet)	WELLBORE / CASING INFORMATION
	0.0 Ft.	Zeroed At Side Scan Lens
 	74.2 Ft.	Static Water Level (SWL)
 	139.6 Ft.	Unknown Square Cutout

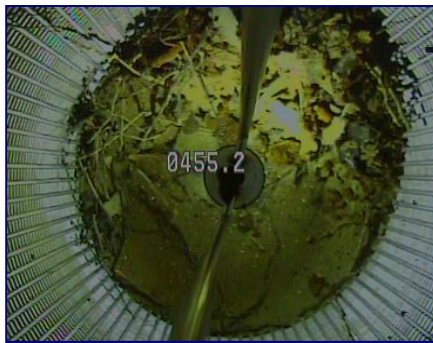
Depth: 455.2 Feet

Bacterial growth was observed on the screens below the installed liner. Although the uppermost screens, behind the 18-inch casing, are not visible, it is reasonable to expect that they are in the same condition as the lower screen sections. Approximately 21-feet of fill material was also observed in the bottom of the well.

455.2 Ft.	Down View Top of Fill @ 456.7, Still in Perforations

- After the inner casing has been removed, the fill material in the well shall be removed via open-ended airlifting. Fluids generated during airlifting shall be discharged to a settling tank. After the fluids have passed through the settling tank, the fluids may be discharged to the on-site sanitary sewer inlet. All fluids discharged to the sanitary sewer inlet will be free of solids. The maximum rate of discharge to the sanitary sewer system will be 300 gpm. A totalizing flow meter and valve to regulate flow shall be installed on the discharge assembly. The daily volume of water discharged to the sanitary sewer system shall be recorded. Airlifting shall continue until the fluids generated from the well are clear and free of solids. At the conclusion of airlifting, the Contractor shall determine the depth of the by direct measurement.

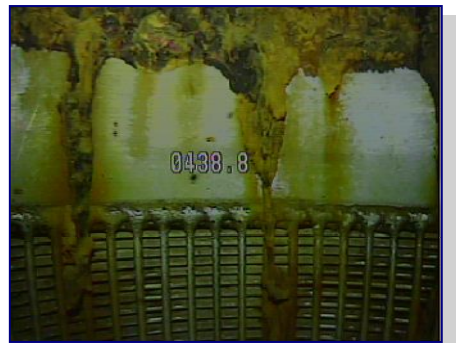
Depth: 438.8 Feet

401.9 Ft.	Wire Wrapped Stainless Steel Screen
 	410.2 Ft.	Perforations, Bottom of Wire Wrapped Stainless Steel Screen
 	438.8 Ft.	Perforations, Top of Wire Wrapped Stainless Steel Screen

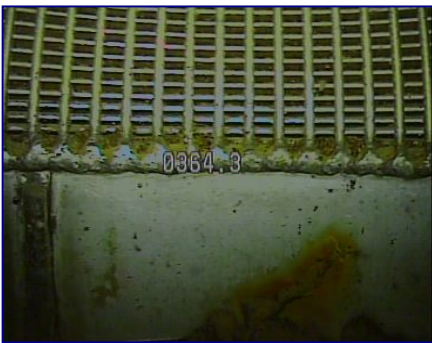
Depth: 364.3 Feet

328.9 Ft.	Perforations, Top of Wire Wrapped Stainless Steel Screen
 	364.3 Ft.	Perforations, Bottom of Wire Wrapped Stainless Steel Screen
 	392.0 Ft.	Perforations, Top of Wire Wrapped Stainless Steel Screen

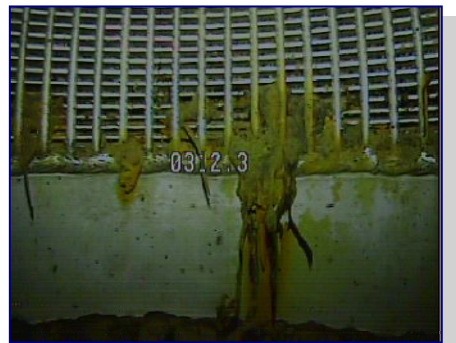
Depth: 312.3 Feet

274.2 Ft.	Perforations, Bottom of Wire Wrapped Stainless Steel Screen
 	292.9 Ft.	Perforations, Top of Wire Wrapped Stainless Steel Screen
 	312.3 Ft.	Perforations, Bottom of Wire Wrapped Stainless Steel Screen

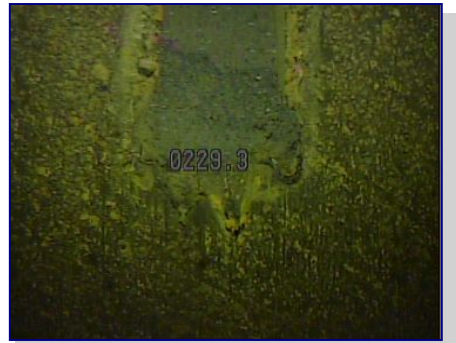
Depth: 229.3 Feet

219.8 Ft.	18-inch x 20-inch Casing Reduction
 	222.3 Ft.	Top of Sounding Box
 	229.3 Ft.	Bottom of Sounding Box
	264.8 Ft.	Perforations, Top of Wire Wrapped Stainless Steel Screen
