East Elevation

House Dealers LLC

415 E Poplar Street
Stockton Ca 95202

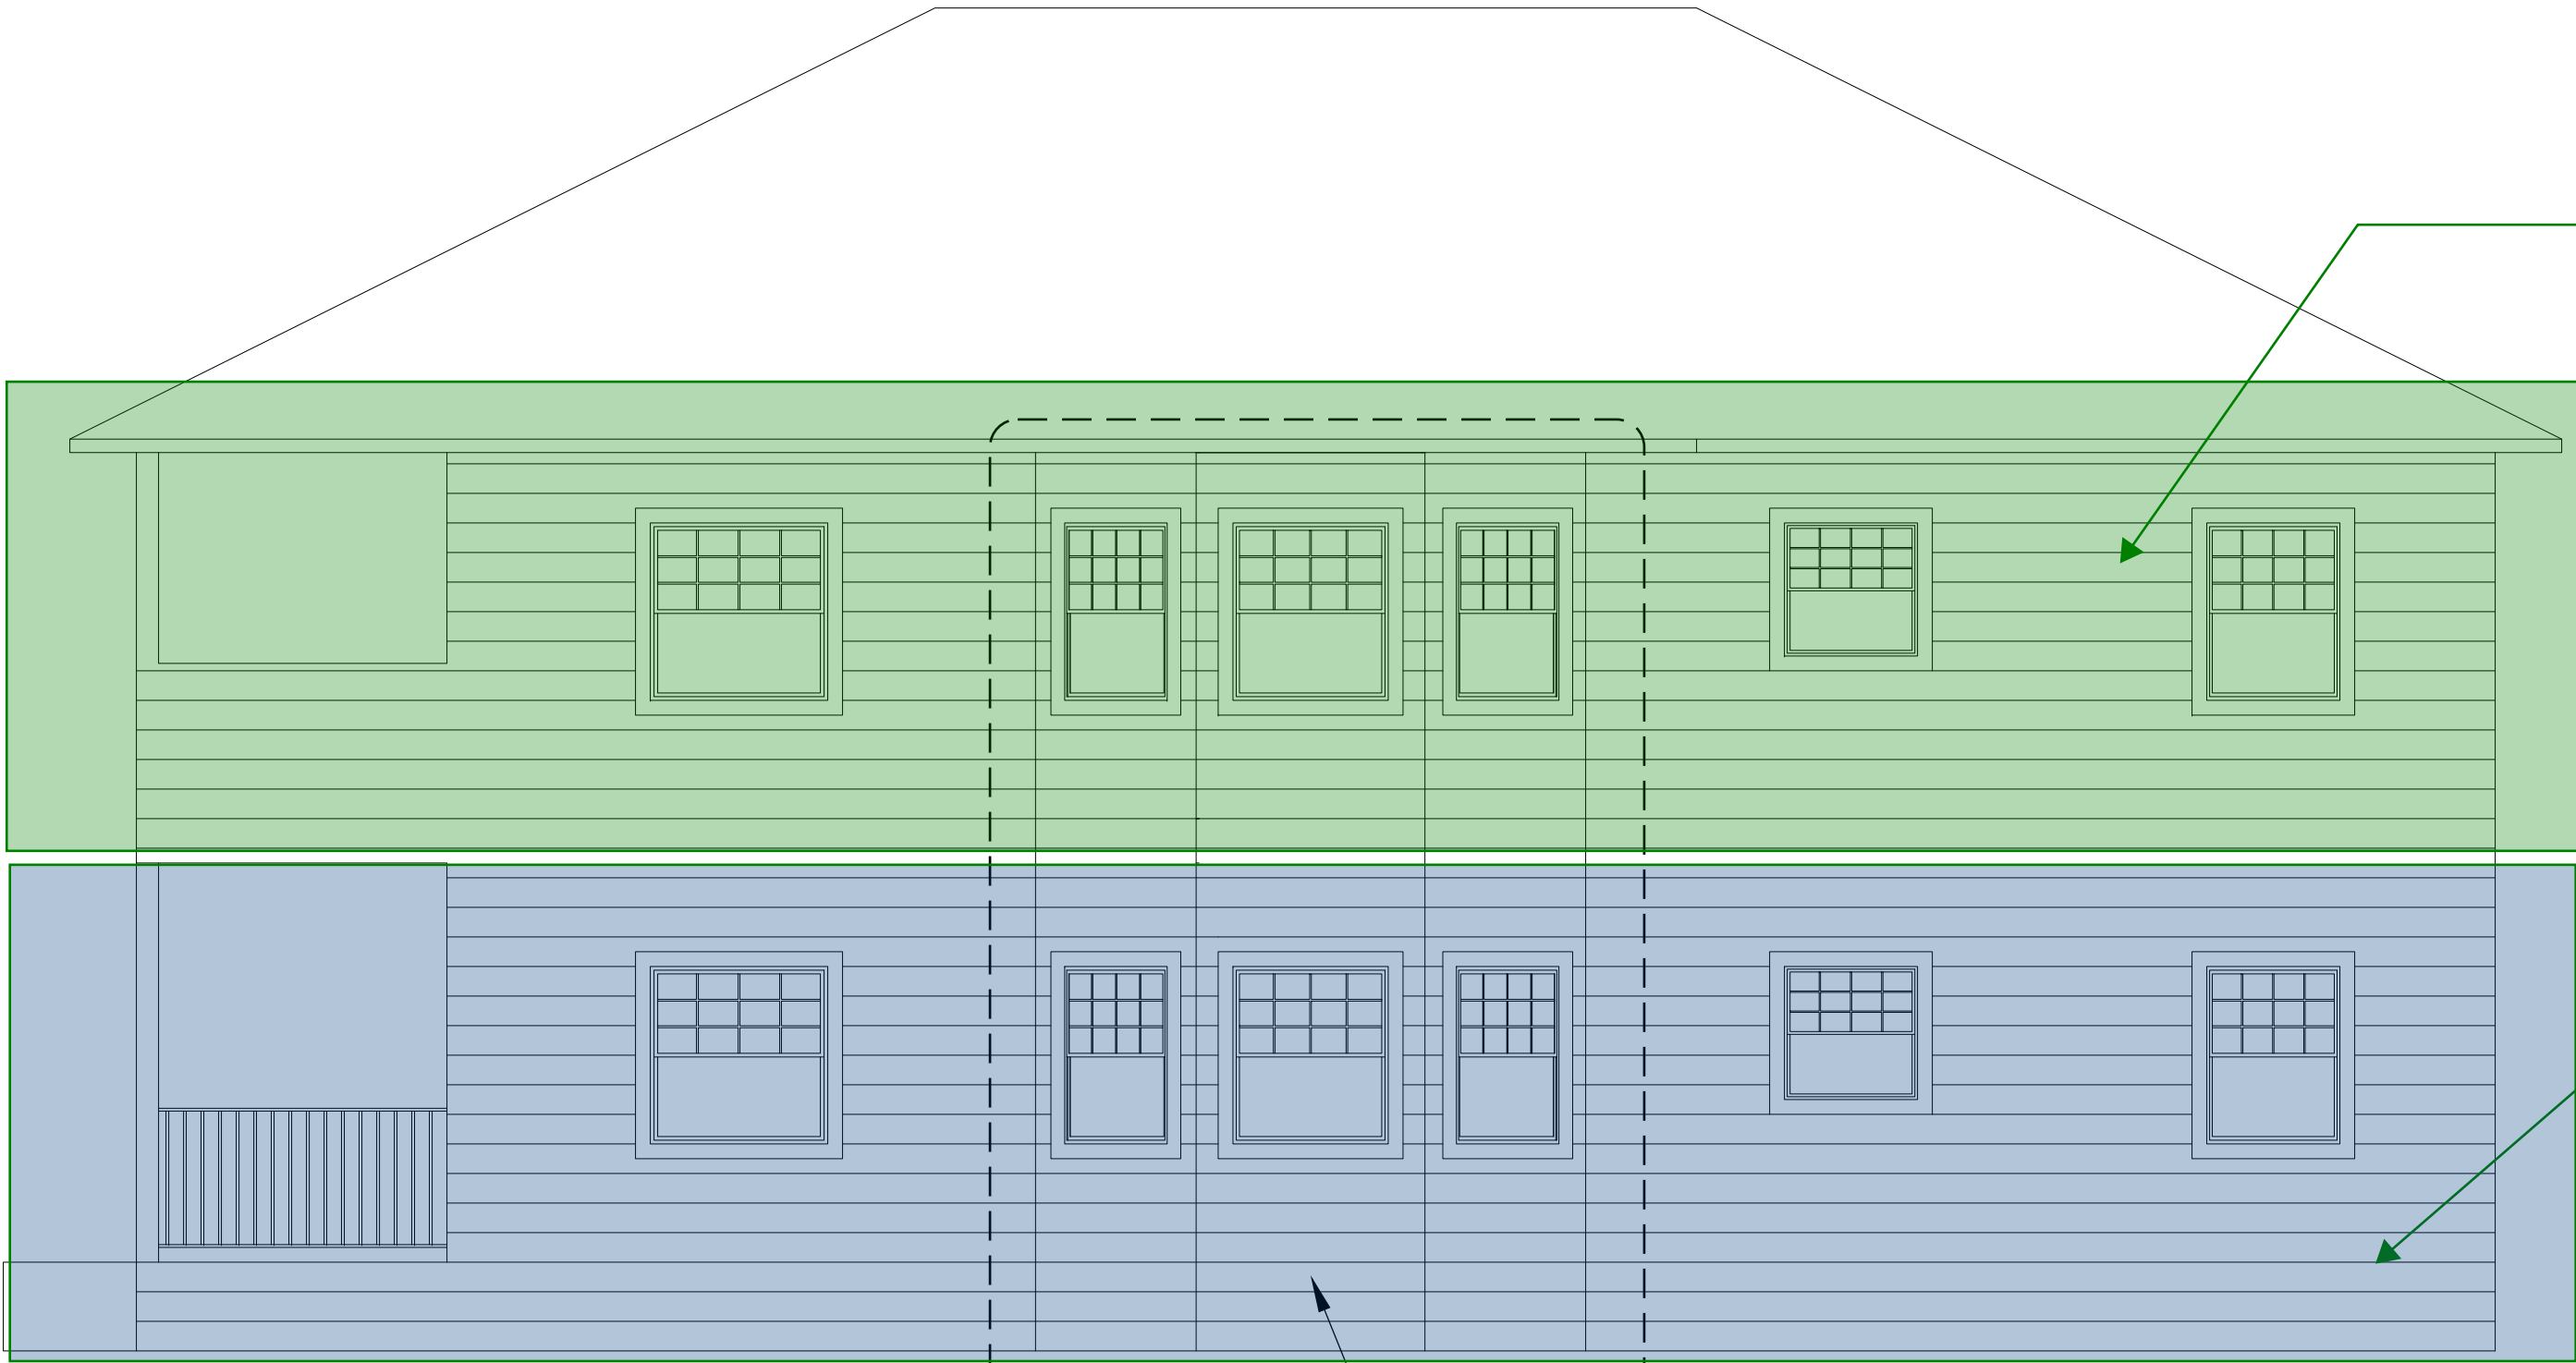
3
A2

Shake siding on on second flilor was removed and replaced with horizontal siding.

First floor horizontal stacked lap siding was replaced with flat wood siding.

On This Area Of The House The Siding Was Damaged & Was Replaced With New Siding With Groves To Match Existing As Close As Possible. See Picture 3/A3

All windows replaced with vinyl windows. Grids shall be added to resemble original windows

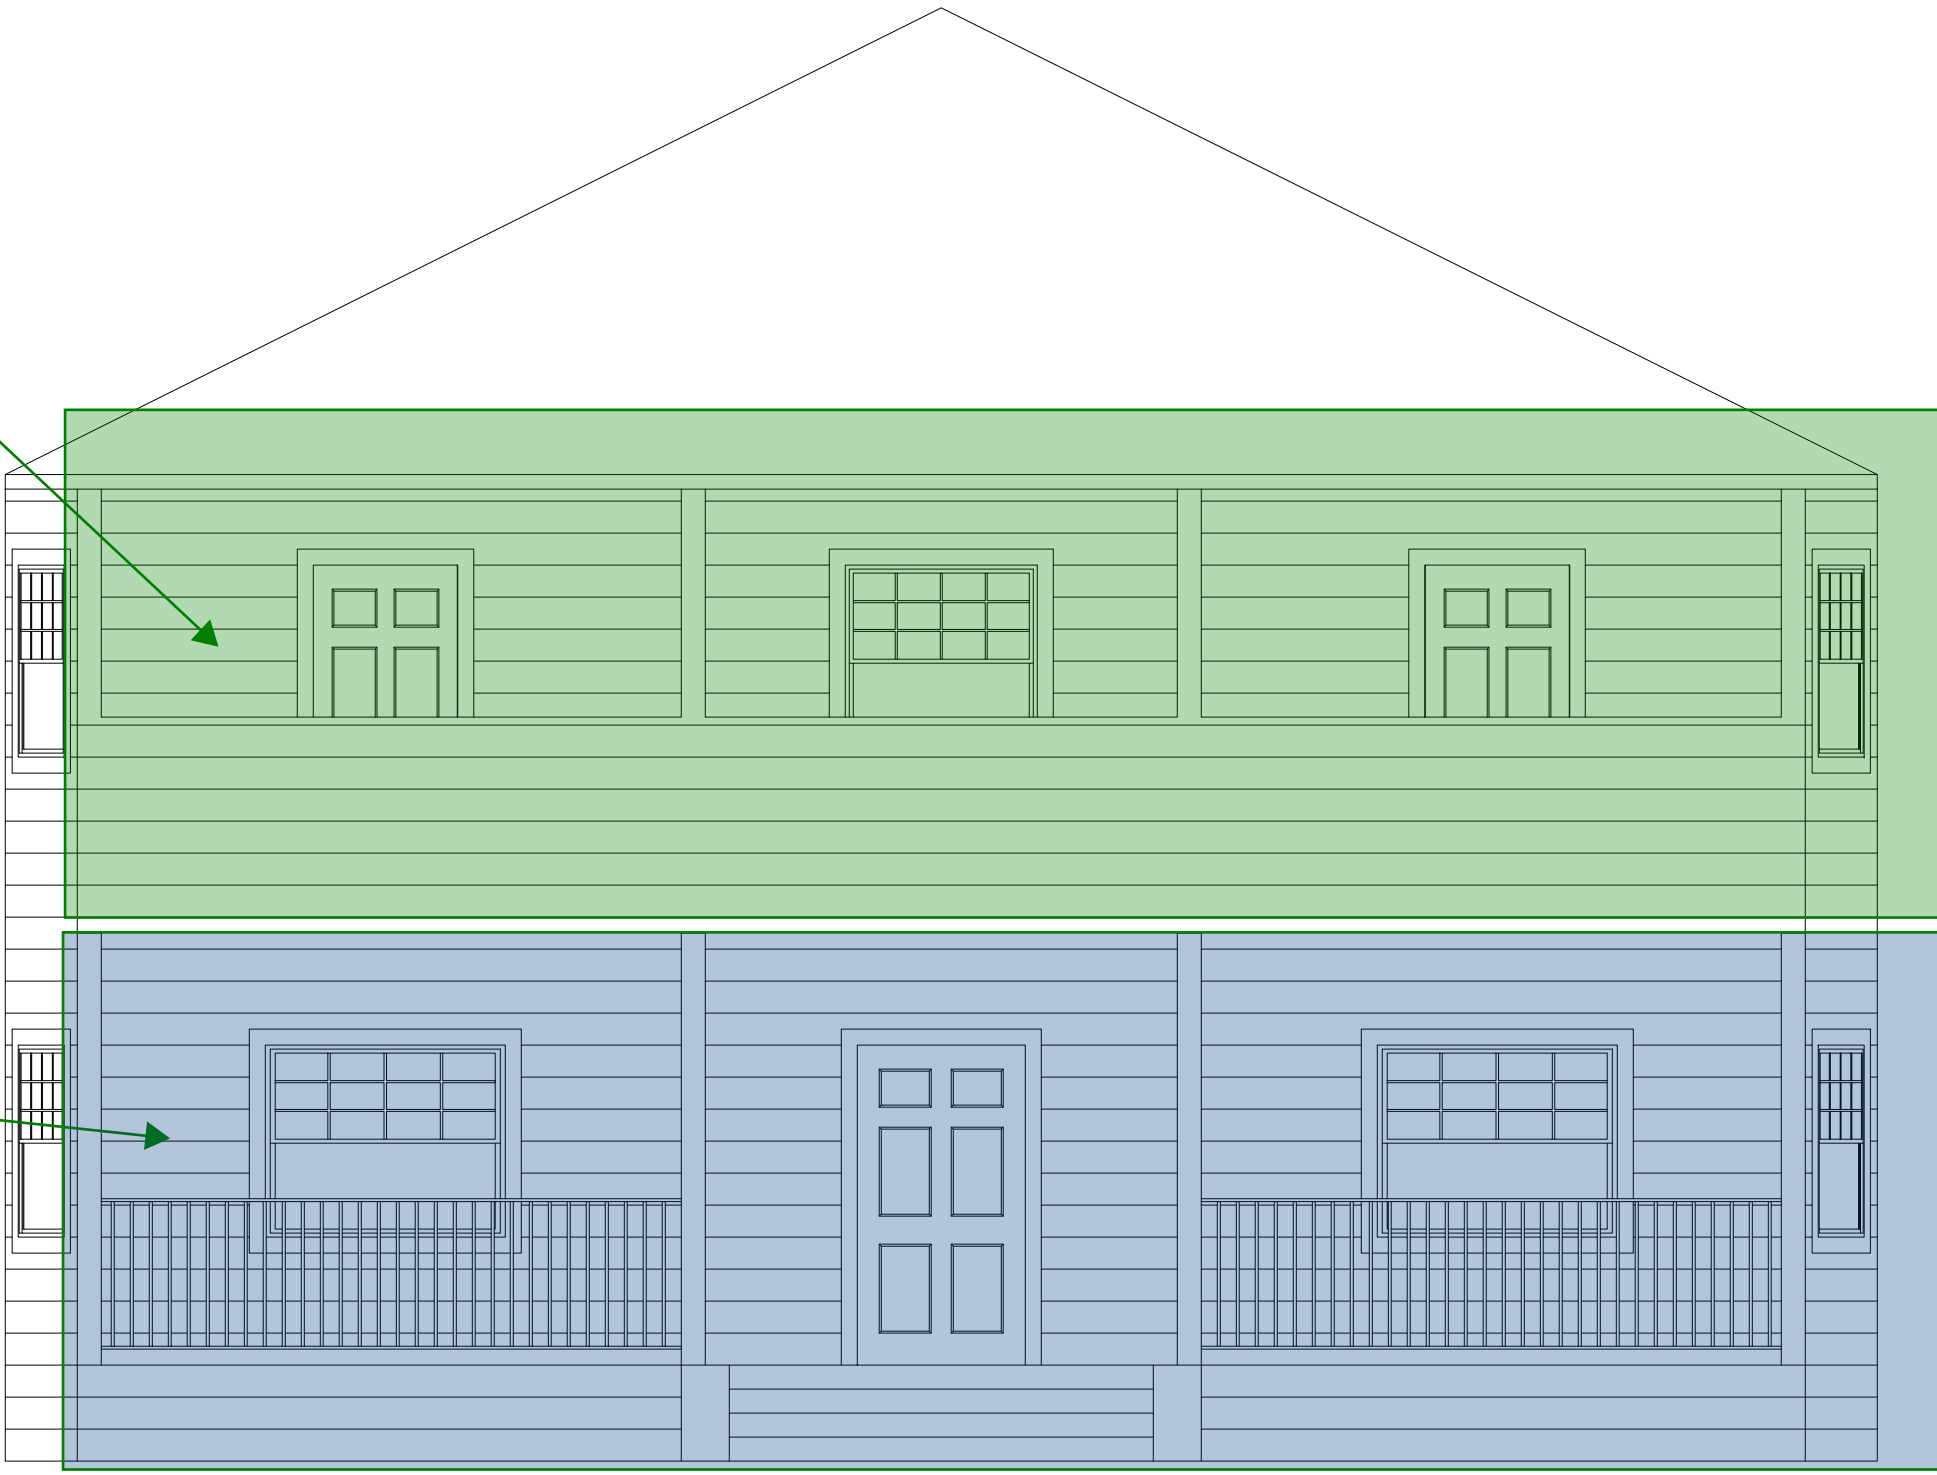
1
A2

No changes to siding on this elevations.

All windows replaced with vinyl windows. Grids shall be added to resemble original windows

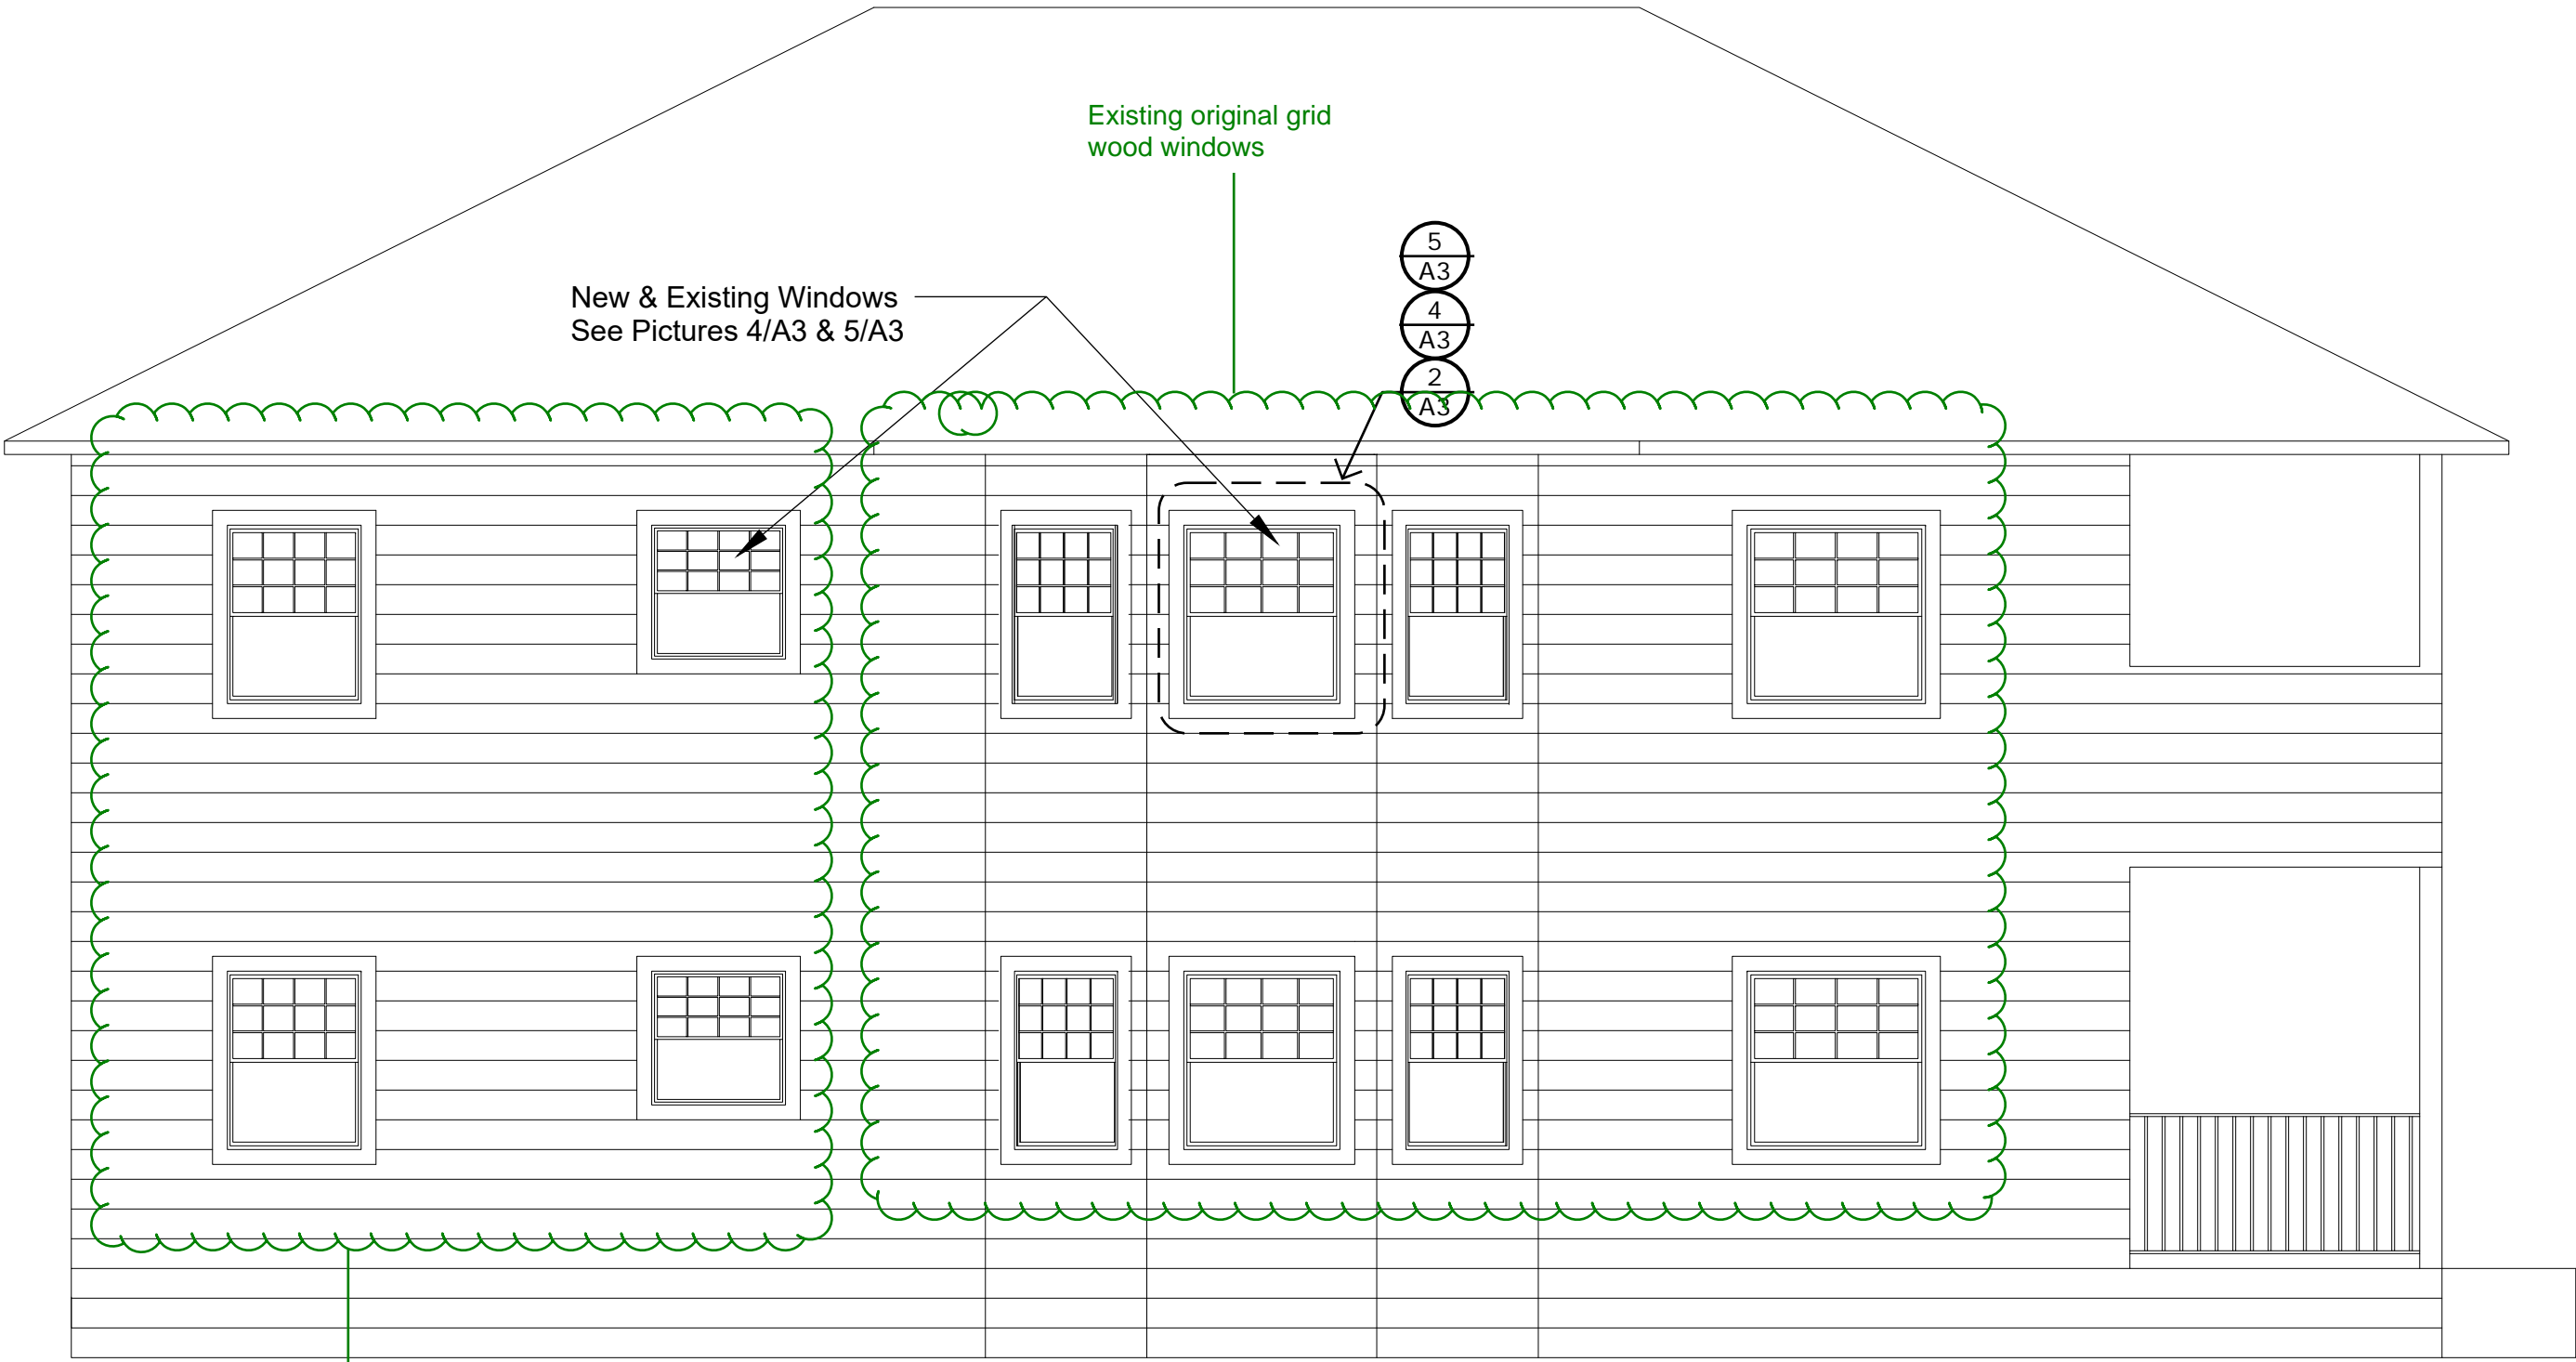
4
A2

Existing original grid wood windows

New & Existing Windows See Pictures 4/A3 & 5/A3

THIS ELEVATION NOT REFELCTING CURRENT CONDITIONS.

Windows replaced with vinyl windows. Grids shall be added to resemble original windows

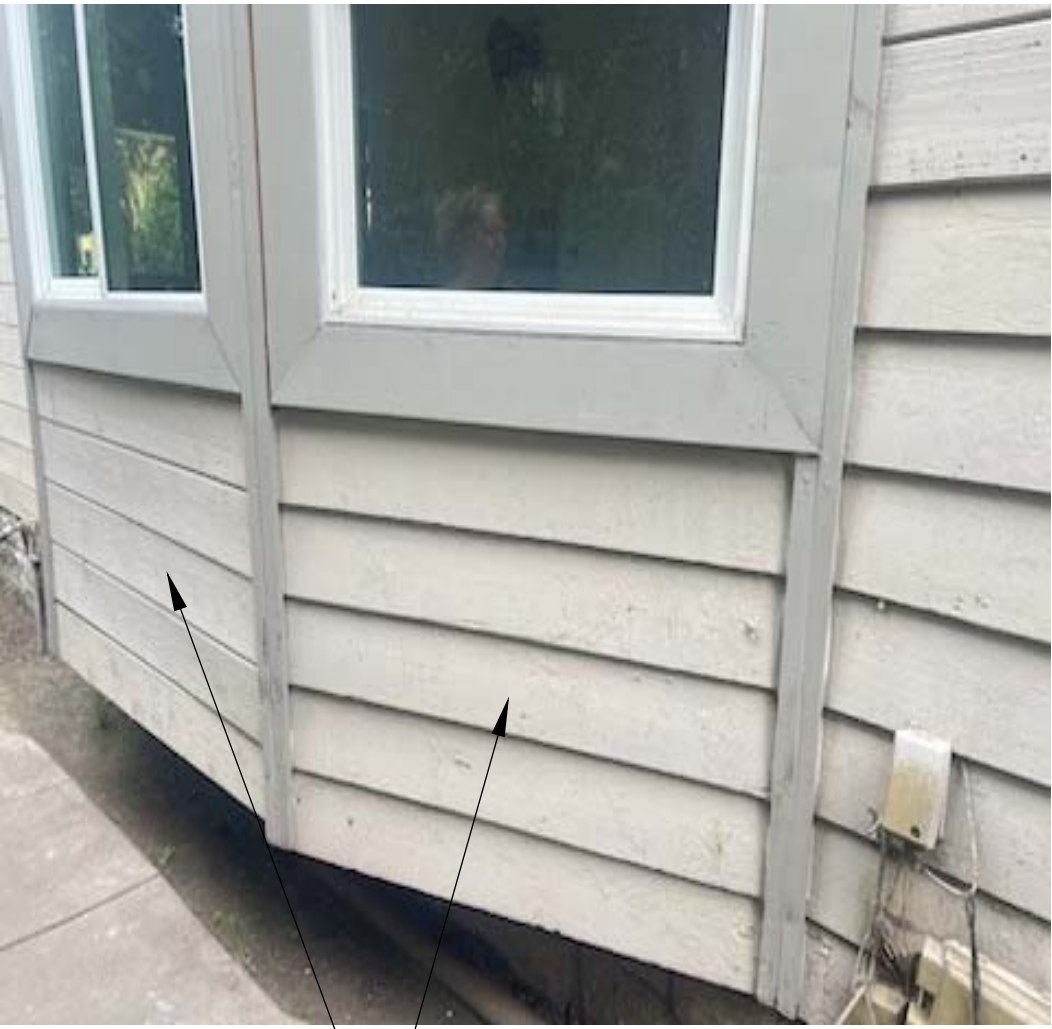
3
A3

Siding Repaired w/ Matching Line Pattern

Repaired Siding Typ

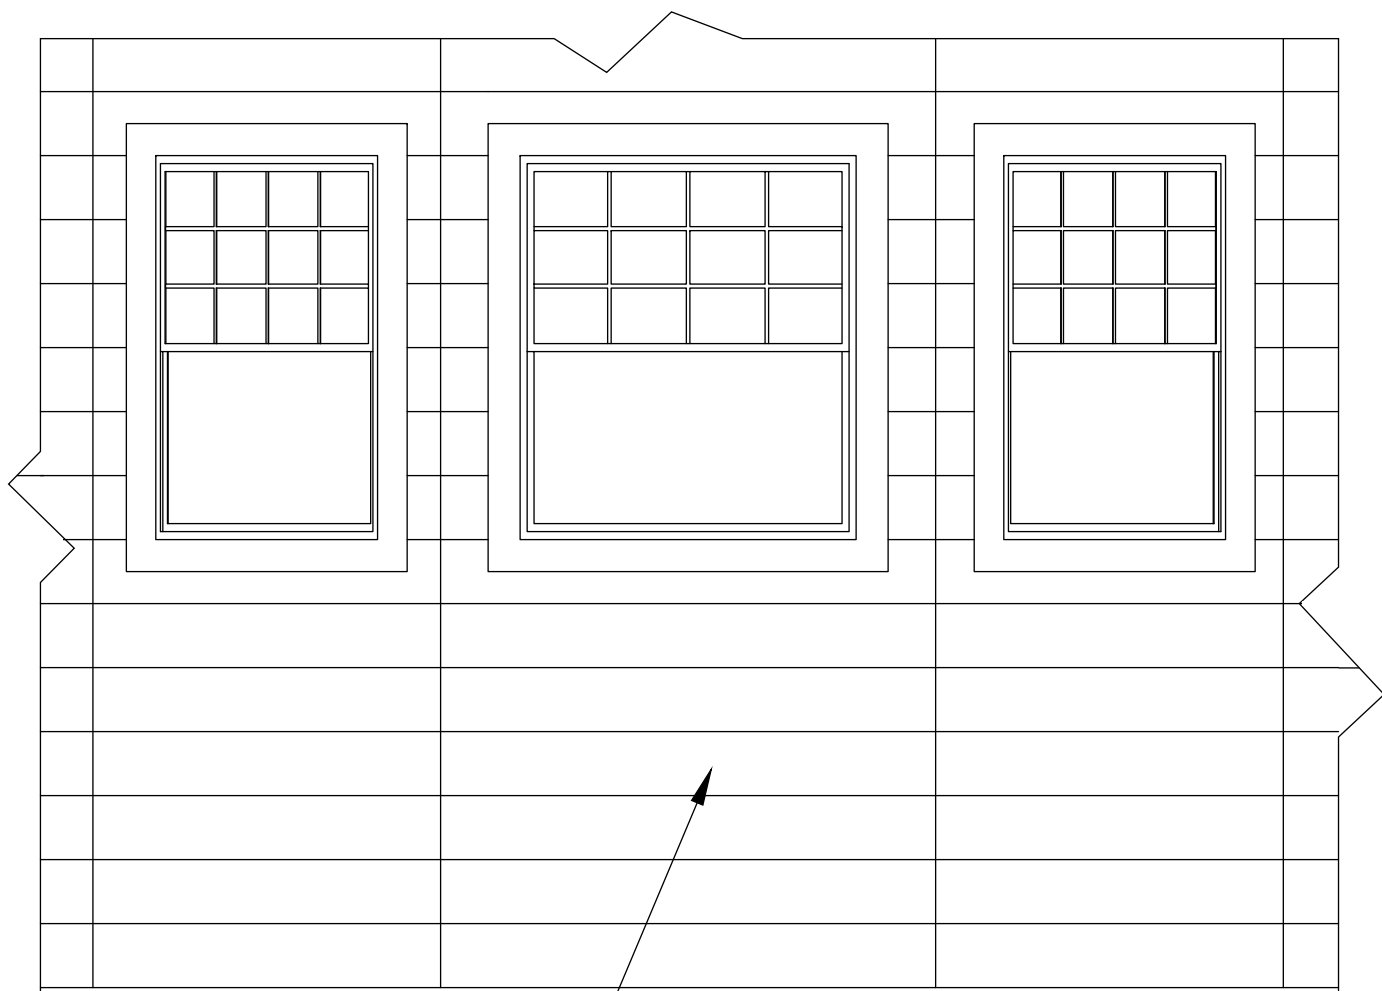
1
A3

Siding Repaired w/ Matching Line Pattern

Repaired Siding Typ

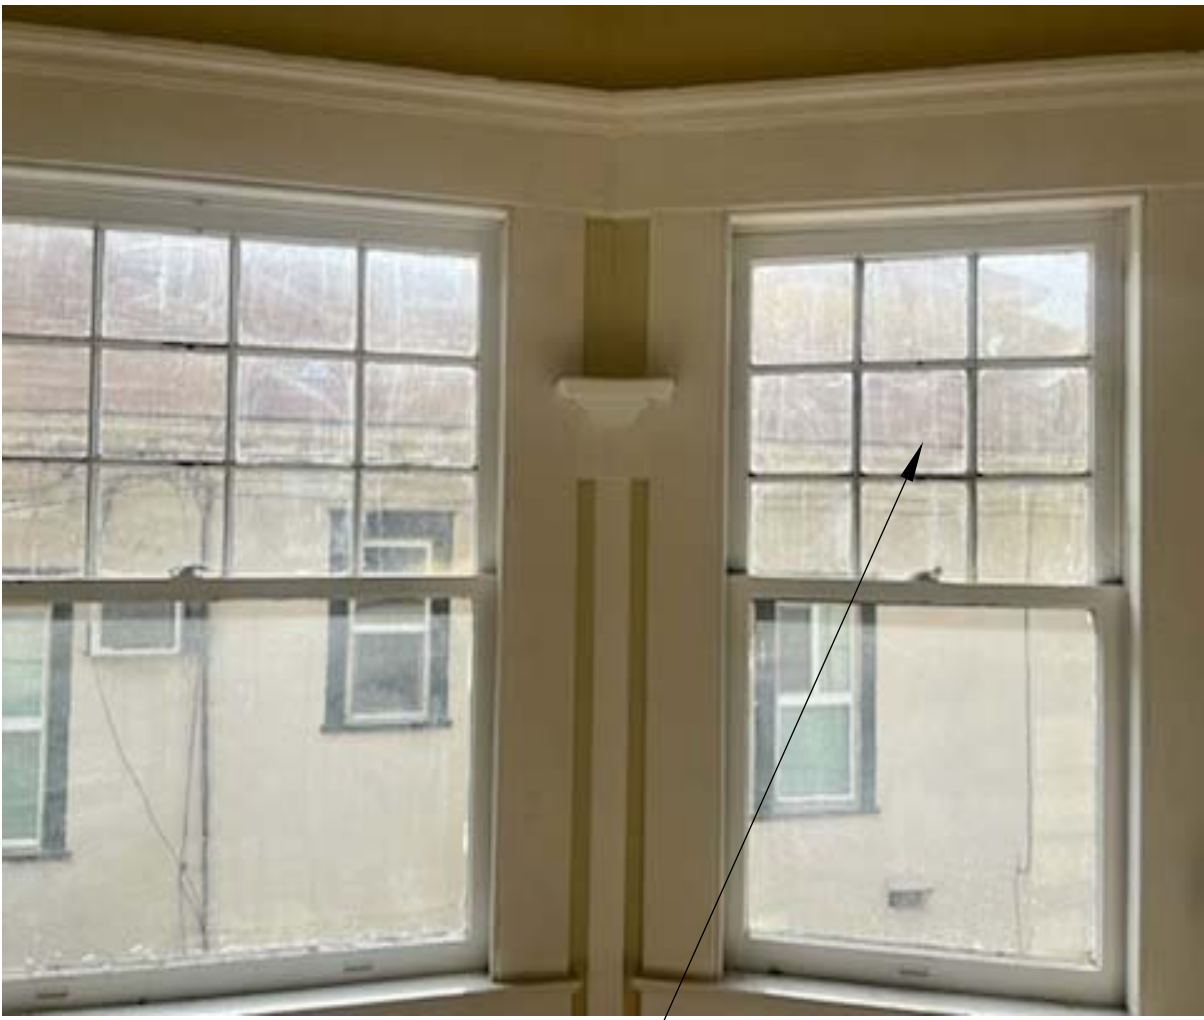
4
A3

Existing Window Grid Pattern

Existing Windows Typ

All New Windows To Have A Vinyl Grid Pattern Added To Match Existing Windows As Close As Possible

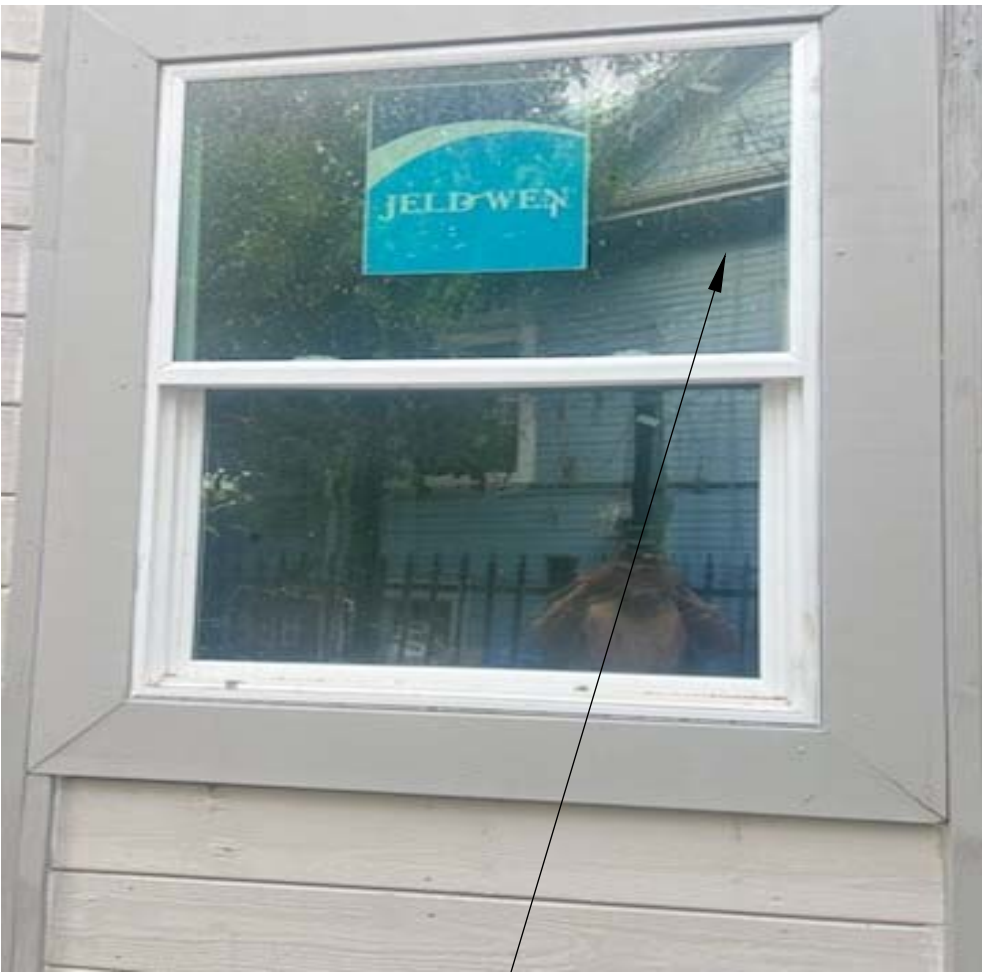
5
A3

New Window Typ

All New Windows To Have A Vinyl Grid Pattern Added To Match Existing Windows As Close As Possible
