## **SAN JOAQUIN COUNTY CIVIL GRAND JURY RELEASES REPORT ON STOCKTON'S MUNICIPAL UTILITIES DEPARTMENT**

### STOCKTON MUNICIPAL UTILITIES DEPARTMENT *Struggling in the MUD*

**2014-2015 Case No. 1412**

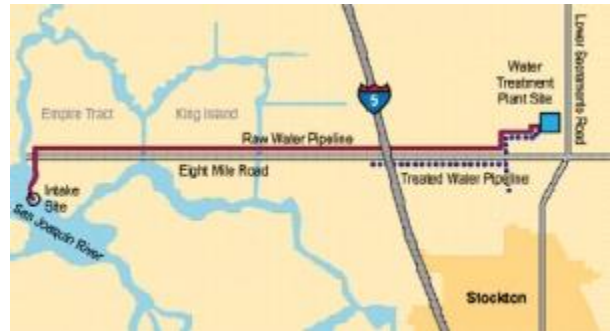
The IPS is located on the south bank of Empire Tract, 6,000 feet south of the intersection of West Eight Mile Road and Correa Road at the San Joaquin River. The IPS draws water from the Sacramento-San Joaquin Delta for treatment and distribution to the COSMA. The facility was constructed on an existing levee, which was raised and widened with engineered fill. The existing levee is underlain by a layer of 10 to 25 feet of peat soils, which are compressible and have low strength. All non-pile supported areas on the levee, including the generator yard, are subject to changes in soil compaction. The February 12, 2015 HDR, Inc. Levee Settlement Monitoring report states that the total settlement along the 54-inch diameter water line between July 2, 2012 and January 14, 2015 was nearly one foot.

At the time of the Grand Jury's tour signs of ground elevation changes were visible at the IPS, e.g. sections of concrete and asphalt were out of alignment and were roped off with yellow caution tape. [See **Appendix B**] During its investigation, the Grand Jury learned that the employee bathroom at the IPS had not been functional since August 2013, due to ground settlement. Despite repeated staff requests, a portable toilet was not installed until March 2015.

A Cal/OSHA complaint was filed regarding conditions at the IPS and MUD acknowledged in its January 2, 2015 response that the area experienced subsidence. As a result, electrical wiring was exposed at the north side of the pump house and the generator yard. Repairs by an outside contractor were expected to proceed by the end of March 2015 at a cost of nearly \$40,000. An assessment of the potential settlement in the area of the IPS by its design engineer HDR, Inc. was to be completed by April 30, 2015.

**F1.1** Non-pile supported areas at the IPS are shifting as evidenced by changes in ground elevation, which has caused concern about employee safety and the integrity of equipment and buried electrical systems and conduits in the generator yard and other areas.

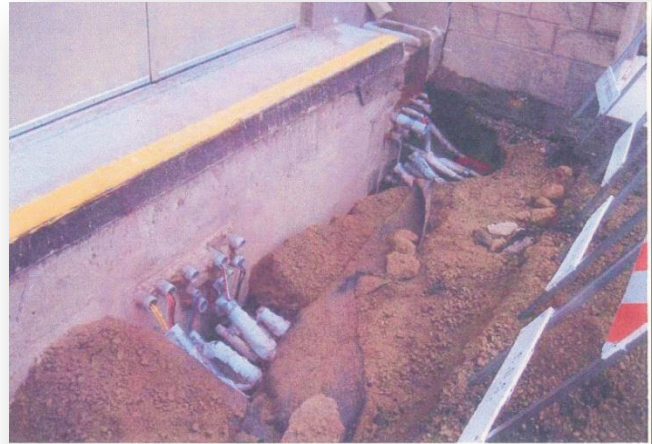
North Side of Pump House

**Electrical repairs necessitated by ground settling on the north side of the IPS pump house.** Source: Bid Request - Delta Water Supply Project, Intake Pump Station

**R1.1** The City Council direct (*through the City Manager*) the Director of MUD to complete needed repairs at the IPS by September 2015 to ensure work areas are safe for employees and to report back annually to the Council regarding the status of IPS ground settling and associated repairs and costs.

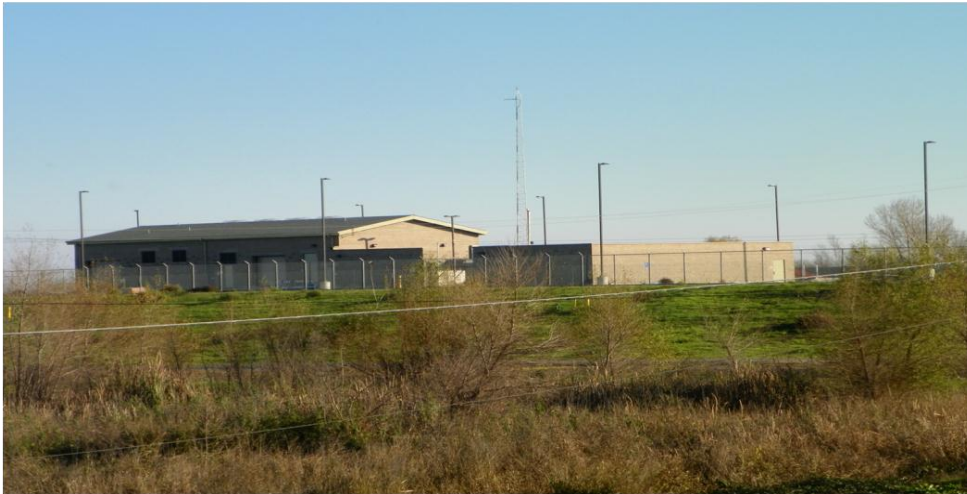
The Intake Pump Station (IPS) on the San Joaquin River west of Interstate 5.

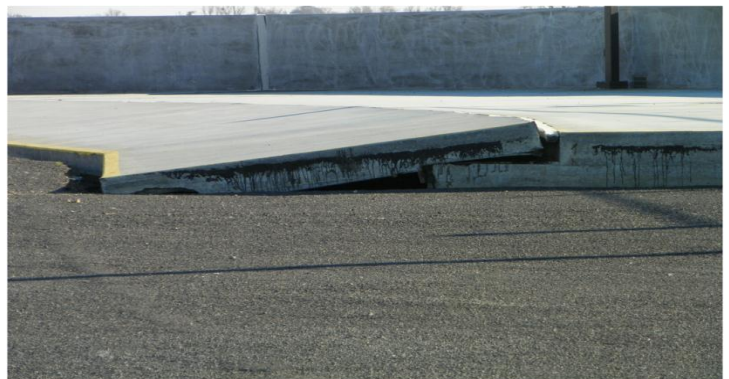
**Appendix B:** Delta Water Supply Project Intake Pump Station; elevation changes on non-pile supported areas of the levee.

A concrete slab has shifted due to soil settling at the IPS.

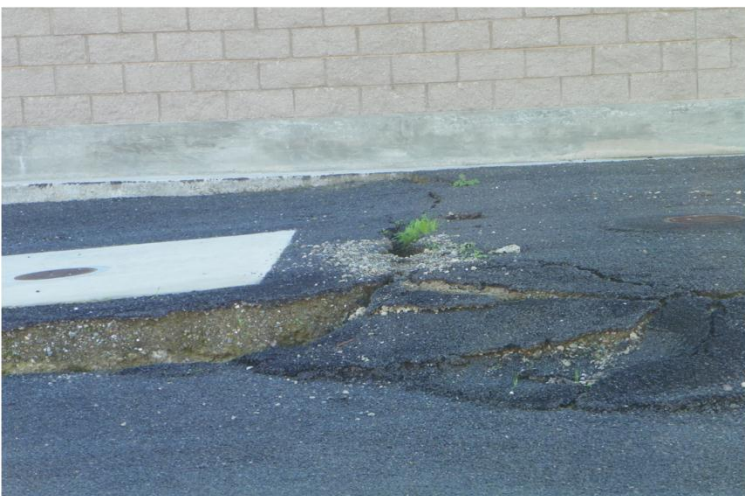
Buckled asphalt at the IPS because of soil settling.

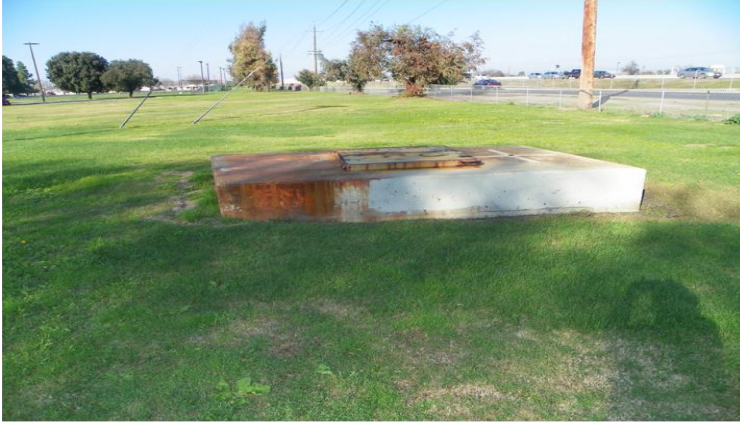
A visual inspection of the utility vault at the southeast corner of Van Buskirk Park showed significant deterioration on the two-year-old vault doors and hinges. [See **Appendix C**] In December 2014, a strong “rotten egg” odor emitted from open spaces on top of the vault. Additionally, the cyclone fence and posts, 26 feet from the utility vault, showed signs of corrosion.

**F2.2** The utility vault at the southeast corner of Van Buskirk Park is extensively corroded and at times emits a strong H<sub>2</sub>S odor, which raises concerns about public safety.

**Appendix C:** Effects of H<sub>2</sub>S corrosion on utility vault at Van Buskirk Park.

A utility vault at Van Buskirk Park with a cyclone fence in the background. Both show signs of corrosion.

**R2.2** The City Council direct (*through the City Manager*) the Director of MUD to ensure the utility vault at Van Buskirk Park is safe for the public (i.e. determine H<sub>2</sub>S exposure level and integrity of corroded vault doors) and report back to the Council by September 2015 identifying what repairs are necessary, why the cyclone fence and posts 26 feet away are showing signs of corrosion, and what effect H<sub>2</sub>S exposure may have on people in the vicinity.

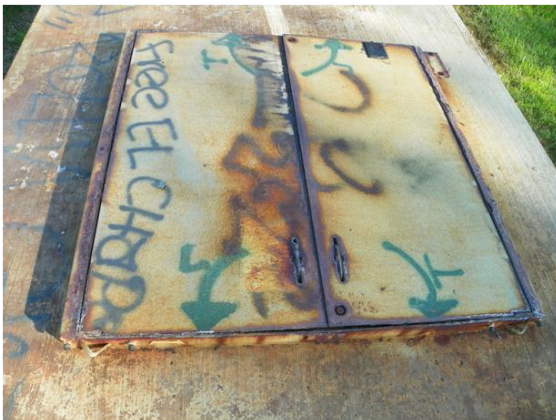
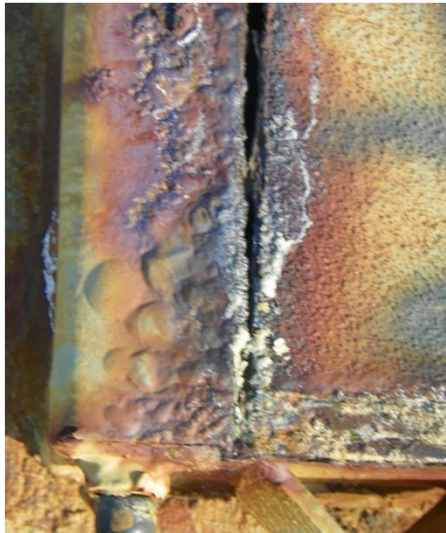
Photos above and at the right are close-ups of corrosion on the two-year-old utility vault doors in Van Buskirk Park.
