## San Joaquin County Grand Jury

### STOCKTON MUNICIPAL UTILITIES DEPARTMENT *Struggling in the MUD*

**2014-2015 Case No. 1412**

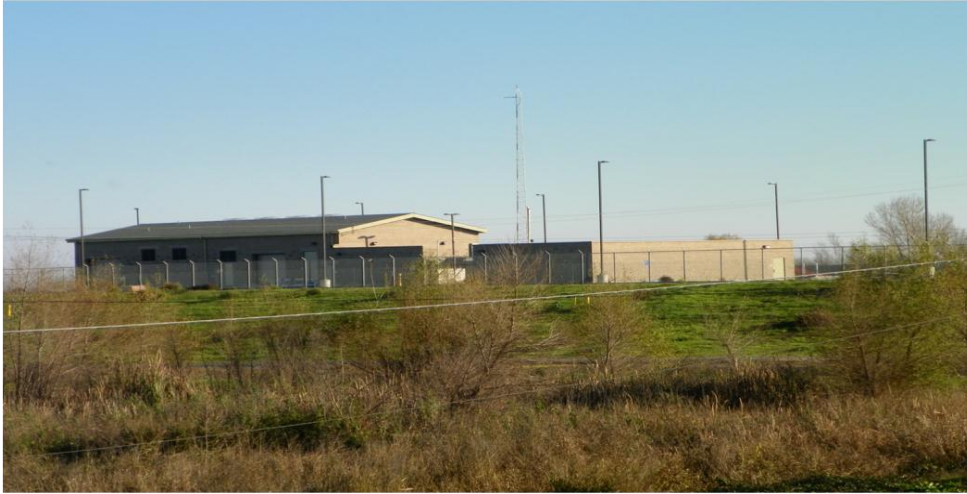
**Appendix B:** Delta Water Supply Project Intake Pump Station; elevation changes on non-pile supported areas of the levee.

The Intake Pump Station (IPS) on the San Joaquin River west of Interstate 5.

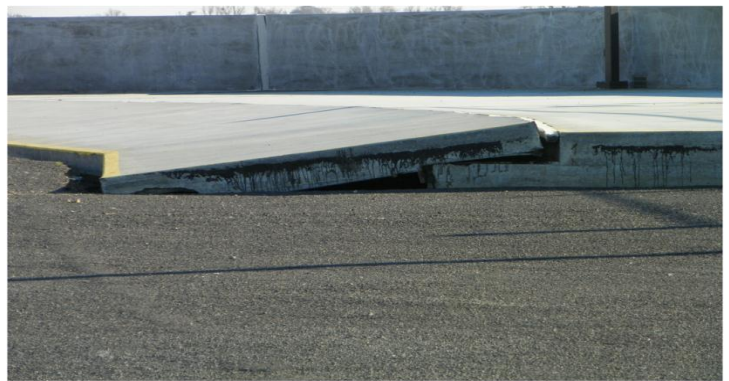
At the time of the Grand Jury's tour signs of ground elevation changes were visible at the IPS, e.g. sections of concrete and asphalt were out of alignment and were roped off with yellow caution tape. [See **Appendix B**] During its investigation, the Grand Jury learned that the employee bathroom at the IPS had not been functional since August 2013, due to ground settlement. Despite repeated staff requests, a portable toilet was not installed until March 2015.

**F1.1** Non-pile supported areas at the IPS are shifting as evidenced by changes in ground elevation, which has caused concern about employee safety and the integrity of equipment and buried electrical systems and conduits in the generator yard and other areas.

A concrete slab has shifted due to soil settling at the IPS.

**R1.1** The City Council direct (*through the City Manager*) the Director of MUD to complete needed repairs at the IPS by September 2015 to ensure work areas are safe for employees and to report back annually to the Council regarding the status of IPS ground settling and associated repairs and costs.
