**National Register of Historic Places  
Inventory—Nomination Form**

historic Benjamin Holt House Residence  
and/or common Boy Scout Headquarters--Forty Niner Council

street & number 548 Park Street \_\_\_\_\_ not for publication  
city, town Stockton \_\_\_\_\_ vicinity of \_\_\_\_\_ congressional district 14th  
state California code 06 county San Joaquin code 077

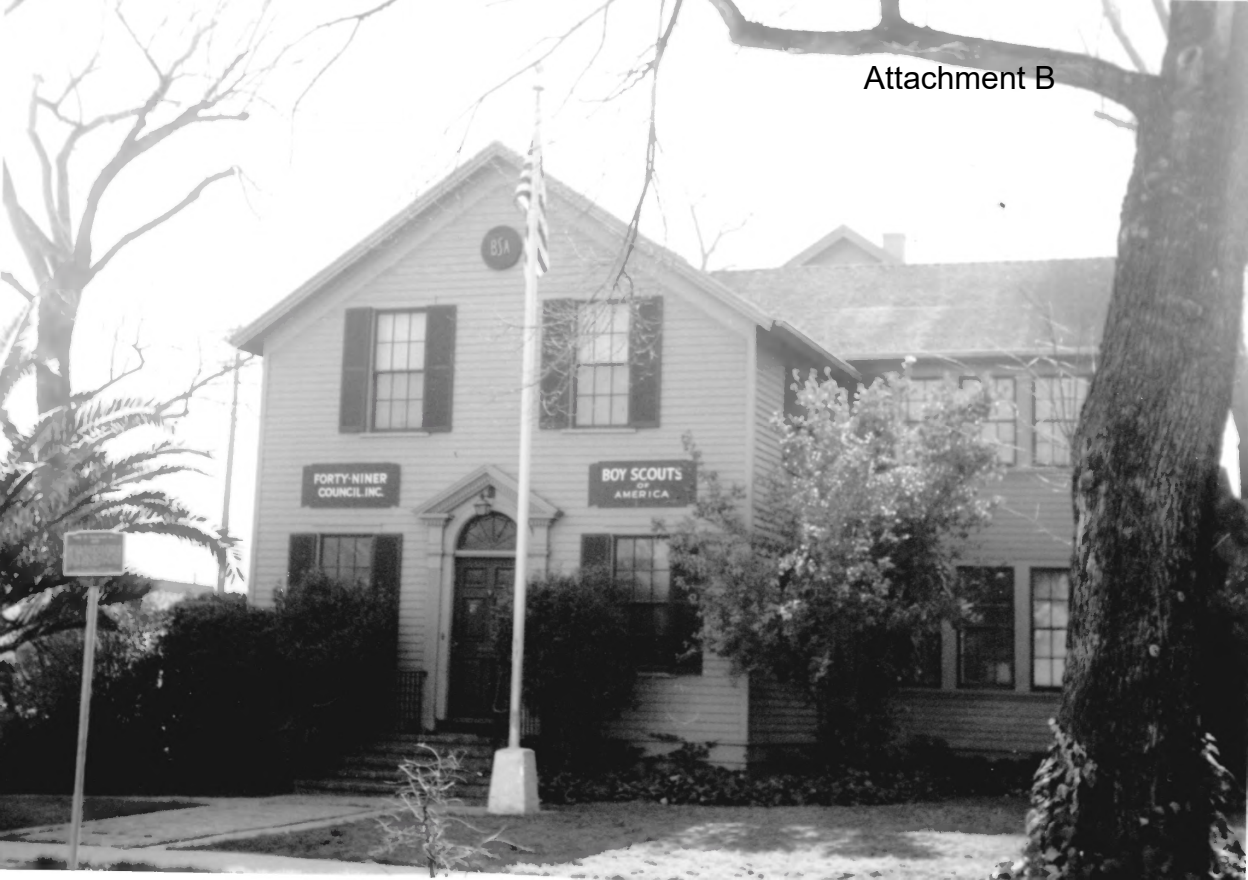
Photo #1 of 5

The Park Street (north), or front, elevation, is dominated by a Colonial Revival entry, which was commissioned by Mrs. Benjamin Holt in 1929. It replaced an earlier front porch. A broken pediment supported by fluted pilasters surmounts the panelled door and fanlight transom of the entry (photo # 1). This elevation is lighted by four 6/6 light double hung windows with wooden shutters.

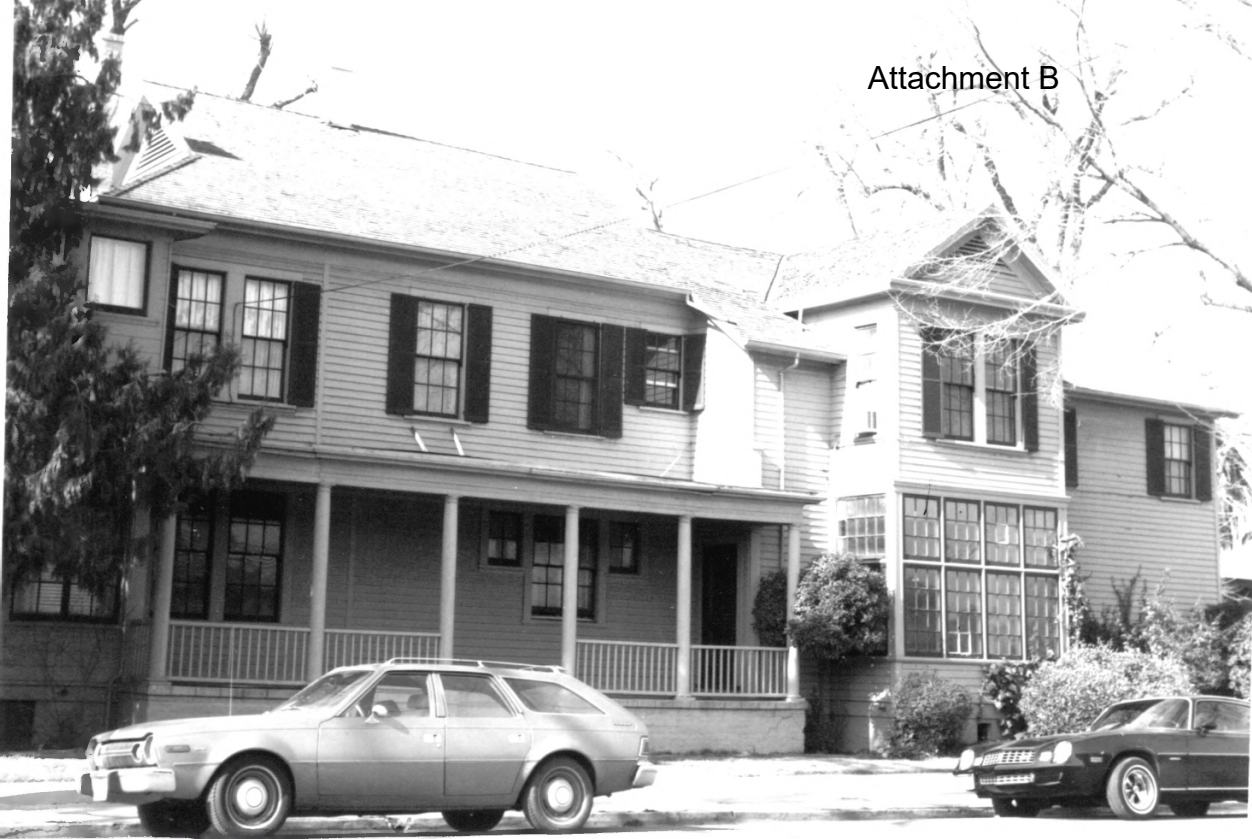
Photo #3 of 5

The east elevation, which fronts on American Street, is visually and structurally divisible into four parts (Photo # 3). At the northeast is a plain wall broken only by two 6/6 light windows with wooden shutters. Moving south, one encounters a two-story square bay window topped by a pediment at its gable end. The first-story of this bay window is abundantly lighted by twelve large multipaned fixed windows, which serve as a solarium. The fenestration on the second story of this bay is somewhat irregular, with 4/4 double-hung windows on the sides and paired 6/6 double hung windows facing the street. The dominant feature of the east elevation is a large, flat-roofed porch, supported by six evenly spaced Doric columns and enclosed by a simple balustrade. Fenestration above the porch is 6/6 double-hung sash. Sheltered by the porch are paired 6/6 double hung windows, as well as paired 4/4 double-hung windows flanked by two fixed four-light windows. The southern end of the east elevation consists of a two-story addition. This addition is sheathed in flush horizontal siding, while the remainder of the house is covered by clapboard siding. Fenestration in this addition deviates notably from that of the primary structure, with two pair of 6 light casement windows on the first story and three single-light hinged windows on the second story.

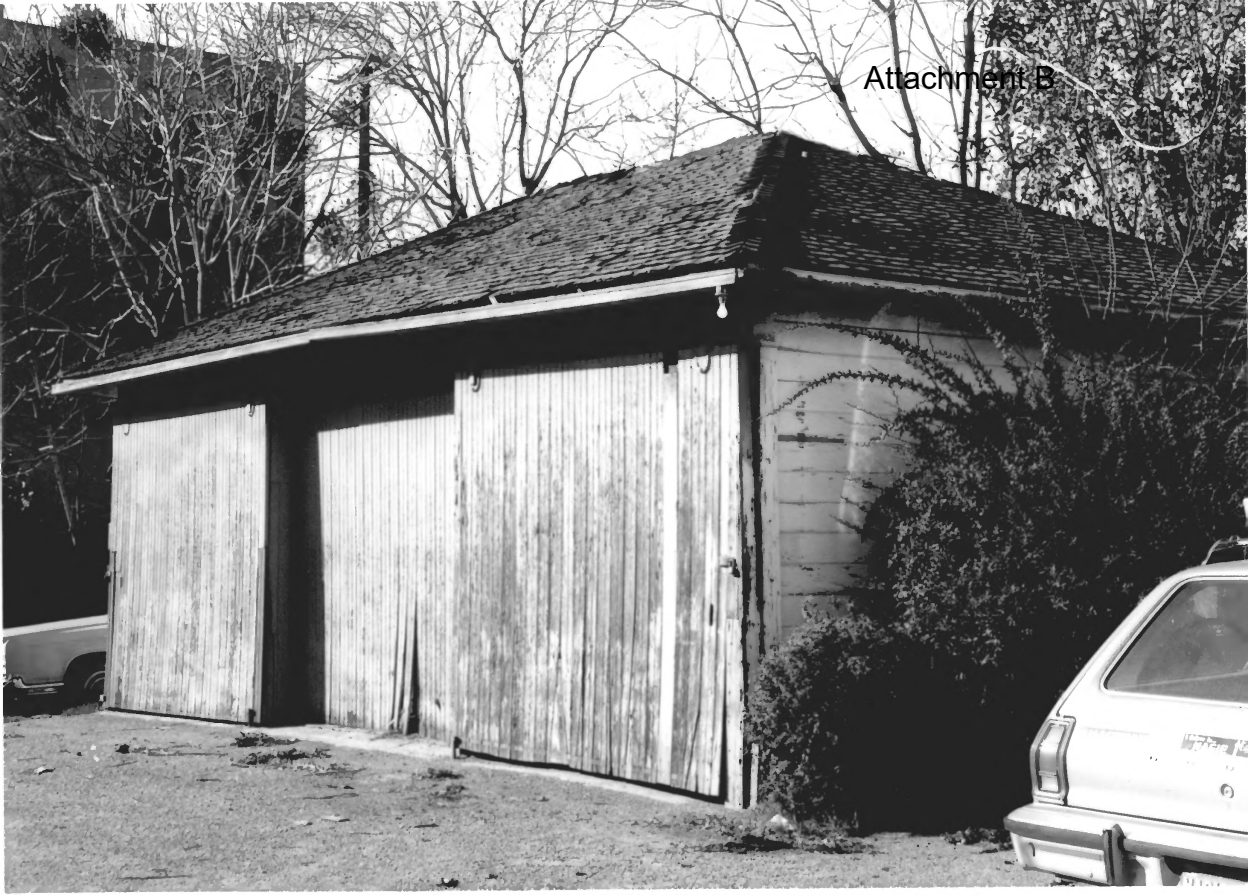
Photo #5 of 5

To the south of the residence is a one-story, hipped-roofed garage. This garage was built circa 1904 when the Holt's obtained their first automobile. The three

sliding doors are original. (photo #5)
