# HISTORIC RESOURCES INVENTORY

1. Common name: Smith House
2. Historic name, if known: -----
3. Street or rural address: 222 East Flora  
City: Stockton ZIP: 95202 County: San Joaquin
4. Present owner, if known: Clara Smith Address: Same  
City: Stockton ZIP: 95202 Ownership is: Public ☐ Private ☒
5. Present Use: Residence Original Use: Same  
Other past uses: Unknown

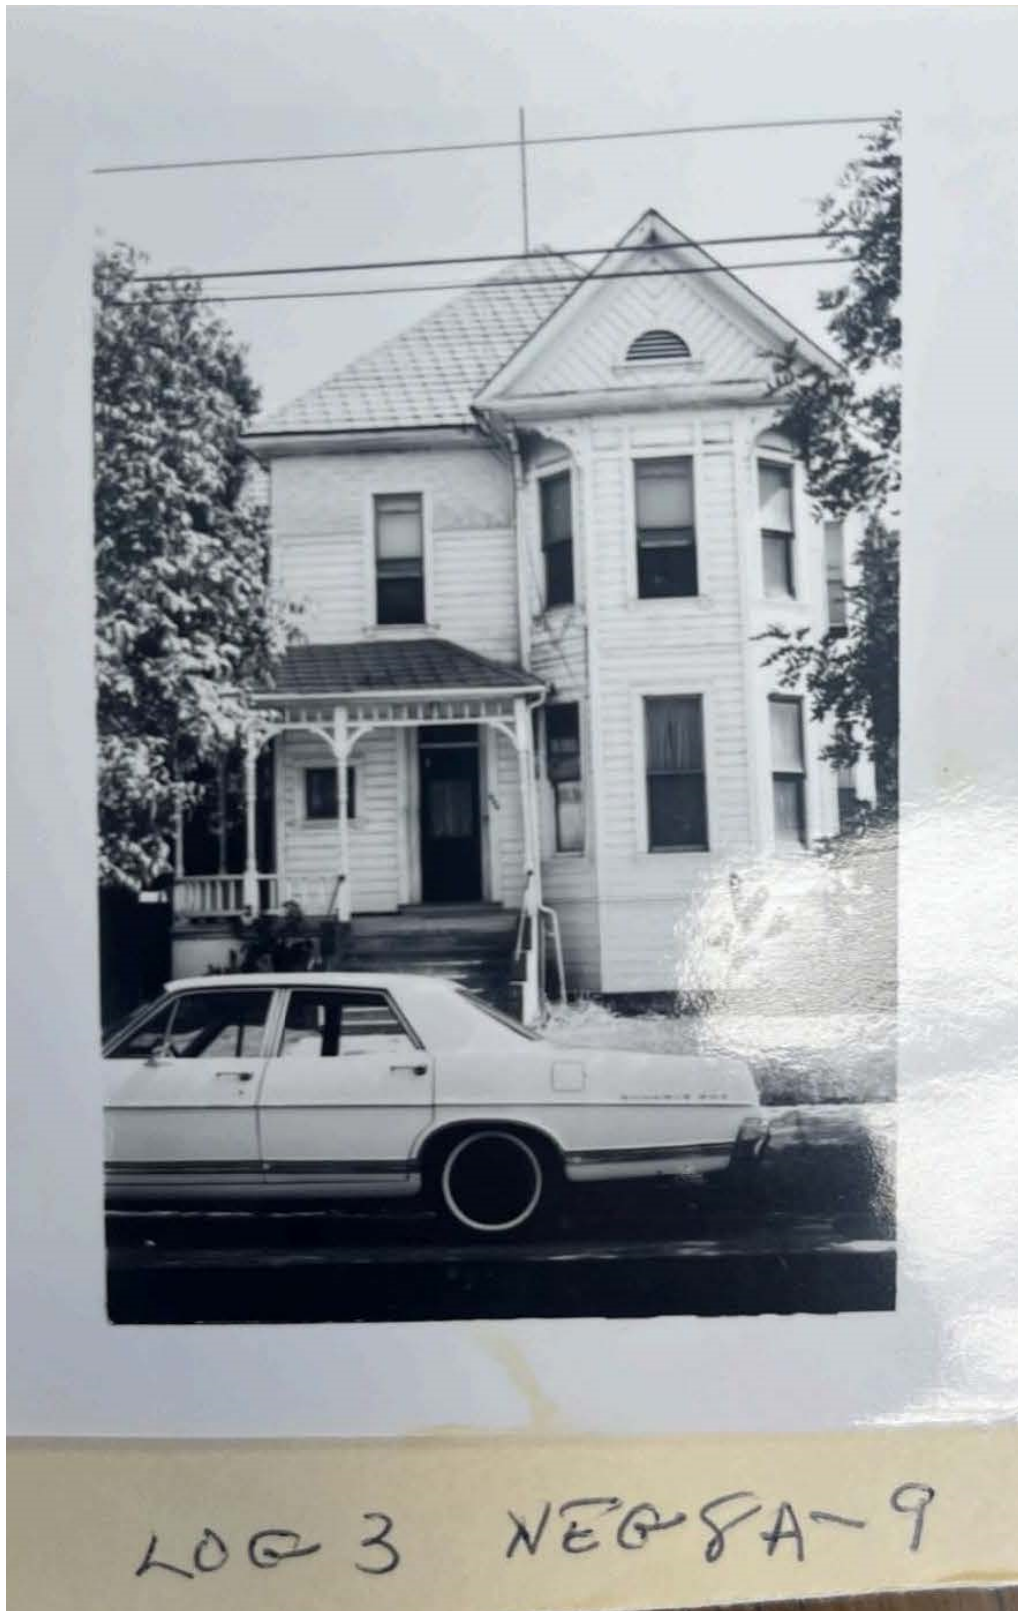
222 East Flora Street (1977)

The structure at 222 East Flora Street is a Queen Anne-Style 2 story wooden frame house. It has a pyramidal roof, 2 square side bays, medium steep gables and louvered vents. "Alternating" shingle (fishscale and butt end) one-fourth the way down and around to the front of the house to a front angled bay. There is a medium steep pedimented gable over the bay, with "Y" angled stick work, and a louver. There are decorative brackets beneath the gable pediment. Another feature of this house is a rectangular glass transom above the door. The porch has a hip roof on attenuated columns curving to the east side of the structure with railings. It has a full basement.
