STOCKTON POOL NEEDS ASSESSMENT UPDATE

JUNE 2024

A. SCOPE & INTRODUCTION

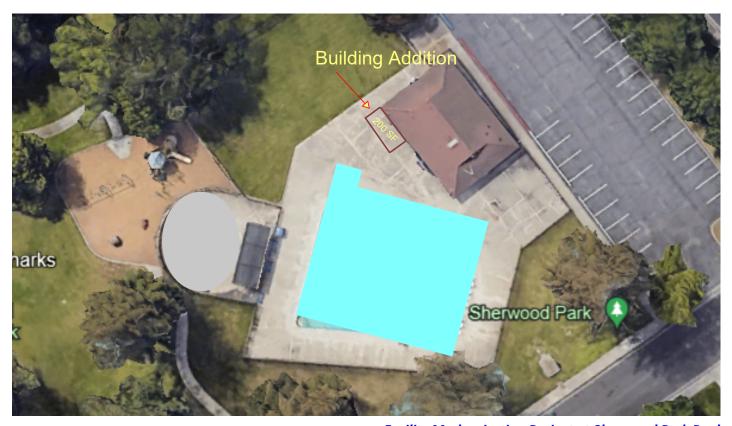
Facility Modernization Project at Sherwood Park Pool

The bathrooms at the Sherwood Park Pool are lacking the proper number of fixtures and are not ADA compliant. ADG recommends eliminating the wading pool and expanding the swimming pool at Sherwood Park. In addition to pool updates it is ADG's recommendation to reconstruct the support building. The swimming pool can go from a trapezoid shape to a rectangle and can add three (3) lanes to be an 8-lane x 25-yard pool. The support building can be 2,600 square feet, up from 2,400 square feet. The new mechanical equipment can include a heater for year-round usage. Below are recommended facility modernization project costs to update the facility and its programs.

- Eliminate wading pool
- Expand 5-lane x 25-yard pool to 8-lane x 25-yard pool
- · Remove and replace support building with larger building
- Remove and replace all mechanical and chemical equipment for pool

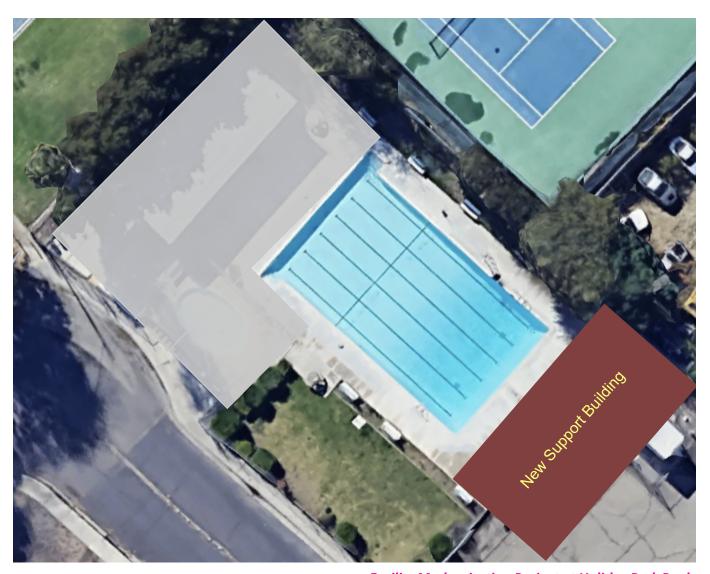
Facility Modernization Project at Holiday Park Pool

The bathrooms at the Holiday Park Pool are not ADA compliant. ADG recommends eliminating the wading pool and reconstructing the aging support building. The support building can be 2,600 square feet, up from 1,600 square feet. It can also be relocated on the site. The new mechanical equipment can include a heater for year-round usage. Below are recommended facility modernization project costs to update the facility and its programs.

- Eliminate wading pool
- Remove and replace support building with larger building
- Remove and replace all mechanical and chemical equipment for pool

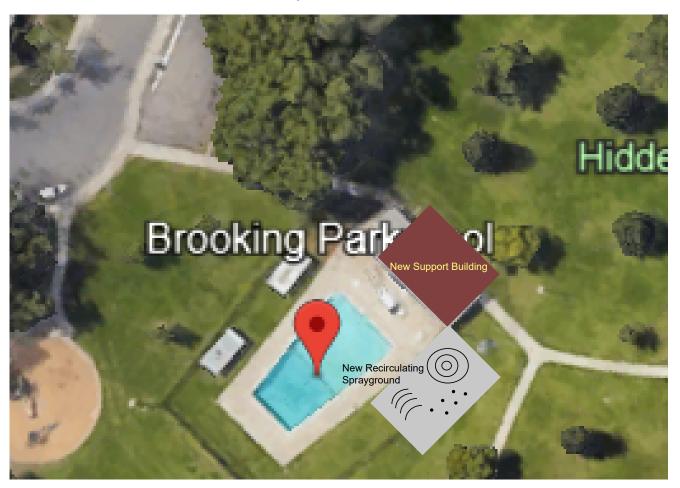
Facility Modernization Project at Brooking Park Pool

The Brooking Park Pool was recently resurfaced. The bathrooms at the Brooking Park Pool are not ADA compliant and the mechanical and chemical equipment is in need of modernization. ADG recommends that improvements be made to the support building. A newly reconstructed support building can be 2,200 square feet, up from 1,300 square feet. The new mechanical equipment can include a heater for year-round usage. In addition, a recirculating sprayground can be added to the site. Below are recommended facility modernization project costs to update the facility and its programs.

- · Add recirculating sprayground
- Remove and replace support building with larger building
- · Remove and replace all mechanical and chemical equipment

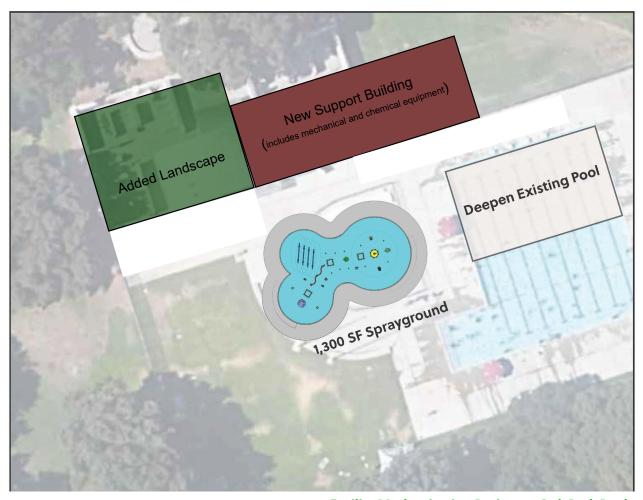
Facility Modernization Project at Oak Park Pool

The bathrooms at the Oak Park Pool are lacking the proper number of fixtures and a roof. In addition, the bathrooms are not ADA compliant. ADG recommends eliminating the wading pool, deepening the existing pool and reconstructing the support building. The pool needs to be deepened to support safe diving from racing platforms. The support building can be 3,000 square feet. The new mechanical equipment, located in the new building, can include a heater for year-round usage. Below are recommended facility modernization project costs to update the facility and its programs.

- Eliminate wading pool and replace it with a recirculating sprayground
- Deepen swimming pool
- Remove and replace support building
- Remove and replace all mechanical and chemical equipment

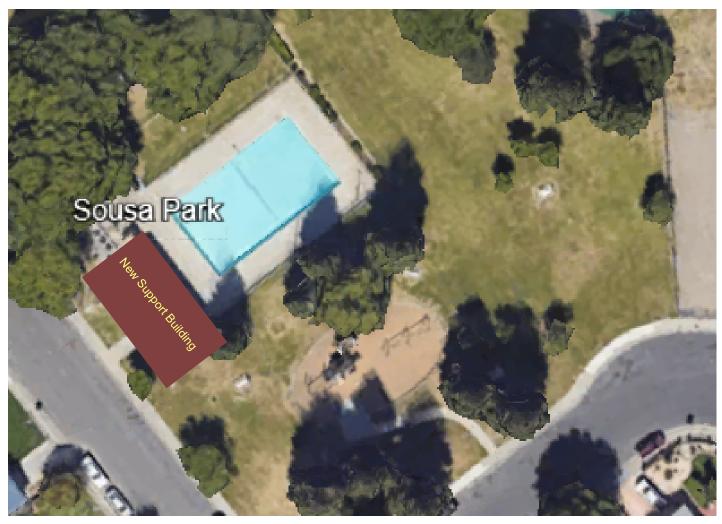
Facility Modernization Project at Sousa Park Pool

The bathrooms at the Sousa Park Pool are not ADA compliant and the mechanical and chemical equipment is in need of modernization. ADG recommends that improvements be made to the support building. A newly reconstructed support building can be 2,600 square feet, up from 1,500 square feet. The new mechanical equipment can include a heater for year-round usage. Below are recommended facility modernization project costs to update the facility and its programs.

- · Remove and replace support building with larger building
- Remove and replace all mechanical and chemical equipment for pool

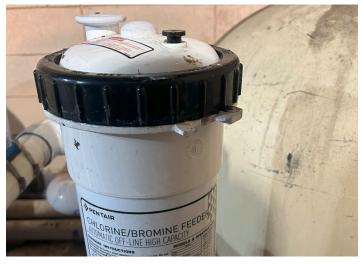
Image 1: Wading Pool Chlorine Tablet Feeder

ITEM	REPAIRS TO MEET CURRENT CODE	CODE	ESTIMATE	LEVEL OF CONCERN	IMAGE (See Page 36)
1.1	The wading pool chlorine tablet feeder lacks interconnection with the flow for the pool's circulation system. A chemical control monitor, chemical metering pump and liquid chlorine feed system should be installed to rectify this code concern.	CBC, Chapter 31B: 3133B.1.	\$15,000.00	9	lmage 1

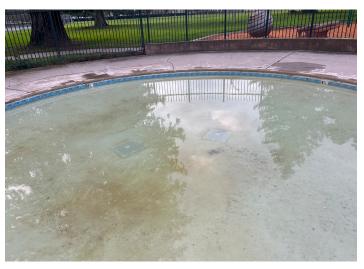
Image 2: Wading Pool

1.2	The wading pool is 18" deep at all areas. The pool lacks an ADA compliant means of entry and egress as required by code. An ADA compliant ramp should be installed in the pool during a pool finish replacement project.	ADA and ADAAG	\$35,000.00	9	Image 2

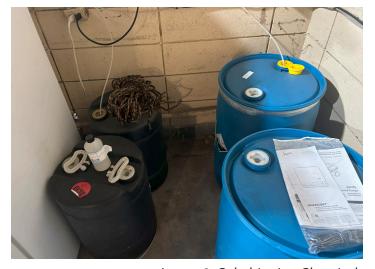
Image 3: Cohabitating Chemicals

1.5	Liquid chlorine and acid are being stored near each other in the mechanical room. The cohabitation of these incompatible corrosives could create mustard gas and cause injury or death. International Fire Code requires at least 20 feet of distance between the chemicals or a noncombustible partition be installed. The City should relocate the storage of one of the chemicals or install a noncombustible partition. A price for a noncombustible partition is provided. In addition, the chemical drums should be stored on containment pallets to contain any incidental releases.	International Fire Code, Chapter 50 Section 5003.9.8.	\$12,000.00	9	Image 3

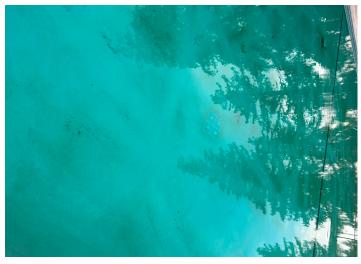
Image 4: Stained Plaster in Swimming Pool

1.6	The swimming pool and wading pool plaster finishes are stained and cracked. The pools are also leaking as a result of failing finishes. They are in need of replacement. A pool finish replacement project would include new tile. The existing tile is chipped and cracked in many locations.	CBC, Chapter 31B: 3108B.	\$200,000.00	8	Image 4

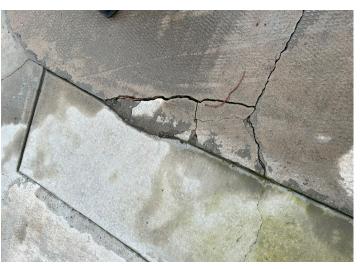
Image 6: Failing Pool Deck

1.8	The pool deck at both pools is at the end of its life cycle and needs to be replaced. Many areas of the deck are cracked and creating safety hazards. The coping tile for both pools should be replaced at the same time. The deck depth markers that are not compliant with code (fractions) would be replaced in a deck replacement project.	CBC, Chapter 31B: 3114B and 3110B.4.	\$550,000.00	8	Image 6

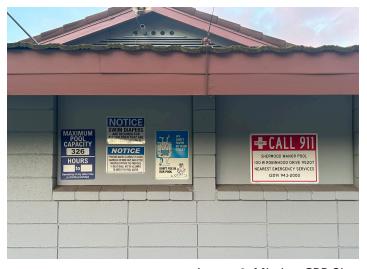
Image 9: Missing CPR Sign

ITEM	REPAIRS TO MEET CURRENT CODE	CODE	ESTIMATE	LEVEL OF CONCERN	IMAGE (See Page 37)
1.9	The swimming pool lacks code required "No Diving" depth markers in all depth locations 6-feet or less. These can be added during a deck replacement project or retrofitted. A retrofitted price is provided.	CBC, Chapter 31B: 3110B.5.	\$4,000.00	8	Image 7
1.11	The swimming pool's plastic grab rails are loose and not sustainable. These should be replaced with stainless-steel grab rails.	CBC, Chapter 31B: 3111B.	\$6,000.00	8	Image 8
1.12	The facility is missing the code-required CPR sign. A CPR sign should be purchased and installed.	CBC, Chapter 31B: 3120B.5.	\$350.00	7	Image 9
1.13	SUBTOTAL CODE COMPLIANCE ISSUES		\$1,053,550.00		_

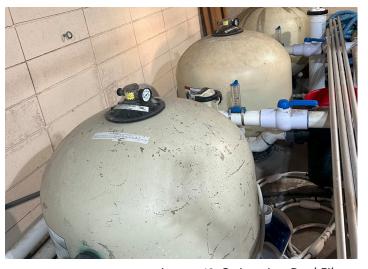
Image 10: Swimming Pool Filters

ITEM	MAINTENANCE & OPERATIONS ISSUES	ESTIMATE	LEVEL OF CONCERN	IMAGE (See Page 37)
2.1	The filter tanks for the pools are 16 years old. The City may start to see more maintenance issues with these aging filters. A plan for replacement is advised. In recent years the sand media and piping were replaced. Good efforts have been made to lengthen their life cycle but filter tanks of this style typically last 10-12 years. Planning for replacement ahead of failure is advised.	\$30,000.00	5	Image 10

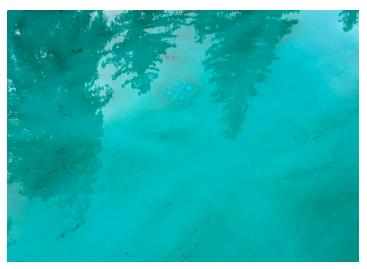
Image 11: Main Drain Cover in Swimming Pool

2.2	The main drain PVC covers for the pools should be replaced at or near their expiration. Contractors replace them during replaster projects. An allowance is provided for new PVC covers during a replaster project.	\$5,000.00	5	lmage 11

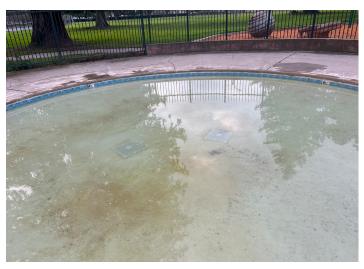
Image 12: Wading Pool

2.3	The wading pool is in need of a new finish and is leaking. In addition, it needs new chemical equipment and the deck surrounding the wading pool is in very poor condition. ADA access is also a concern. Lastly, it is not highly used. The City should consider eliminating the wading pool. An allowance for filling it in with new concrete is provided.	\$25,000.00	3 & 2	Image 12

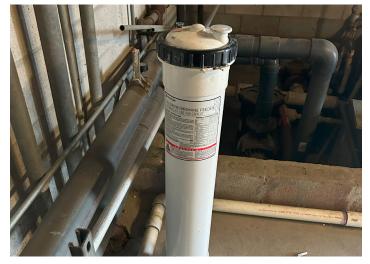
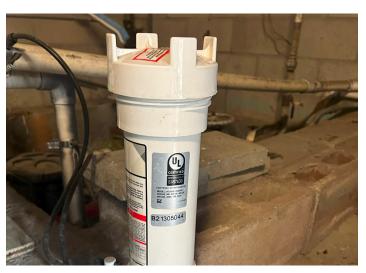
ITEM	REPAIRS TO MEET CURRENT CODE	CODE	ESTIMATE	LEVEL OF CONCERN	IMAGE (See Pages
1.1	The chlorine tablet feeders for both pools lack interconnection with the flow for the pools' circulation systems. Two chemical control monitors, chemical metering pumps and liquid chlorine feed systems should be installed to rectify this code concern.	CBC, Chapter 31B: 3133B.1.	\$25,000.00	9	38-39) Images 13 & 14

Image 13: Chlorine Tablet Feeder for Swimming Pool

Image 14: Chlorine Tablet Feeder for Wading Pool

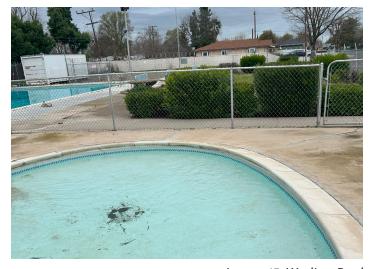
Image 15: Wading Pool

1.2	The wading pool is 18" deep at all areas. The pool lacks an ADA compliant means of entry and egress as required by code. An ADA compliant ramp should be installed in the pool during a pool finish replacement project.	ADA and ADAAG	\$35,000.00	9	Image 15

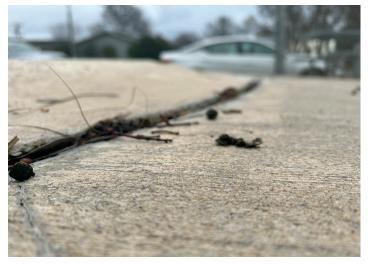
Image 16: Failing Deck

1.3	The swimming pool does not have a fixed ADA means of access. An ADA compliant lift should be installed.	ADA and ADAAG	\$12,500.00	9	N/A
1.4	The pool deck at both pools is at the end of its life cycle and needs to be replaced. Many areas of the deck are cracked and creating safety hazards. The coping tile for both pools should be replaced at the same time. The deck depth markers that are not compliant with code (fractions, missing units of measure) would be replaced in a deck replacement project. In addition, a portion of the deck around the wading pool has a slope greater than 2% in violation of ADA standards.	CBC, Chapter 31B: 3114B and 3110B.4. ADA and ADAAG	\$300,000.00	9	Image 16

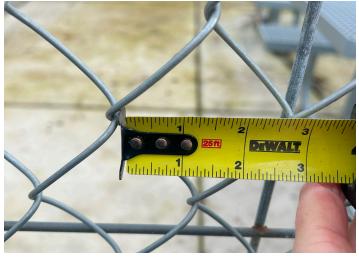
Image 17: Chain Link With Wide Opening

1.5	The gates inside the facility and on the perimeter fence line are not self-closing and self-latching as required by code. In addition, the chain link fencing itself has holes larger than allowed by code. The chain link fence and gates should be replaced.	CBC, Chapter 31B: 3119B.	\$100,000.00	9	Image 17

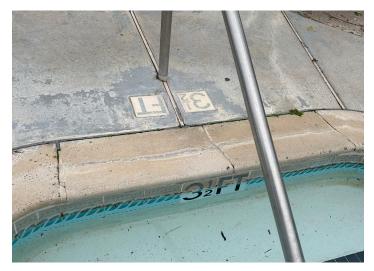
Image 19: Missing "No Diving" Marker at Swimming Pool

1.8	Both pools lack code required "No Diving" depth markers in all depth locations 6-feet or less. These can be added during a deck replacement project or retrofitted. A retrofitted price is provided.	CBC, Chapter 31B: 3110B.5.	\$6,000.00	8	Image 19

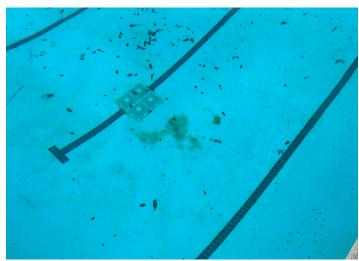
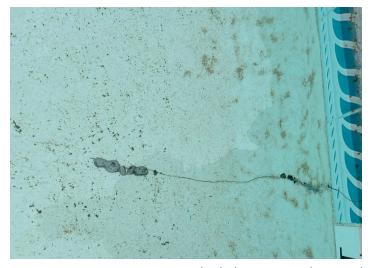
ITEM	REPAIRS TO MEET CURRENT CODE	CODE	ESTIMATE	LEVEL OF CONCERN	IMAGE (See Page 39)
1.9	The plaster finishes for the pools are stained and cracked. The pools are also leaking as a result of failing finishes. They are in need of replacement. A pool finish replacement project would include new tile. The existing tile is chipped, missing and cracked in many locations.	CBC, Chapter 31B: 3108B.	\$175,000.00	8	Images 20 & 21

Image 20: Stained Plaster in Swimming Pool

Image 21: Cracked Plaster in Wading Pool

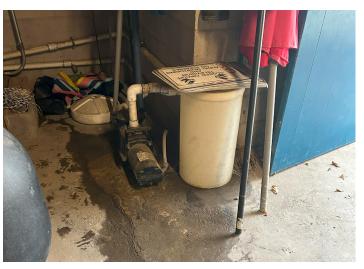
Image 24: Wading Pool Pump

ITEM	MAINTENANCE & OPERATIONS ISSUES	ESTIMATE	LEVEL OF CONCERN	IMAGE (See Pages 39-40)
2.1	The pump for the wading pool is aging. A plan for replacement is advised.	\$4,500.00	5	lmage 24

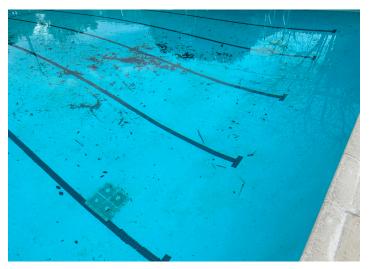
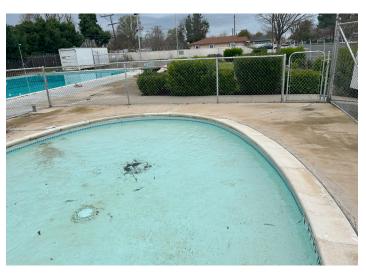
2.2	The main drain PVC covers for the pools should be replaced at or near their expiration. Contractors replace them during replaster projects. An allowance is provided for new PVC covers during a replaster project.	\$5,000.00	5	Images 25 & 26

Image 25: Main Drain Cover in Swimming Pool

Image 26: Main Drain Cover in Wading Pool

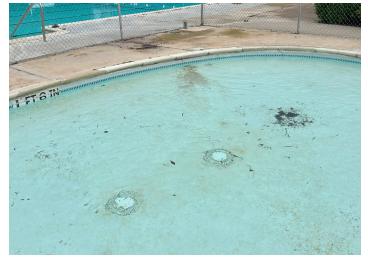
Image 27: Failing Wading Pool Finish

2.3	The mechanical room needs replacement light bulbs for the overhead lights. New light bulbs should be purchased and installed.	\$100.00	5	N/A
2.4	The wading pool is in need of a new finish and is leaking. In addition, it needs new chemical equipment and the deck surrounding the wading pool is in very poor condition. ADA access is also a concern. Lastly, it is not highly used. The City should consider eliminating the wading pool. An allowance for filling it in with new concrete is provided.	\$20,000.00	3 & 2	lmage 27

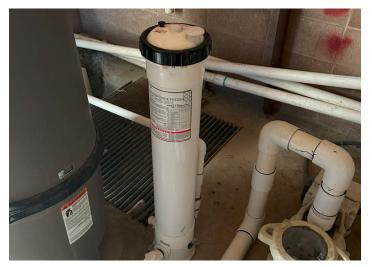
Image 28: Chlorine Tablet Feeder for Swimming Pool

ITEM	REPAIRS TO MEET CURRENT CODE	CODE	ESTIMATE	LEVEL OF CONCERN	IMAGE (See Page 41)
1.1	The chlorine tablet feeder for the pool lacks interconnection with the flow for the pool's circulation system. A chemical control monitor, chemical metering pump and liquid chlorine feed system should be installed to rectify this code concern.	CBC, Chapter 31B: 3133B.1.	\$15,000.00	9	lmage 28

2.2	The circulation pump for the pool may be more than 8 years old, based on a 2016 Kitchell conditions assessment. The City may start to see more maintenance issues with this aging circulation pump. A plan for replacement is advised. A circulation pump of this style typically lasts 4-5 years. Planning for replacement ahead of failure is advised.	\$10,000.00	5	Image 28

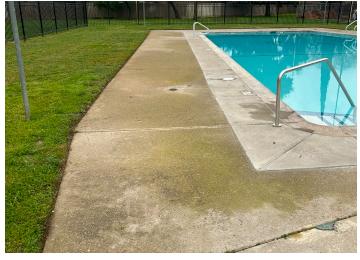
Image 32: Failing Deck

1.8	The pool deck, outside of an area that was just redone, is near the end of its life cycle and needs to be replaced.	CBC, Chapter 31B: 3114B and 3110B.4.	\$120,000.00	6	Image 32

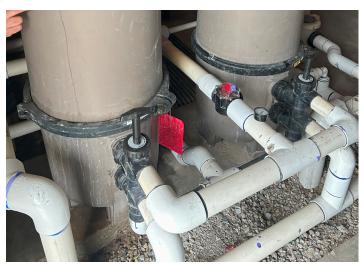
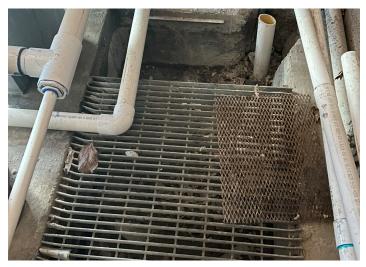
ITEM	MAINTENANCE & OPERATIONS ISSUES	ESTIMATE	LEVEL OF CONCERN	IMAGE (See Pages 41-42)
2.1	The mechanical room is missing concrete in front of the existing filters. Concrete should be poured in this area. In addition, concrete should fill in the pit behind the filters. The combination of the added concrete and the addition of a new concrete housekeeping pad will provide an acceptable surface to receive a new sand filtration system.	\$10,000.00	6	Images 33 & 34

Image 33: Concrete Missing By Filters

Image 34: Concrete Missing Behind Filters

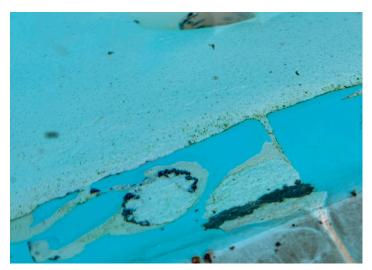
Image 38: Black Algae in Pool Finish

1.6	The pool's plaster finish is harboring black algae. If scrubbing and cleaning methods cannot remove the black algae the pool finish will need to be replaced. A cost for pool finish replacement is provided. Tile would be replaced during a pool finish replacement project.	CBC, Chapter 31B: 3108B.	\$250,000.00	8	Image 38

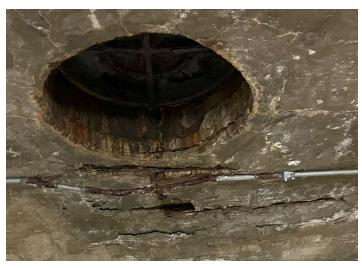
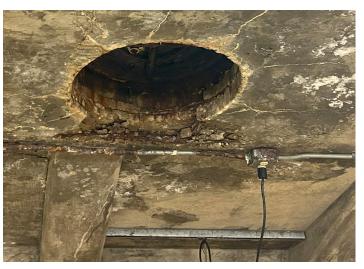
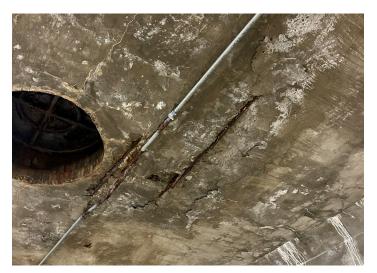
2.2	The mechanical room ceiling is failing. Some of the concrete is missing and a lot of the rebar is exposed. The ceiling leaks frequently. A structural consultant would need to be hired to develop repair solutions.	-	6	Images 39, 40 & 41

Image 39: Failing Ceiling in Mechanical Room

Image 40: Failing Ceiling in Mechanical Room

Image 41: Failing Ceiling in Mechanical Room

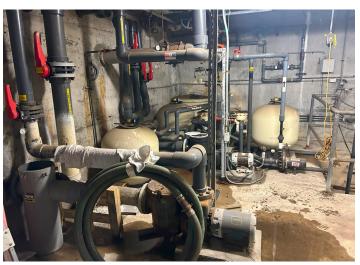
Image 42: Activity / Wading Pool Equipment

2.4	The activity / wading pool has been abandoned. At minimum the equipment for it should be cleared out of the mechanical room. Even if the City decided to restore that pool the equipment would not function due to lack of use and degradation. New equipment would need to be purchased and installed.	-	6	Image 42

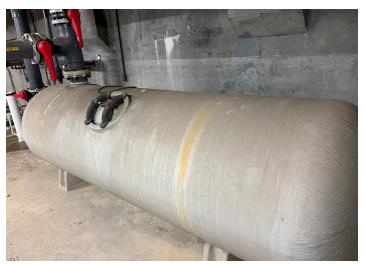
Image 44: Swimming Pool Filter Tank

2.6	The filter tank for the main pool may be more than 8 years old, based on a 2016 Kitchell conditions assessment. The City may start to see more maintenance issues with this aging filter. A plan for replacement is advised. The sand media was replaced 6 years ago. Good efforts have been made to lengthen the life cycle. Filter tanks of this style typically last 20-25 years. Planning for replacement ahead of failure is advised.	\$50,000.00	5	lmage 44

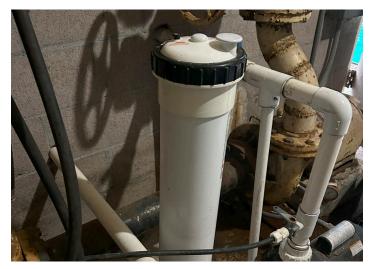
Image 44: Chlorine Tablet Feeder for Swimming Pool

ITEM	REPAIRS TO MEET CURRENT CODE	CODE	ESTIMATE	LEVEL OF CONCERN	IMAGE (See Pages 45-46)
1.1	The chlorine tablet feeder for the pool lacks interconnection with the flow for the pool's circulation system. A chemical control monitor, chemical metering pump and liquid chlorine feed system should be installed to rectify this code concern.	CBC, Chapter 31B: 3133B.1.	\$15,000.00	9	Image 45

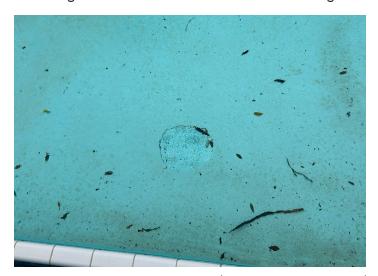
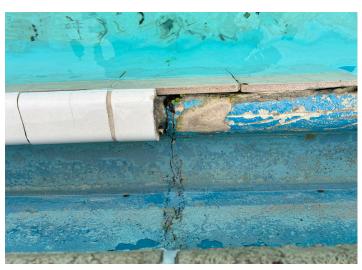
1.4	The swimming pool does not have a fixed ADA means of access. An ADA compliant lift should be installed.	ADA and ADAAG	\$12,500.00	9	N/A
1.5	The plaster finish for the pool is stained, cracked and missing in several places. Tiles are also missing from the waterline. In addition, the pool is leaking as a result of potential joint failure and return line leaks. The pool finish is in need of replacement. A pool finish replacement project would include new tile.	CBC, Chapter 31B: 3108B.	\$160,000.00	8	Images 47 & 48

Image 46: Missing Plaster in Swimming Pool

Image 47: Missing Tile in Swimming Pool

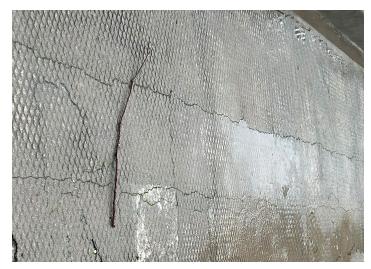
Image 48: Failing Deck

1.6	The pool deck is at the end of its life cycle and needs to be replaced. Many areas of the deck are cracked and creating safety hazards. The coping tile for the pool should be replaced at the same time.	CBC, Chapter 31B: 3114B and 3110B.4.	\$260,000.00	8	Image 49

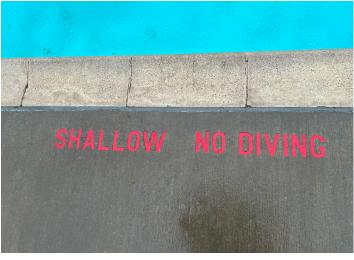
Image 49: Missing "No Diving" Graphic Marker

1.7	The pool lacks code required "No Diving" depth markers in all depth locations 6-feet or less. These can be added during a deck replacement project or retrofitted. A retrofitted price is provided.	CBC, Chapter 31B: 3110B.5	\$4,000.00	8	Image 50

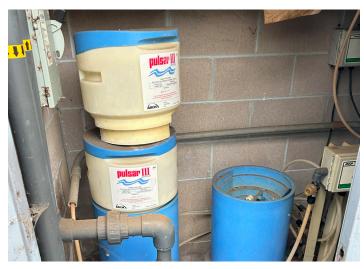
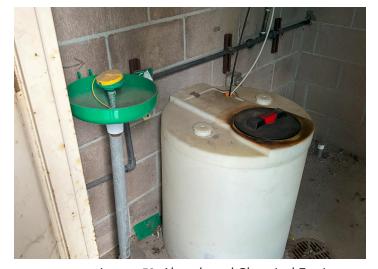
ITEM	MAINTENANCE & OPERATIONS ISSUES	ESTIMATE	LEVEL OF CONCERN	IMAGE (See Page 46)
2.1	Abandoned chemical equipment is in various rooms at the pool. The abandoned equipment should be cleared out.	-	6	Images 52 & 53
2.2	The valves for the main drain suction and skimmer suction piping are failing and need to be replaced.	\$2,000.00	5	N/A
2.3	The main drain PVC covers for the pool should be replaced at or near their expiration. Contractors replace them during replaster projects. An allowance is provided for new PVC covers during a replaster project.	\$4,000.00	5	N/A
2.4	The City may want to add a variable frequency drive to the pump / motor for the pool. VFDs increase energy savings and extend the life of pumps / motors. An allowance for one (1) new VFD is provided.	\$30,000.00	4	N/A
2.5	SUBTOTAL MAINTENANCE & OPERATIONS ISSUES	\$36,000.00

Image 51: Abandoned Chemical Equipment

Image 52: Abandoned Chemical Equipment
