# STOCKTON POOL NEEDS ASSESSMENT UPDATE

JUNE 2024

## A. SCOPE & INTRODUCTION

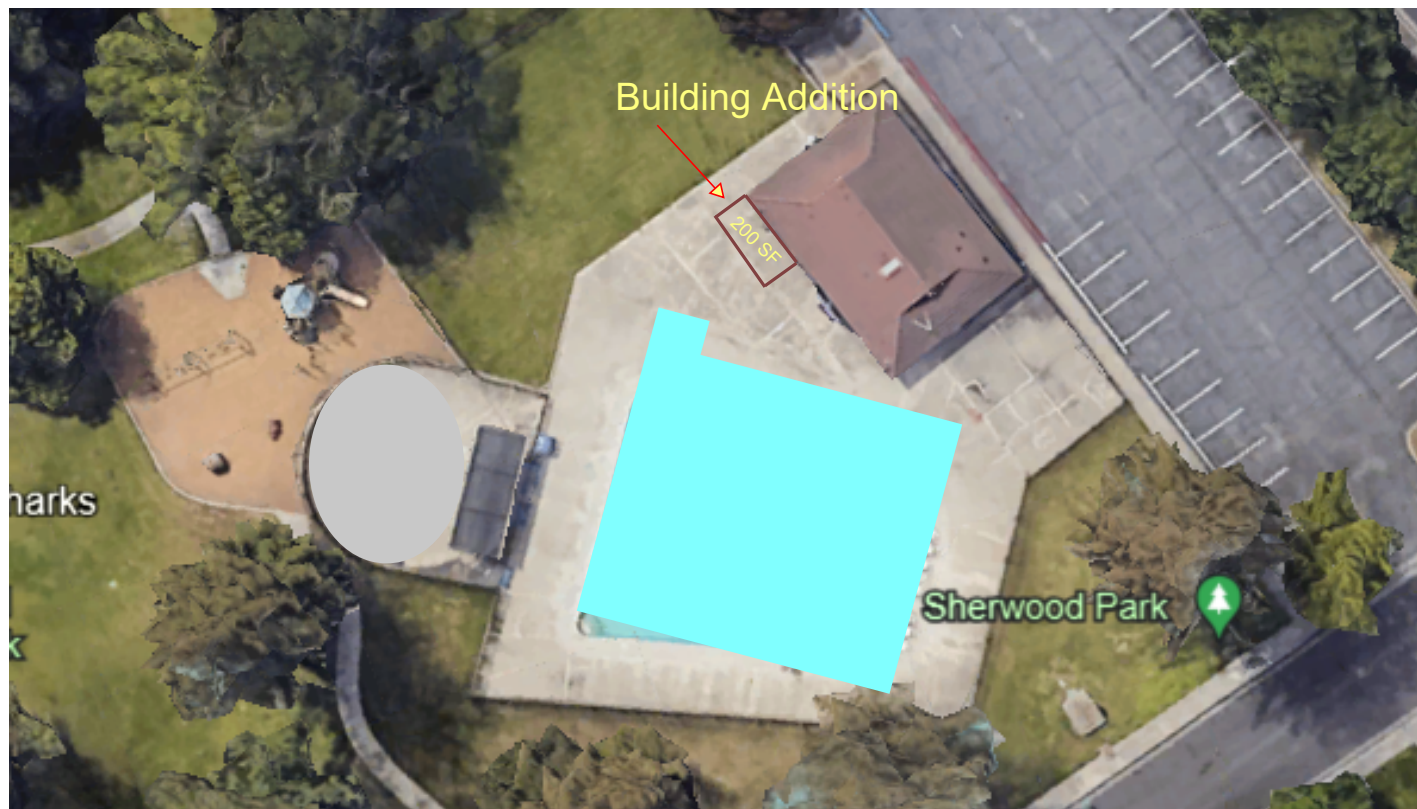
**Facility Modernization Project at Sherwood Park Pool**

- Eliminate wading pool
- Expand 5-lane x 25-yard pool to 8-lane x 25-yard pool
- Remove and replace support building with larger building
- Remove and replace all mechanical and chemical equipment for pool

The bathrooms at the Sherwood Park Pool are lacking the proper number of fixtures and are not ADA compliant. ADG recommends eliminating the wading pool and expanding the swimming pool at Sherwood Park. In addition to pool updates it is ADG's recommendation to reconstruct the support building. The swimming pool can go from a trapezoid shape to a rectangle and can add three (3) lanes to be an 8-lane x 25-yard pool. The support building can be 2,600 square feet, up from 2,400 square feet. The new mechanical equipment can include a heater for year-round usage. Below are recommended facility modernization project costs to update the facility and its programs.

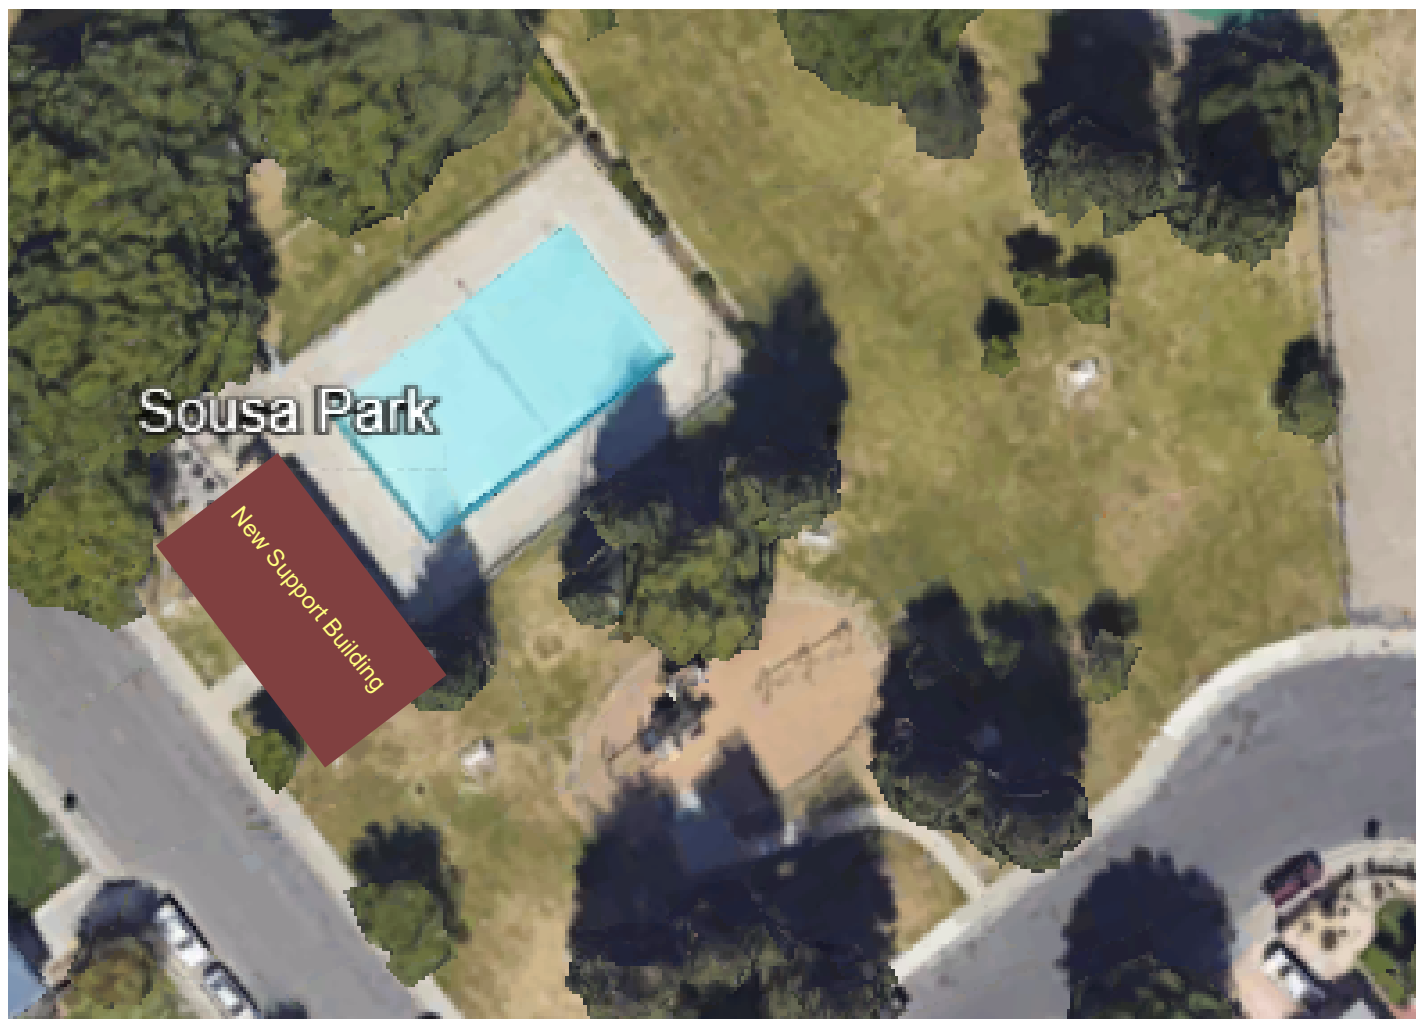
*Facility Modernization Project at Sousa Park Pool*

- Remove and replace support building with larger building
- Remove and replace all mechanical and chemical equipment for pool

The bathrooms at the Sousa Park Pool are not ADA compliant and the mechanical and chemical equipment is in need of modernization. ADG recommends that improvements be made to the support building. A newly reconstructed support building can be 2,600 square feet, up from 1,500 square feet. The new mechanical equipment can include a heater for year-round usage. Below are recommended facility modernization project costs to update the facility and its programs.

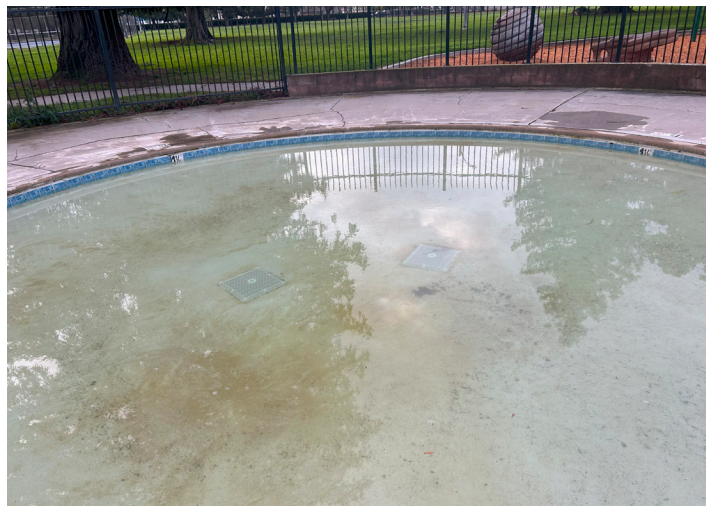
Image 2: Wading Pool

| ITEM | REPAIRS TO MEET CURRENT CODE | CODE | ESTIMATE | LEVEL OF CONCERN | IMAGE<br>(See Page 36) |
|---|---|---|---|---|---|
| 1.2 | The wading pool is 18" deep at all areas. The pool lacks an ADA compliant means of entry and egress as required by code. An ADA compliant ramp should be installed in the pool during a pool finish replacement project. | ADA and ADAAG | \$35,000.00 | 9 | Image 2 |

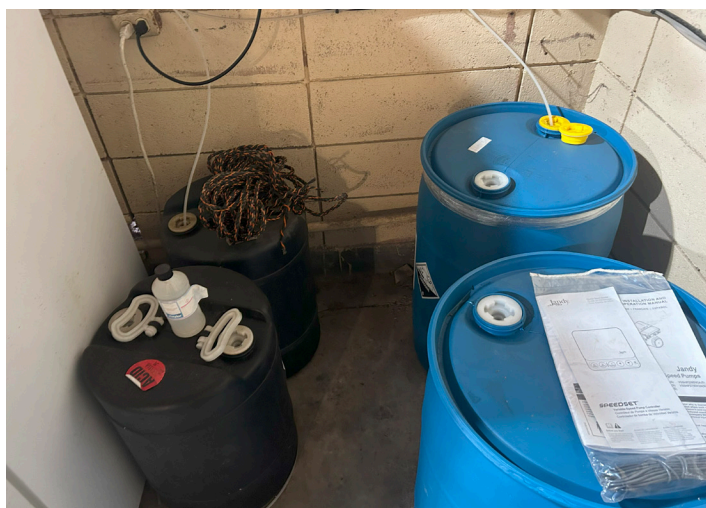
Image 3: Cohabiting Chemicals

| ITEM | REPAIRS TO MEET CURRENT CODE | CODE | ESTIMATE | LEVEL OF CONCERN | IMAGE<br>(See Page 36) |
|---|---|---|---|---|---|
| 1.5 | Liquid chlorine and acid are being stored near each other in the mechanical room. The cohabitation of these incompatible corrosives could create mustard gas and cause injury or death. International Fire Code requires at least 20 feet of distance between the chemicals or a noncombustible partition be installed. The City should relocate the storage of one of the chemicals or install a noncombustible partition. A price for a noncombustible partition is provided. In addition, the chemical drums should be stored on containment pallets to contain any incidental releases. | International Fire Code, Chapter 50 Section 5003.9.8. | \$12,000.00 | 9 | Image 3 |

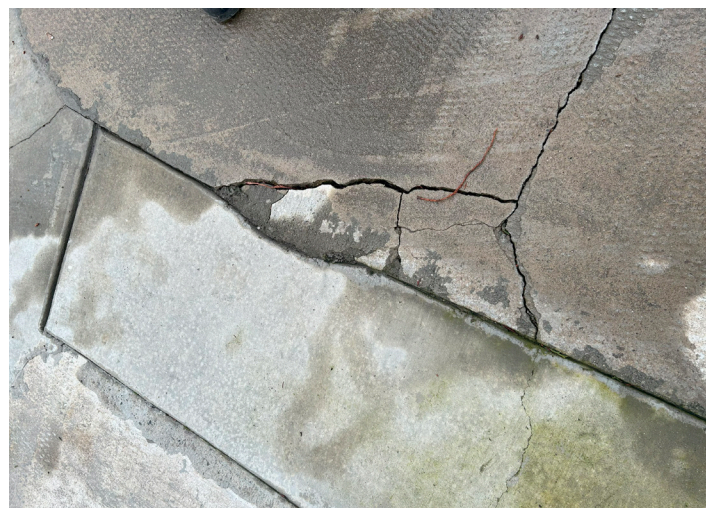
Image 6: Failing Pool Deck

| ITEM | REPAIRS TO MEET CURRENT CODE | CODE | ESTIMATE | LEVEL OF CONCERN | IMAGE<br>(See Page 36) |
|---|---|---|---|---|---|
| 1.8 | The pool deck at both pools is at the end of its life cycle and needs to be replaced. Many areas of the deck are cracked and creating safety hazards. The coping tile for both pools should be replaced at the same time. The deck depth markers that are not compliant with code (fractions) would be replaced in a deck replacement project. | CBC, Chapter 31B: 3114B and 3110B.4. | \$550,000.00 | 8 | Image 6 |

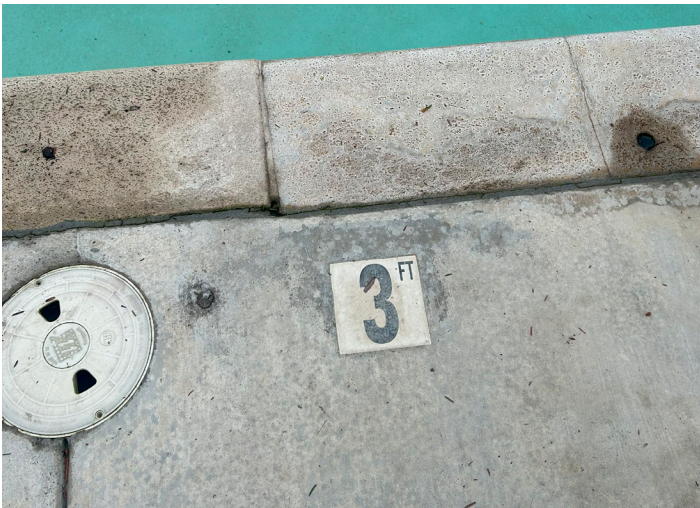
Image 7: Missing "No Diving" Marker at Swimming Pool

| ITEM | REPAIRS TO MEET CURRENT CODE | CODE | ESTIMATE | LEVEL OF CONCERN | IMAGE<br>(See Page 37) |
|---|---|---|---|---|---|
| 1.9 | The swimming pool lacks code required "No Diving" depth markers in all depth locations 6-feet or less. These can be added during a deck replacement project or retrofitted. A retrofitted price is provided. | CBC, Chapter 31B: 3110B.5. | \$4,000.00 | 8 | Image 7 |

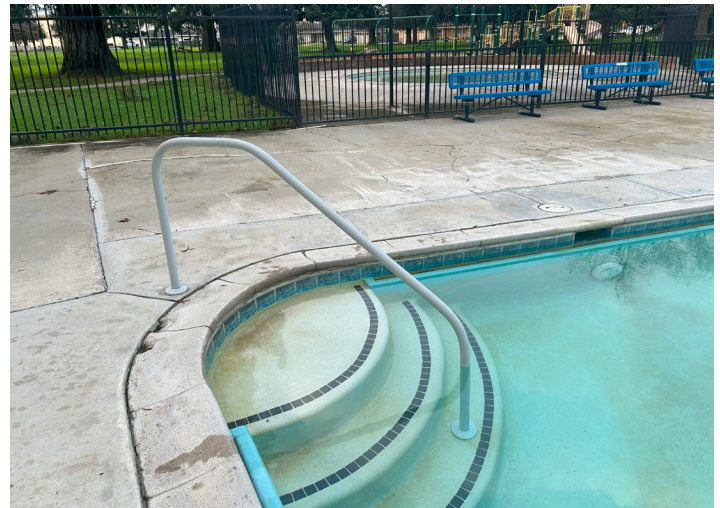
Image 8: Plastic Grab Rails

| ITEM | REPAIRS TO MEET CURRENT CODE | CODE | ESTIMATE | LEVEL OF CONCERN | IMAGE<br>(See Page 37) |
|---|---|---|---|---|---|
| 1.11 | The swimming pool's plastic grab rails are loose and not sustainable. These should be replaced with stainless-steel grab rails. | CBC, Chapter 31B: 3111B. | \$6,000.00 | 8 | Image 8 |

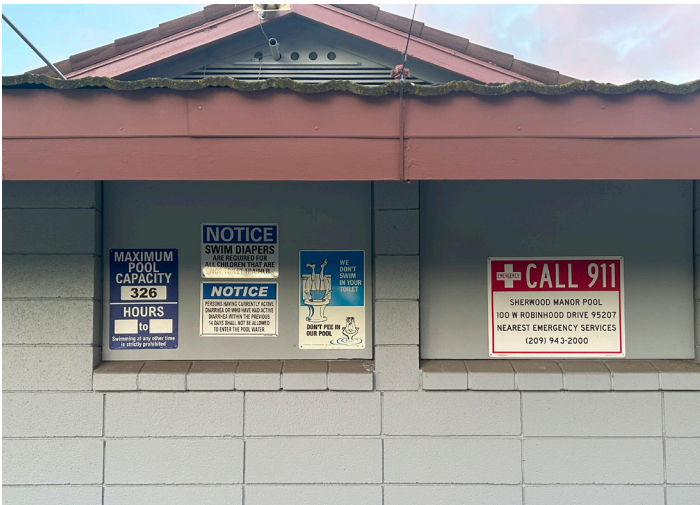
Image 9: Missing CPR Sign

| ITEM | REPAIRS TO MEET CURRENT CODE | CODE | ESTIMATE | LEVEL OF CONCERN | IMAGE<br>(See Page 37) |
|---|---|---|---|---|---|
| 1.12 | The facility is missing the code-required CPR sign. A CPR sign should be purchased and installed. | CBC, Chapter 31B: 3120B.5. | \$350.00 | 7 | Image 9 |

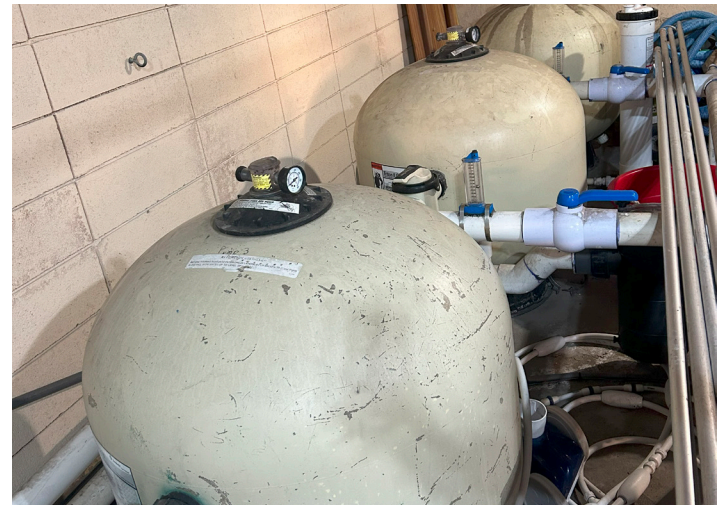
Image 10: Swimming Pool Filters

| ITEM | MAINTENANCE & OPERATIONS ISSUES | ESTIMATE | LEVEL OF CONCERN | IMAGE<br>(See Page 37) |
|---|---|---|---|---|
| 2.1 | The filter tanks for the pools are 16 years old. The City may start to see more maintenance issues with these aging filters. A plan for replacement is advised. In recent years the sand media and piping were replaced. Good efforts have been made to lengthen their life cycle but filter tanks of this style typically last 10-12 years. Planning for replacement ahead of failure is advised. | \$30,000.00 | 5 | Image 10 |

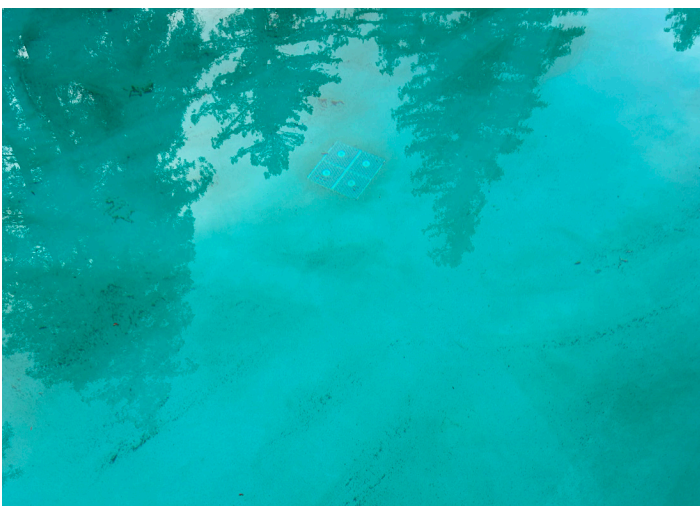
Image 11: Main Drain Cover in Swimming Pool

| ITEM | MAINTENANCE & OPERATIONS ISSUES | ESTIMATE | LEVEL OF CONCERN | IMAGE<br>(See Page 37) |
|---|---|---|---|---|
| 2.2 | The main drain PVC covers for the pools should be replaced at or near their expiration. Contractors replace them during replaster projects. An allowance is provided for new PVC covers during a replaster project. | \$5,000.00 | 5 | Image 11 |

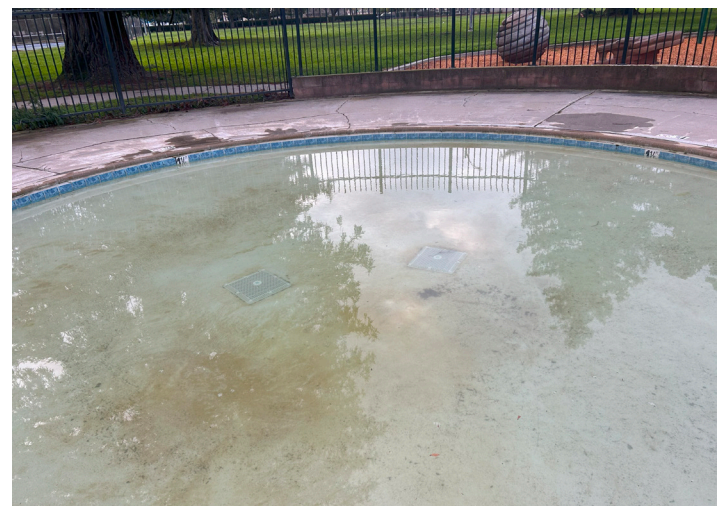
Image 12: Wading Pool

| ITEM | MAINTENANCE & OPERATIONS ISSUES | ESTIMATE | LEVEL OF CONCERN | IMAGE<br>(See Page 37) |
|---|---|---|---|---|
| 2.3 | The wading pool is in need of a new finish and is leaking. In addition, it needs new chemical equipment and the deck surrounding the wading pool is in very poor condition. ADA access is also a concern. Lastly, it is not highly used. The City should consider eliminating the wading pool. An allowance for filling it in with new concrete is provided. | \$25,000.00 | 3 & 2 | Image 12 |

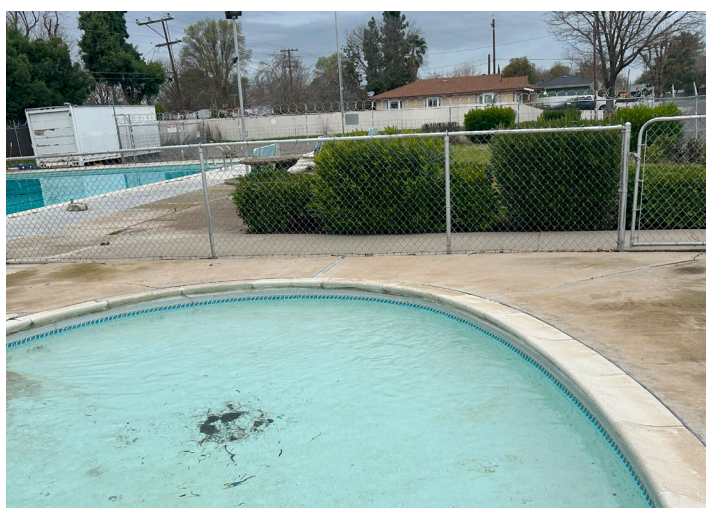
Image 15: Wading Pool

| ITEM | REPAIRS TO MEET CURRENT CODE | CODE | ESTIMATE | LEVEL OF CONCERN | IMAGE<br>(See Pages 38-39) |
|---|---|---|---|---|---|
| 1.2 | The wading pool is 18" deep at all areas. The pool lacks an ADA compliant means of entry and egress as required by code. An ADA compliant ramp should be installed in the pool during a pool finish replacement project. | ADA and ADAAG | \$35,000.00 | 9 | Image 15 |

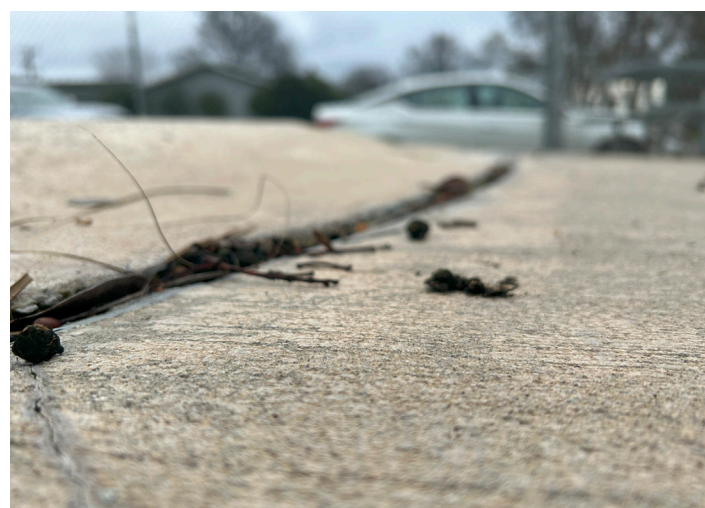
Image 16: Failing Deck

| ITEM | REPAIRS TO MEET CURRENT CODE | CODE | ESTIMATE | LEVEL OF CONCERN | IMAGE<br>(See Pages 38-39) |
|---|---|---|---|---|---|
| 1.4 | The pool deck at both pools is at the end of its life cycle and needs to be replaced. Many areas of the deck are cracked and creating safety hazards. The coping tile for both pools should be replaced at the same time. The deck depth markers that are not compliant with code (fractions, missing units of measure) would be replaced in a deck replacement project. In addition, a portion of the deck around the wading pool has a slope greater than 2% in violation of ADA standards. | CBC, Chapter 31B: 3114B and 3110B.4.<br><br>ADA and ADAAG | \$300,000.00 | 9 | Image 16 |

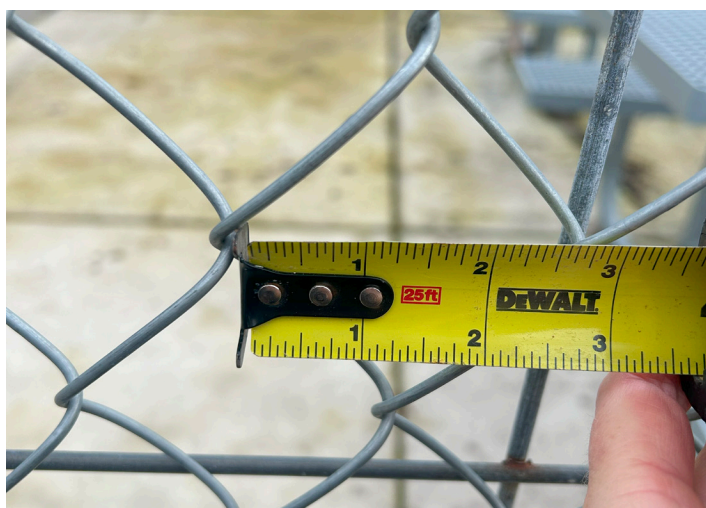
Image 17: Chain Link With Wide Opening

| ITEM | REPAIRS TO MEET CURRENT CODE | CODE | ESTIMATE | LEVEL OF CONCERN | IMAGE<br>(See Pages 38-39) |
|---|---|---|---|---|---|
| 1.5 | The gates inside the facility and on the perimeter fence line are not self-closing and self-latching as required by code. In addition, the chain link fencing itself has holes larger than allowed by code. The chain link fence and gates should be replaced. | CBC, Chapter 31B: 3119B. | \$100,000.00 | 9 | Image 17 |

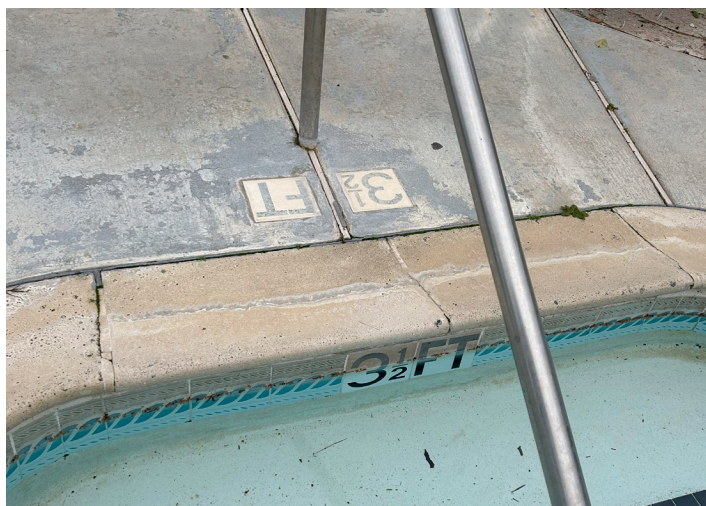
Image 19: Missing "No Diving" Marker at Swimming Pool

| ITEM | REPAIRS TO MEET CURRENT CODE | CODE | ESTIMATE | LEVEL OF CONCERN | IMAGE<br>(See Pages 38-39) |
|---|---|---|---|---|---|
| 1.8 | Both pools lack code required "No Diving" depth markers in all depth locations 6-feet or less. These can be added during a deck replacement project or retrofitted. A retrofitted price is provided. | CBC, Chapter 31B: 3110B.5. | \$6,000.00 | 8 | Image 19 |

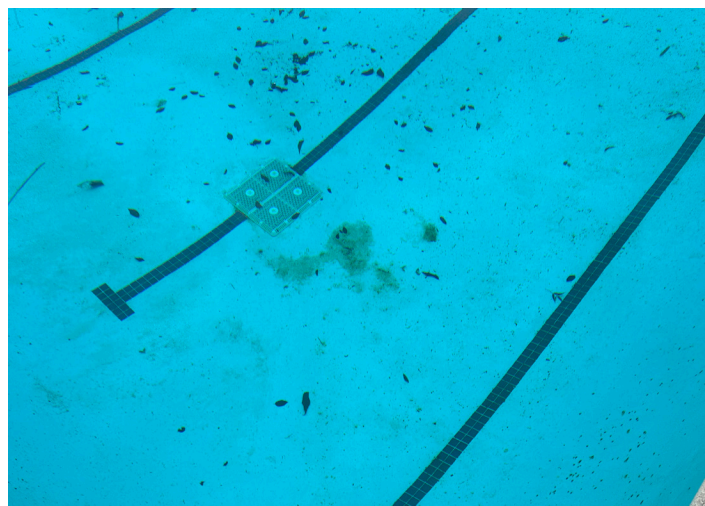
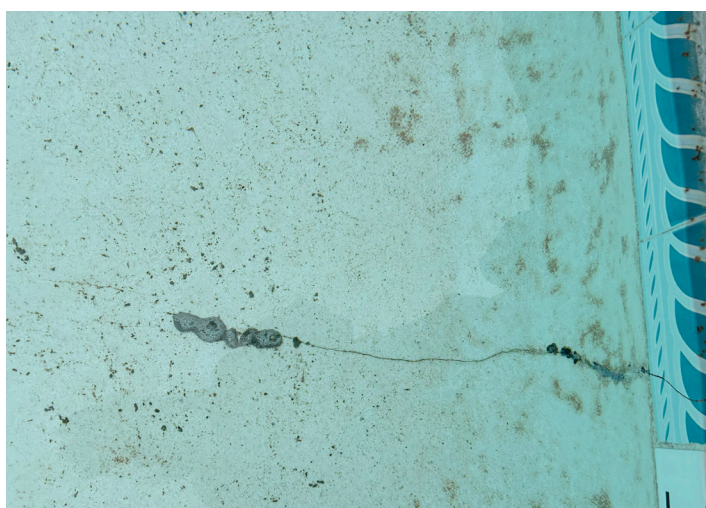
| ITEM | REPAIRS TO MEET CURRENT CODE | CODE | ESTIMATE | LEVEL OF CONCERN | IMAGE<br>(See Page 39) |
|---|---|---|---|---|---|
| 1.9 | The plaster finishes for the pools are stained and cracked. The pools are also leaking as a result of failing finishes. They are in need of replacement. A pool finish replacement project would include new tile. The existing tile is chipped, missing and cracked in many locations. | CBC, Chapter 31B: 3108B. | \$175,000.00 | 8 | Images 20 & 21 |

Image 20: Stained Plaster in Swimming Pool

Image 21: Cracked Plaster in Wading Pool

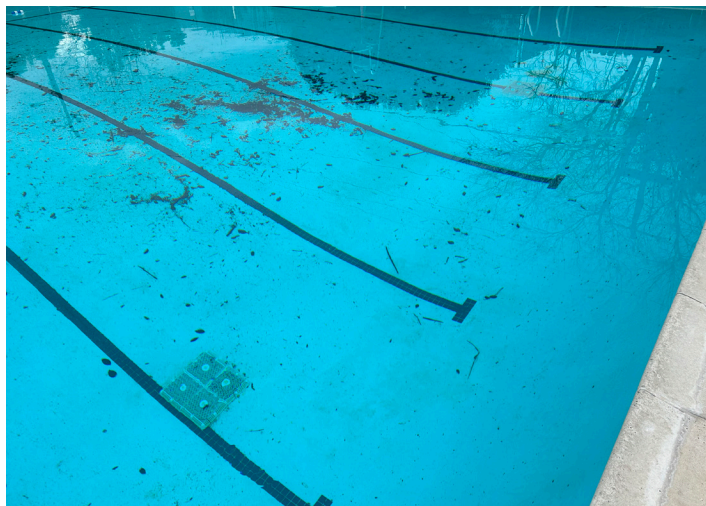
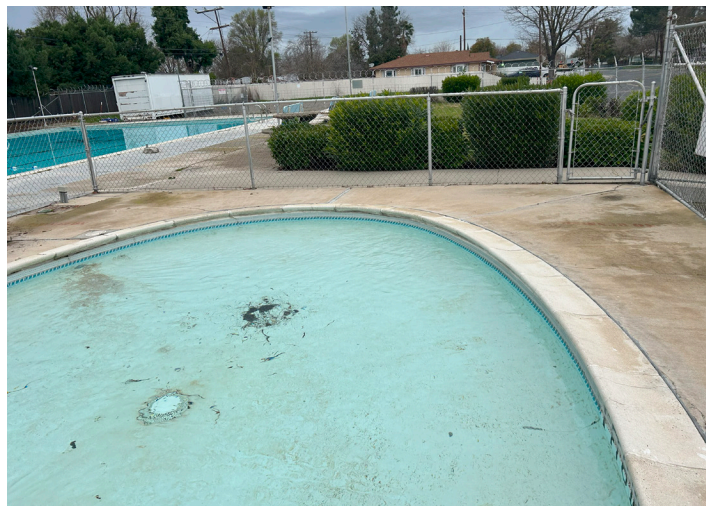
| ITEM | MAINTENANCE & OPERATIONS ISSUES | ESTIMATE | LEVEL OF CONCERN | IMAGE<br>(See Pages 39-40) |
|---|---|---|---|---|
| 2.2 | The main drain PVC covers for the pools should be replaced at or near their expiration. Contractors replace them during replaster projects. An allowance is provided for new PVC covers during a replaster project. | \$5,000.00 | 5 | Images 25 & 26 |

*Image 25: Main Drain Cover in Swimming Pool*

*Image 26: Main Drain Cover in Wading Pool*

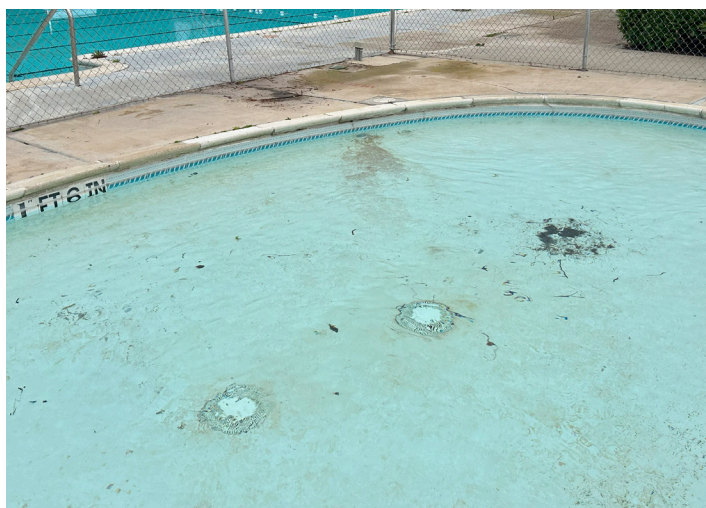
*Image 27: Failing Wading Pool Finish*

| ITEM | MAINTENANCE & OPERATIONS ISSUES | ESTIMATE | LEVEL OF CONCERN | IMAGE<br>(See Pages 39-40) |
|---|---|---|---|---|
| 2.4 | The wading pool is in need of a new finish and is leaking. In addition, it needs new chemical equipment and the deck surrounding the wading pool is in very poor condition. ADA access is also a concern. Lastly, it is not highly used. The City should consider eliminating the wading pool. An allowance for filling it in with new concrete is provided. | \$20,000.00 | 3 & 2 | Image 27 |

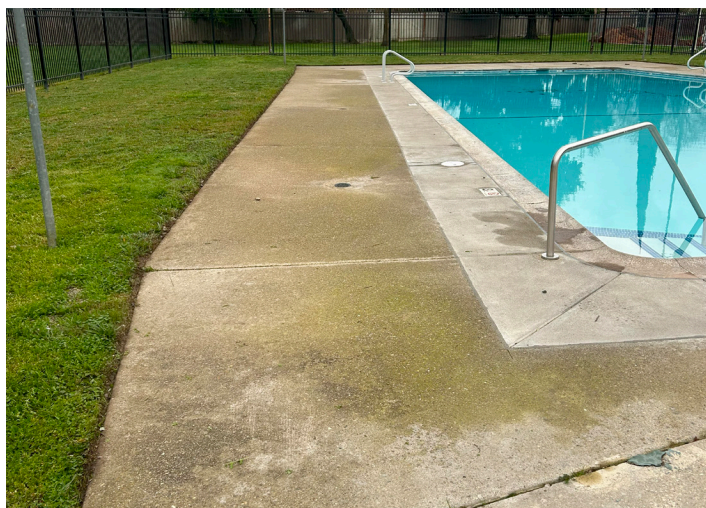
Image 32: Failing Deck

| ITEM | REPAIRS TO MEET CURRENT CODE | CODE | ESTIMATE | LEVEL OF CONCERN | IMAGE<br>(See Page 41) |
|---|---|---|---|---|---|
| 1.8 | The pool deck, outside of an area that was just redone, is near the end of its life cycle and needs to be replaced. | CBC,<br>Chapter<br>31B: 3114B<br>and 3110B.4. | \$120,000.00 | 6 | Image 32 |

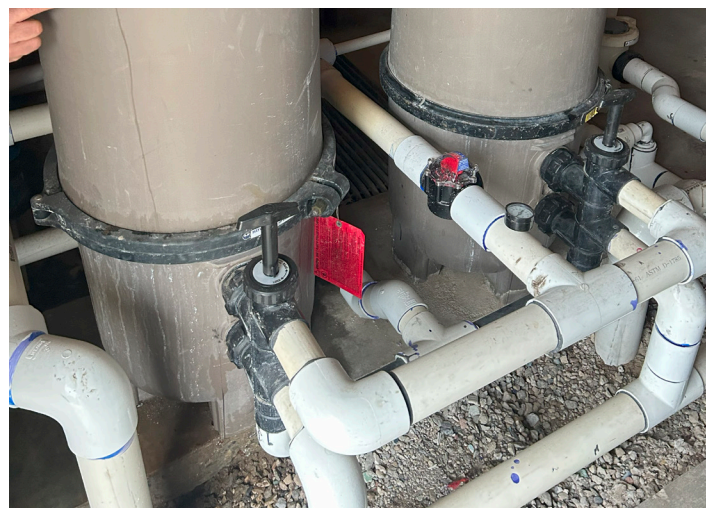
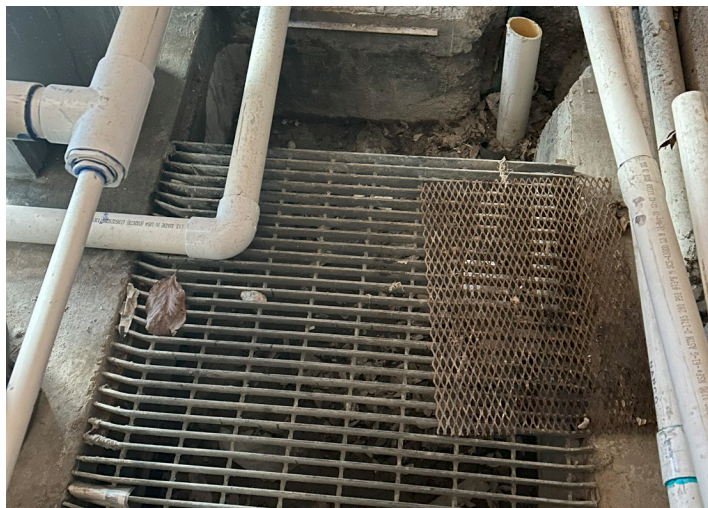
| ITEM | MAINTENANCE & OPERATIONS ISSUES | ESTIMATE | LEVEL OF CONCERN | IMAGE<br>(See Pages 41-42) |
|---|---|---|---|---|
| 2.1 | The mechanical room is missing concrete in front of the existing filters. Concrete should be poured in this area. In addition, concrete should fill in the pit behind the filters. The combination of the added concrete and the addition of a new concrete housekeeping pad will provide an acceptable surface to receive a new sand filtration system. | \$10,000.00 | 6 | Images 33 & 34 |

Image 33: Concrete Missing By Filters

*Image 34: Concrete Missing Behind Filters*

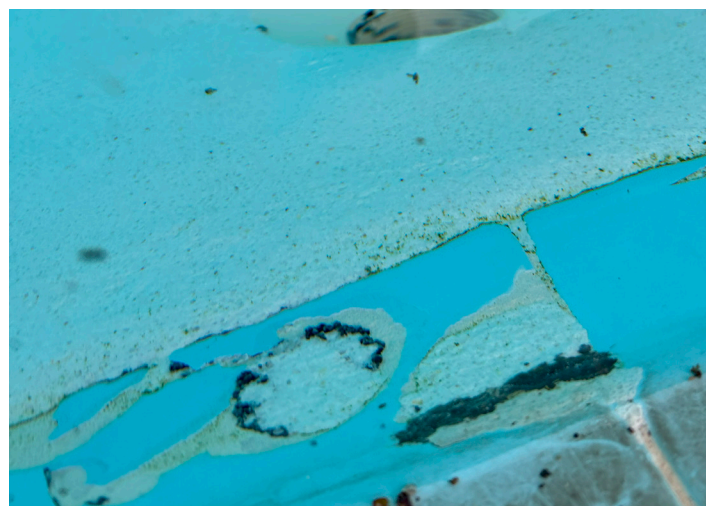
Image 38: Black Algae in Pool Finish

| ITEM | REPAIRS TO MEET CURRENT CODE | CODE | ESTIMATE | LEVEL OF CONCERN | IMAGE<br>(See Page 43) |
|---|---|---|---|---|---|
| 1.6 | The pool's plaster finish is harboring black algae. If scrubbing and cleaning methods cannot remove the black algae the pool finish will need to be replaced. A cost for pool finish replacement is provided. Tile would be replaced during a pool finish replacement project. | CBC, Chapter 31B: 3108B. | \$250,000.00 | 8 | Image 38 |

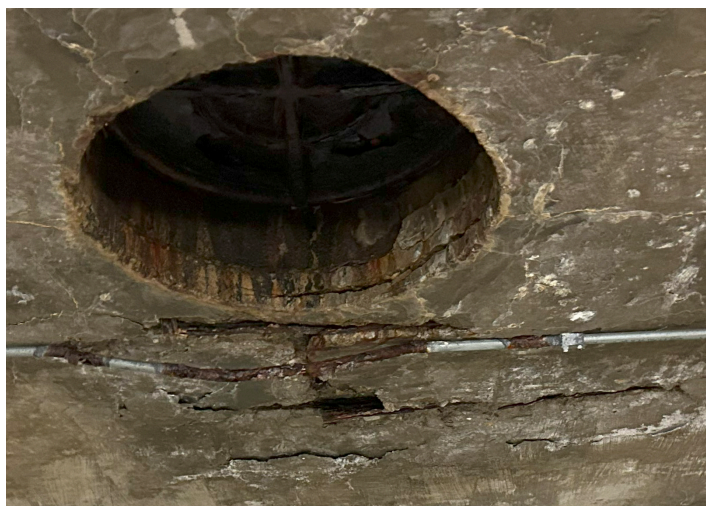
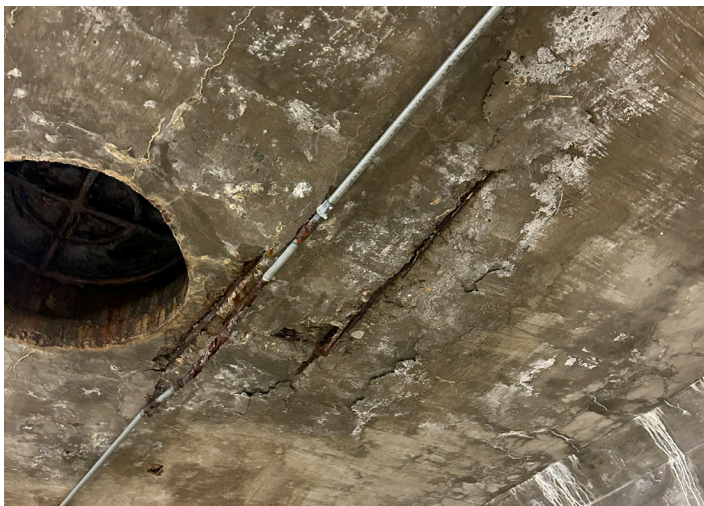
| ITEM | MAINTENANCE & OPERATIONS ISSUES | ESTIMATE | LEVEL OF CONCERN | IMAGE<br>(See Pages 43-44) |
|---|---|---|---|---|
| 2.2 | The mechanical room ceiling is failing. Some of the concrete is missing and a lot of the rebar is exposed. The ceiling leaks frequently. A structural consultant would need to be hired to develop repair solutions. | - | 6 | Images 39, 40 & 41 |

Image 39: Failing Ceiling in Mechanical Room

Image 40: Failing Ceiling in Mechanical Room

Image 41: Failing Ceiling in Mechanical Room

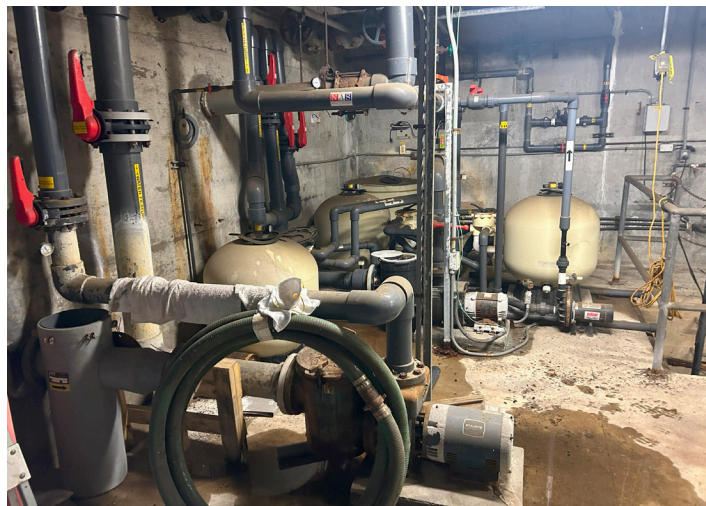
Image 42: Activity / Wading Pool Equipment

| ITEM | MAINTENANCE & OPERATIONS ISSUES | ESTIMATE | LEVEL OF CONCERN | IMAGE<br>(See Pages 43-44) |
|---|---|---|---|---|
| 2.4 | The activity / wading pool has been abandoned. At minimum the equipment for it should be cleared out of the mechanical room. Even if the City decided to restore that pool the equipment would not function due to lack of use and degradation. New equipment would need to be purchased and installed. | - | 6 | Image 42 |

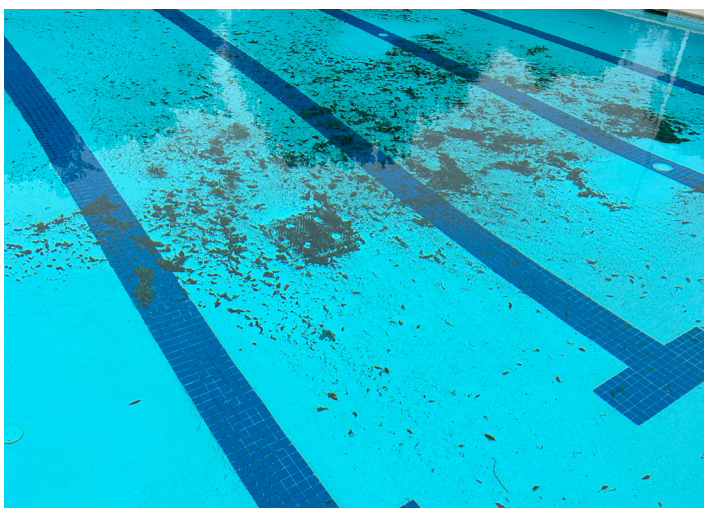
Image 43: Main Drain Cover in Swimming Pool

| ITEM | MAINTENANCE & OPERATIONS ISSUES | ESTIMATE | LEVEL OF CONCERN | IMAGE<br>(See Pages 43-44) |
|---|---|---|---|---|
| 2.5 | The main drain PVC covers for the pool should be replaced at or near their expiration. Contractors replace them during replaster projects. An allowance is provided for new PVC covers during a replaster project. | \$5,000.00 | 5 | Image 43 |

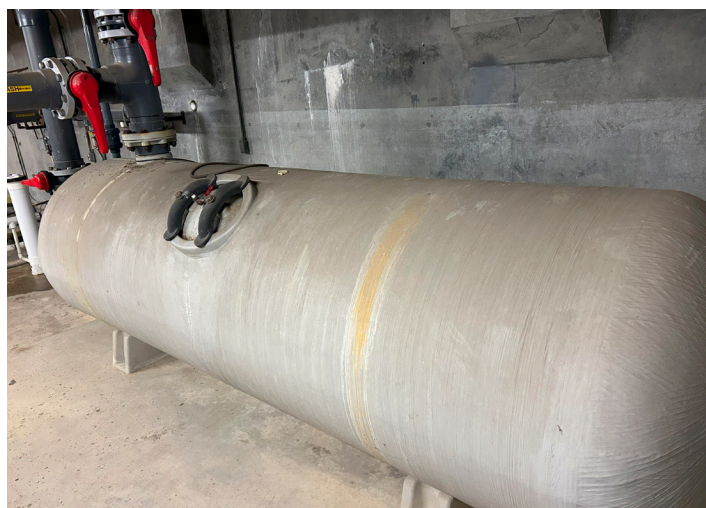
Image 44: Swimming Pool Filter Tank

| ITEM | MAINTENANCE & OPERATIONS ISSUES | ESTIMATE | LEVEL OF CONCERN | IMAGE<br>(See Pages 43-44) |
|---|---|---|---|---|
| 2.6 | The filter tank for the main pool may be more than 8 years old, based on a 2016 Kitchell conditions assessment. The City may start to see more maintenance issues with this aging filter. A plan for replacement is advised. The sand media was replaced 6 years ago. Good efforts have been made to lengthen the life cycle. Filter tanks of this style typically last 20-25 years. Planning for replacement ahead of failure is advised. | \$50,000.00 | 5 | Image 44 |

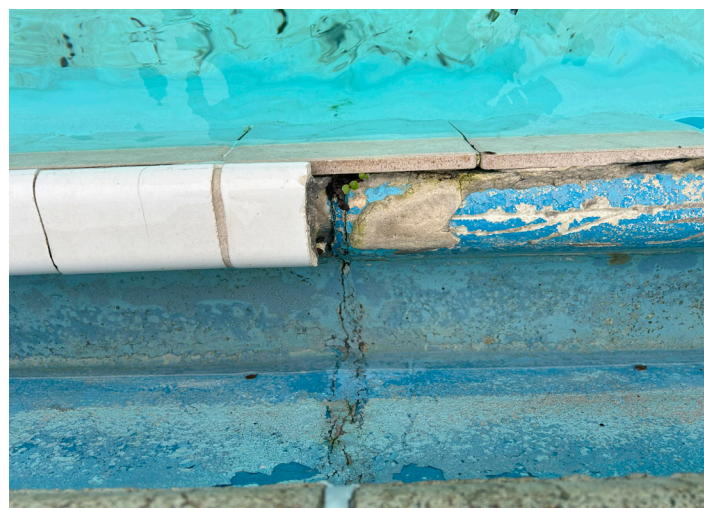
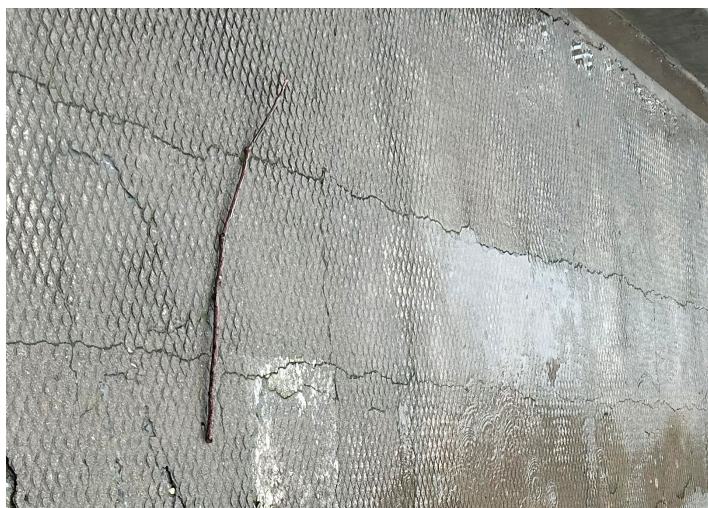
| ITEM | REPAIRS TO MEET CURRENT CODE | CODE | ESTIMATE | LEVEL OF CONCERN | IMAGE<br>(See Pages 45-46) |
|---|---|---|---|---|---|
| 1.5 | The plaster finish for the pool is stained, cracked and missing in several places. Tiles are also missing from the waterline. In addition, the pool is leaking as a result of potential joint failure and return line leaks. The pool finish is in need of replacement. A pool finish replacement project would include new tile. | CBC,<br>Chapter<br>31B: 3108B. | \$160,000.00 | 8 | Images 47 &<br>48 |

Image 47: Missing Tile in Swimming Pool

Image 48: Failing Deck

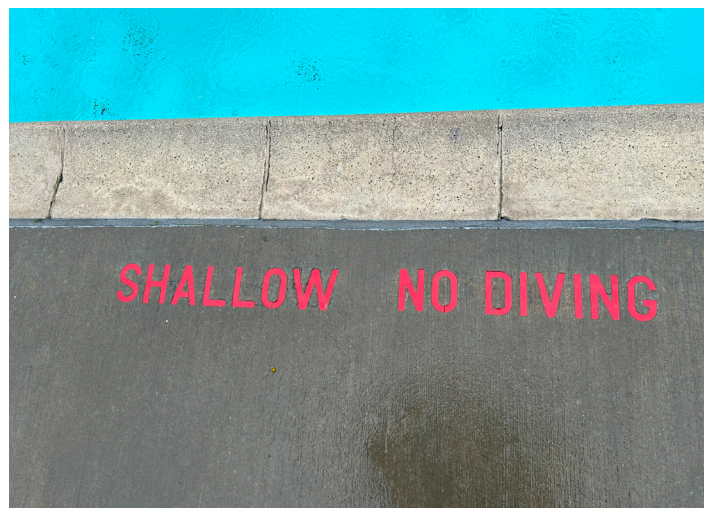
Image 49: Missing "No Diving" Graphic Marker

| ITEM | REPAIRS TO MEET CURRENT CODE | CODE | ESTIMATE | LEVEL OF CONCERN | IMAGE<br>(See Pages 45-46) |
|---|---|---|---|---|---|
| 1.6 | The pool deck is at the end of its life cycle and needs to be replaced. Many areas of the deck are cracked and creating safety hazards. The coping tile for the pool should be replaced at the same time. | CBC,<br>Chapter<br>31B: 3114B<br>and 3110B.4. | \$260,000.00 | 8 | Image 49 |
| 1.7 | The pool lacks code required "No Diving" depth markers in all depth locations 6-feet or less. These can be added during a deck replacement project or retrofitted. A retrofitted price is provided. | CBC,<br>Chapter<br>31B: 3110B.5 | \$4,000.00 | 8 | Image 50 |
