Silver Lake Campground Facility Condition Assessment

Final Report

August 16, 2024

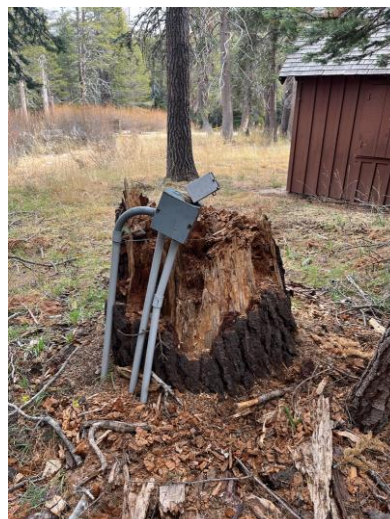
Record ID: 16
System: G4010 - SITE ELECTRIC DISTRIBUTION SYSTEMS
Item No.: G4010.10.001
Priority: Immediate (0-1 Years)
Quantity/Unit of Measure: 1/EA
Total Deficiency Cost: \$380
Deficiency Description: *The wiring device (outlet box, junction box, receptacle, etc.) needs to be replaced.*

Description of Work: *Supply and install a new junction box and cover.*

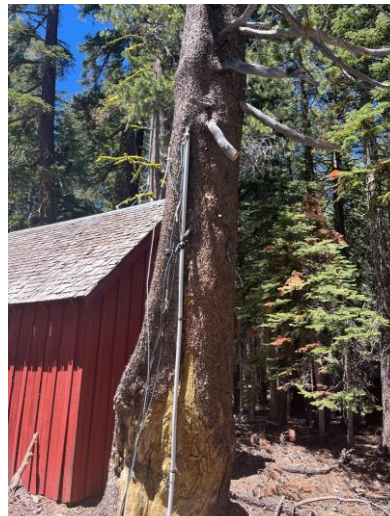
Record ID: 223
System: G4050 - SITE LIGHTING
Item No.: G4050.10.006
Priority: Immediate (0-1 Years)
Quantity/Unit of Measure: 1/EA
Total Deficiency Cost: \$7,400
Deficiency Description: *Site lighting is not functioning or is damaged.*

Comments: *Near Cabin U1*

Description of Work: *Replace lighting (LED).*

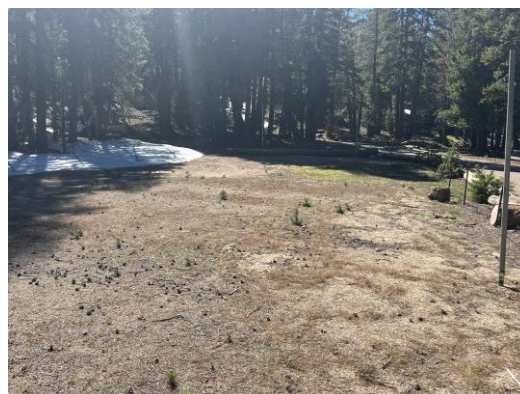
The visual assessment of the leach field showed no signs of failure; however, considering that the site has not been used for several years and the water appears to have been shut off to the site, this would be a difficult deficiency to note.

The EPA estimates a septic system expected useful life to be between 15 to 40 years depending on the material and maintenance. Based on the assumed age of the campground and facilities, it is likely the system is past its expected useful life (EUL). It is recommended that a full test and inspection of the septic system and tank be completed.

Record ID: 240
System: G3020 - SANITARY SEWERAGE UTILITIES
Item No.: G3020.40.008
Priority: Immediate (0-1 Years)
Quantity/Unit of Measure: 17,000/SF
Total Deficiency Cost: \$514,310
Deficiency Description: *Leach fields need to be replaced.*

Description of Work: *Provide equipment replacement and installation.*

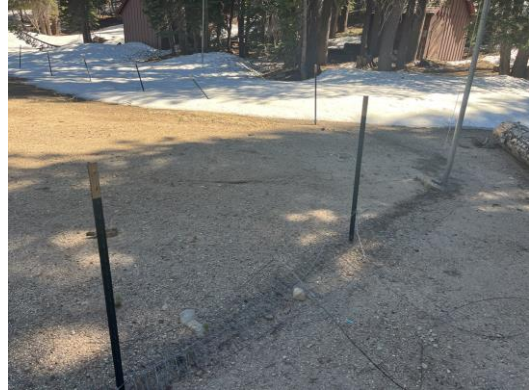
Priority: Immediate (0-1 Years)
Quantity/Unit of Measure: 540/LF
Total Deficiency Cost: \$71,870
Deficiency Description: *Metal wire mesh fence is approaching the end of its expected useful life (up to 5'H).*

Description of Work: *Replace metal wire mesh fence.*

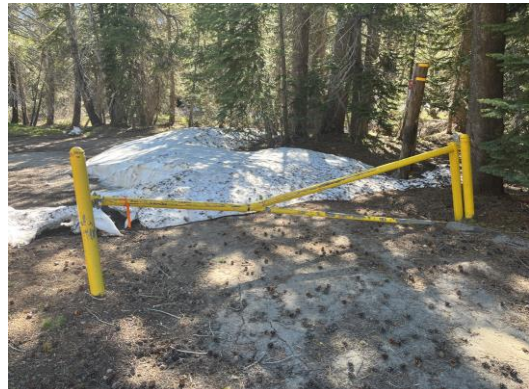
Priority: Immediate (0-1 Years)
Quantity/Unit of Measure: 1/EA
Total Deficiency Cost: \$9,690
Deficiency Description: *Vehicular swing gate has major damage or missing portions.*

Description of Work: *Replace single vehicular swing gate (up to 12 ft wide, 10 ft high).*

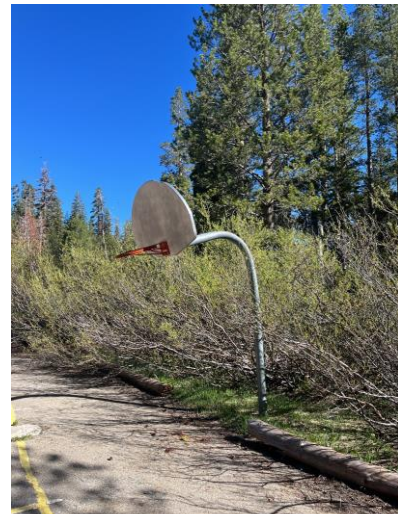
Priority: Immediate (0-1 Years)
Quantity/Unit of Measure: 1/EA
Total Deficiency Cost: \$10,100
Deficiency Description: *The basketball hoop, backboard and pole is damaged and/or past its expected useful life.*

Description of Work: *Replace basketball hoop, backboard and pole.*

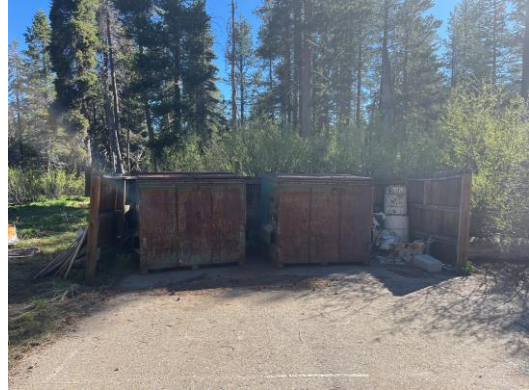
Priority: Immediate (0-1 Years)
Quantity/Unit of Measure: 600/SF
Total Deficiency Cost: \$20,580
Deficiency Description: *Wood slat fencing (up to 6 ft high) shows heavy damage and requires full replacement.*

Description of Work: *Replace entire fence, including rails and posts.*

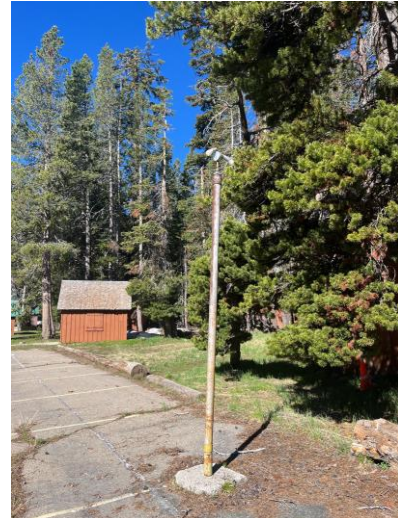
Priority: Immediate (0-1 Years)
Quantity/Unit of Measure: 1/EA
Total Deficiency Cost: \$8,400
Deficiency Description: *Site lighting pole is approaching the end of its useful life.*

Description of Work: *Replace steel pole and lighting (up to 20 ft high).*

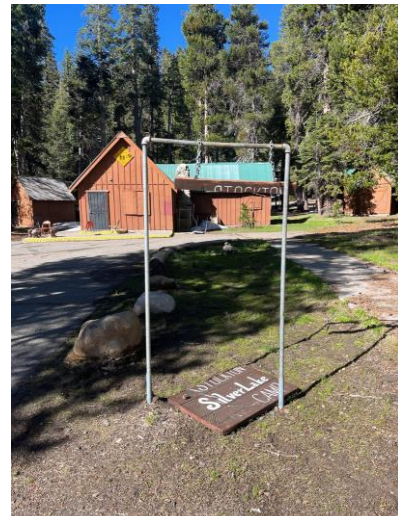
Priority: Immediate (0-1 Years)
Quantity/Unit of Measure: 1/EA
Total Deficiency Cost: \$3,350
Deficiency Description: *Sign shows major damage.*

Description of Work: *Replace wood sign.*

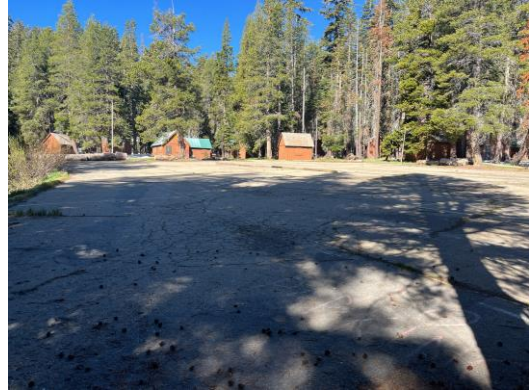
The asphalt concrete (AC) pavement in the parking areas is showing signs of cracking, age and wear and should be replaced within the next five years.

Record ID: 251
System: G2020 - PARKING LOTS
Item No.: G2020.10.002
Priority: Immediate (0-1 Years)
Quantity/Unit of Measure: 27,000/SF
Total Deficiency Cost: \$789,640
Deficiency Description: AC paving shows evidence of potholing.

Description of Work: Replace AC pavement section.

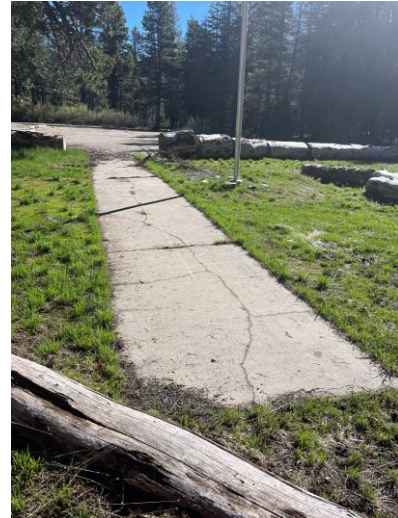
Record ID: 252
System: G2030 - PEDESTRIAN PLAZAS AND WALKWAYS
Item No.: G2030.10.00
Priority: Immediate (0-1 Years)
Quantity/Unit of Measure: 200/SF
Total Deficiency Cost: \$7,250
Deficiency Description: Concrete pavement has major damage and structural failure.

Description of Work: Repair and replace concrete and base to match existing.

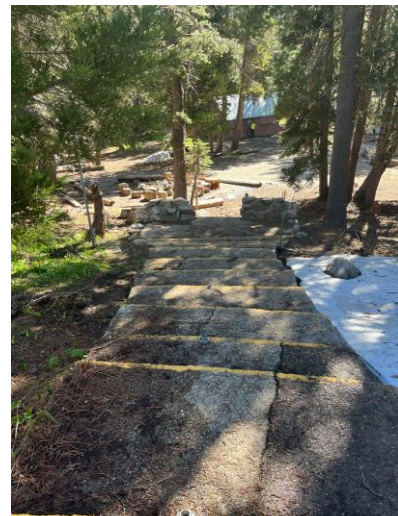
Record ID: 255
System: G2030 - PEDESTRIAN PLAZAS AND WALKWAYS
Item No.: G2030.30.038
Priority: Immediate (0-1 Years)
Quantity/Unit of Measure: 80/LFNS
Total Deficiency Cost: \$51,640
Deficiency Description: Stairs are heavily damaged and/or at the end of their useful life.

Description of Work: Replace entire concrete stair system, including steps, handrails, and landings.

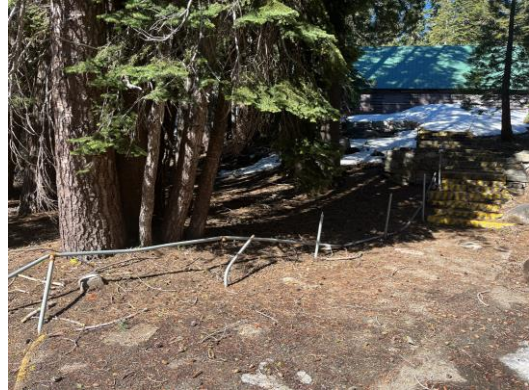
Priority: Immediate (0-1 Years)
Quantity/Unit of Measure: 80/LF
Total Deficiency Cost: \$27,420
Deficiency Description: *Handrails are damaged.*

Description of Work: *Replace section of handrail.*

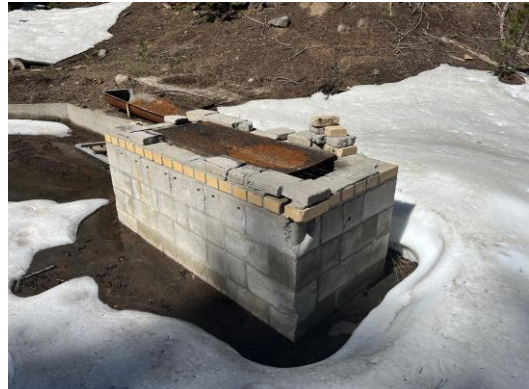
Priority: Immediate (0-1 Years)
Quantity/Unit of Measure: 1/EA
Total Deficiency Cost: \$6,050
Deficiency Description: *Barbeque equipment is damaged or missing.*

Description of Work: *Replace concrete barbeque.*

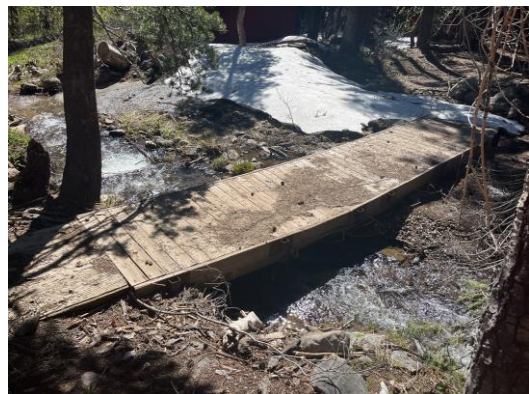
There are three wooden bridges that cross two streams that run through the property. The bridges have concrete or metal supports at each abutment with wood spans and decking. There are attachments to install future handrails on each side. Two of the three bridges appear to be in good condition; however, the wood beam for the bridge to Cabins X, Y1 and Y2 is damaged and failing and should be repaired or replaced.

Priority: Immediate (0-1 Years)
Quantity/Unit of Measure: 150/SF
Total Deficiency Cost: \$151,260
Deficiency Description: *Wood bridge overall is severely damaged*

Description of Work: *Replace wood bridge.*

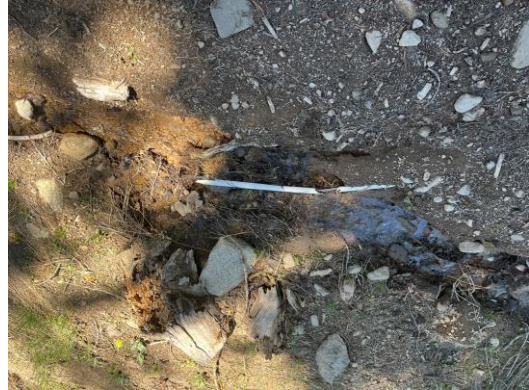
Priority: Immediate (0-1 Years)
Quantity/Unit of Measure: 2/LF
Total Deficiency Cost: \$120
Deficiency Description: Buried PVC electrical conduit is damaged (1" DIA).

Description of Work: Replace the electrical conduit.

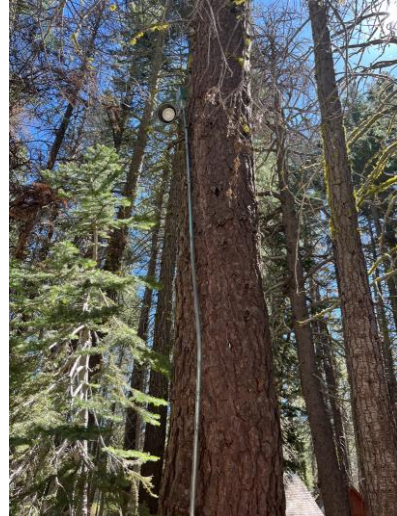
Priority: Immediate (0-1 Years)
Quantity/Unit of Measure: 1/EA
Total Deficiency Cost: \$7,400
Deficiency Description: Site lighting is not functioning or is damaged.

Description of Work: Replace lighting (LED).

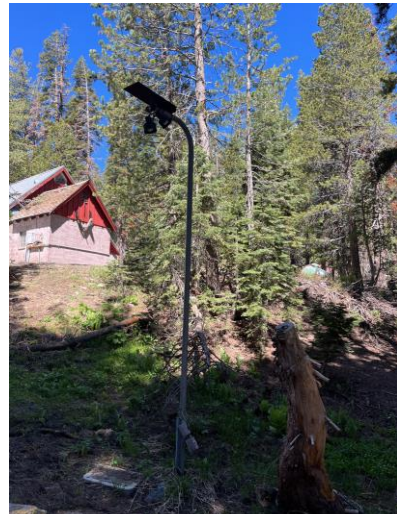
Priority: Immediate (0-1 Years)
Quantity/Unit of Measure: 1/EA
Total Deficiency Cost: \$8,400
Deficiency Description: Site lighting pole is approaching the end of its useful life.

Description of Work: Replace steel pole and lighting (up to 20 ft high).

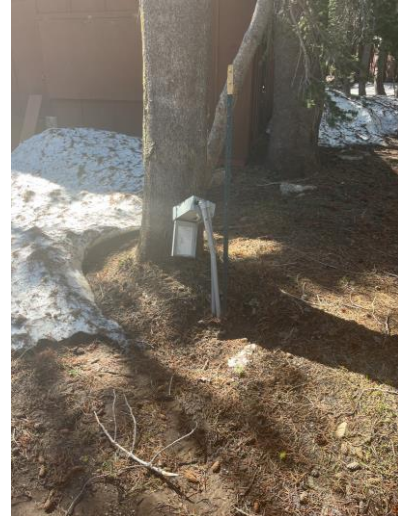
Priority: Immediate (0-1 Years)
Quantity/Unit of Measure: 1/EA
Total Deficiency Cost: \$380
Deficiency Description: *The wiring device (outlet box, junction box, receptacle, etc.) needs to be replaced.*

Description of Work: *Supply and install a new junction box and cover.*

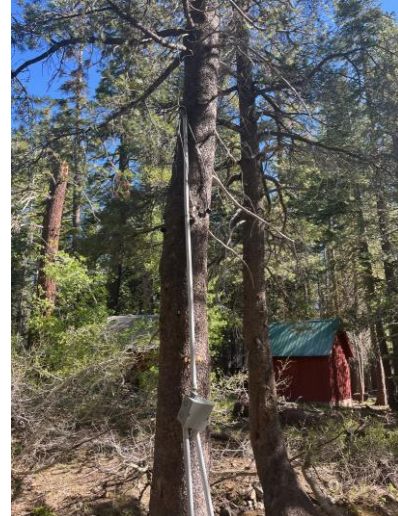
Priority: Immediate (0-1 Years)
Quantity/Unit of Measure: 1/EA
Total Deficiency Cost: \$7,400
Deficiency Description: *Site lighting is not functioning or is damaged.*

Description of Work: *Replace lighting (LED).*

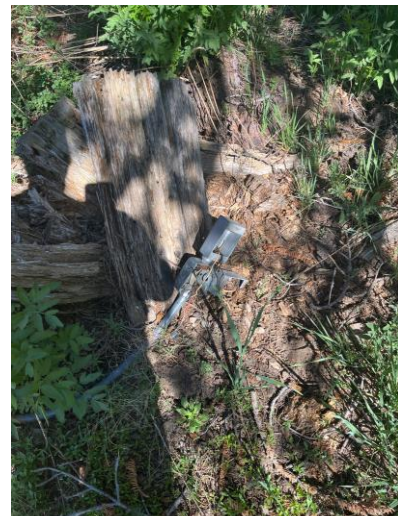
Priority: Immediate (0-1 Years)
Quantity/Unit of Measure: 1/EA
Total Deficiency Cost: \$380
Deficiency Description: *The wiring device (outlet box, junction box, receptacle, etc.) needs to be replaced.*

Description of Work: *Supply and install a new junction box and cover.*

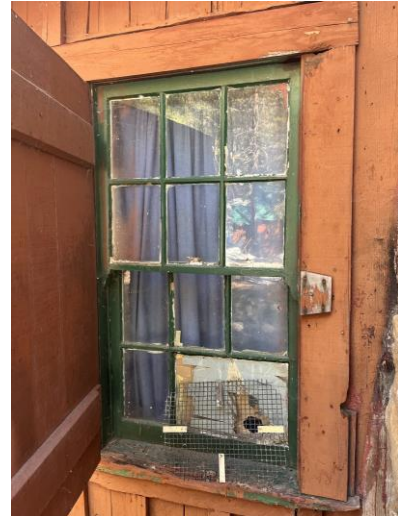
Record ID: 160
System: B2010 - EXTERIOR WALLS
Item No.: B2010.10.016
Priority: Immediate (0-1 Years)
Quantity/Unit of Measure: 900/SF
Total Deficiency Cost: \$22,690
Deficiency Description: *The exterior wood board siding is showing signs of age and wear.*

Description of Work: *Power wash and repaint existing wood board siding.*

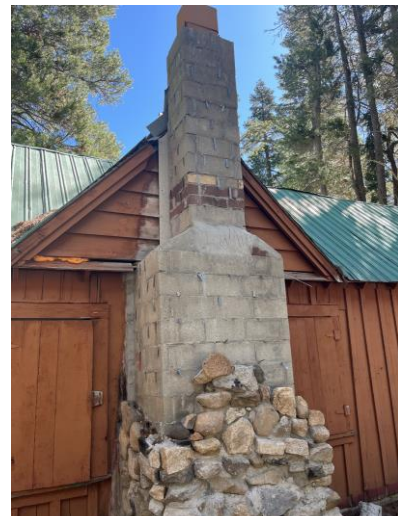
Record ID: 161
System: B2010 - EXTERIOR WALLS
Item No.: B2010.10.008
Priority: Immediate (0-1 Years)
Quantity/Unit of Measure: 100/SF
Total Deficiency Cost: \$1,670
Deficiency Description: *Stone veneer is missing or damaged.*

Description of Work: *Repair or replace damaged stone veneer.*

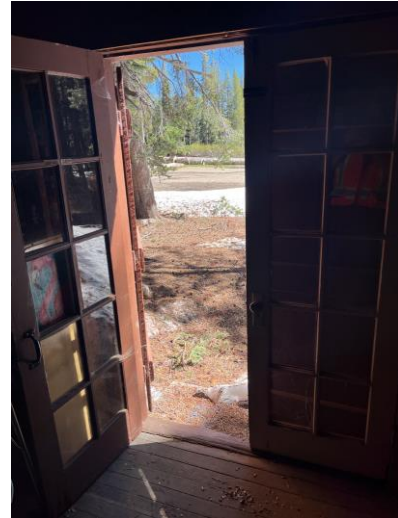
Record ID: 164
System: B2050 - EXTERIOR DOORS AND GRILLES
Item No.: B2050.10.001
Priority: Immediate (0-1 Years)
Quantity/Unit of Measure: 3/EA
Total Deficiency Cost: \$25,220
Deficiency Description: *Exterior wood entrance door is approaching the end of its useful life.*

Description of Work: *Replace wood door.*

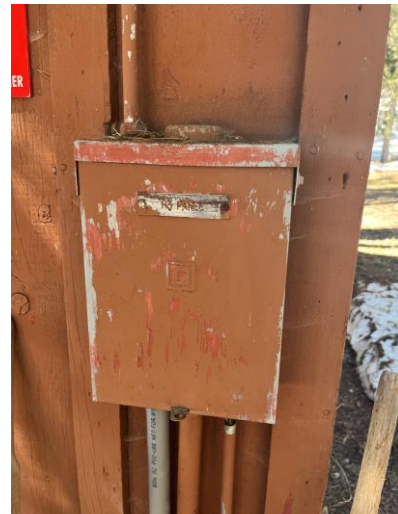
Record ID: 165
System: D5020 - ELECTRICAL SERVICE AND DISTRIBUTION
Item No.: D5020.30.9114
Priority: Immediate (0-1 Years)
Quantity/Unit of Measure: 1/EA
Total Deficiency Cost: \$6,750
Deficiency Description: *The outdoor load center is past its expected useful life.*

Description of Work: *Replace the existing load center with a new load center.*

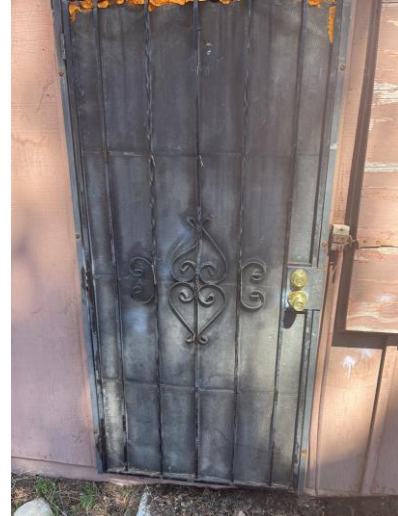
Record ID: 167
System: B2050 - EXTERIOR DOORS AND GRILLES
Item No.: B2050.10.006
Priority: Immediate (0-1 Years)
Quantity/Unit of Measure: 3/EA
Total Deficiency Cost: \$22,110
Deficiency Description: *Exterior aluminum entrance door, frame and hardware is approaching the end of its useful life.*
Description of Work: *Replace aluminum door, frame, and hardware.*
Comments:

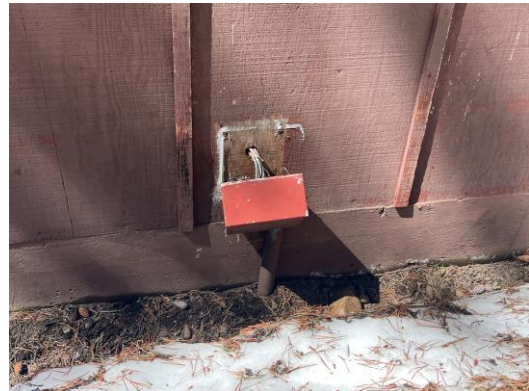
Record ID: 168
System: G4010 - SITE ELECTRIC DISTRIBUTION SYSTEMS
Item No.: G4010.10.001
Priority: Immediate (0-1 Years)
Quantity/Unit of Measure: 1/EA
Total Deficiency Cost: \$380
Deficiency Description: *The wiring device (outlet box, junction box, receptacle, etc.) needs to be replaced.*
Description of Work: *Supply and install a new junction box and cover.*
Comments:

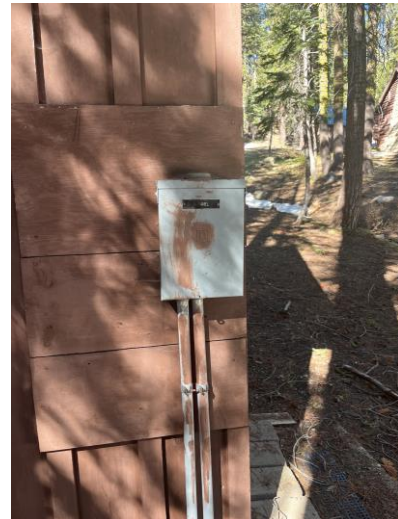
Priority: Immediate (0-1 Years)
Quantity/Unit of Measure: 1/EA
Total Deficiency Cost: \$6,750
Deficiency Description: *The outdoor load center is past its expected useful life.*

Description of Work: *Replace the existing load center with a new load center.*

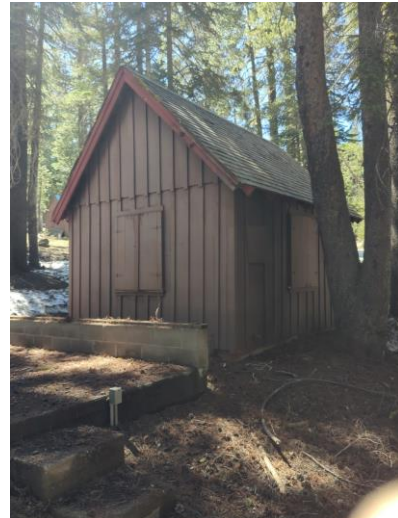
Record ID: 336
System: B2010 - EXTERIOR WALLS
Item No.: B2010.10.016

Priority: Immediate (0-1 Years)
Quantity/Unit of Measure: 700/SF
Total Deficiency Cost: \$17,640
Deficiency Description: *The exterior wood board siding and/or wall finish is showing signs of age and wear.*

Comments: *Signs of water damage noted along bottom edge of siding.*

Description of Work: *Power wash and repaint existing wood board siding and/or wall finish.*

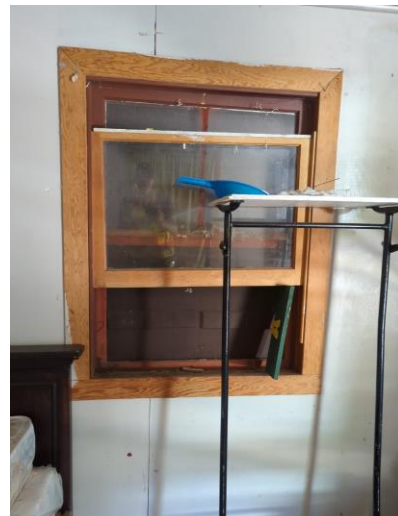
Record ID: 338
System: B2020 - EXTERIOR WINDOWS
Item No.: B2020.10.015

Priority: Immediate (0-1 Years)
Quantity/Unit of Measure: 45/SF
Total Deficiency Cost: \$23,460
Deficiency Description: *Windows are damaged and/or past their expected useful life.*

Description of Work: *Replace window.*

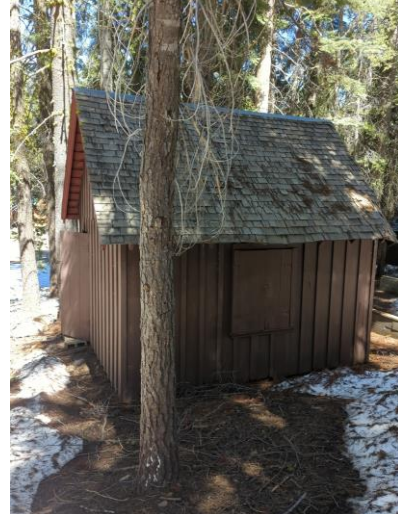
Record ID: 339
System: B3010 - ROOFING
Item No.: B3010.10.007
Priority: Immediate (0-1 Years)
Quantity/Unit of Measure: 200/SF
Total Deficiency Cost: \$7,720
Deficiency Description: *Wood shake roof is past its expected useful life.*

Description of Work: *Remove and replace wood shake roof and replace with metal roofing.*

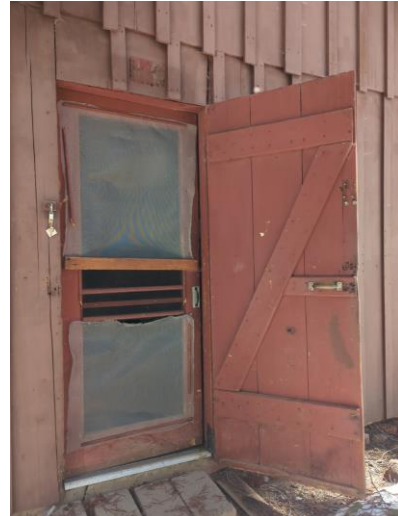
Record ID: 599
System: B2050 - EXTERIOR DOORS AND GRILLES
Item No.: B2050.10.001
Priority: Immediate (0-1 Years)
Quantity/Unit of Measure: 1/EA
Total Deficiency Cost: \$8,400
Deficiency Description: *Exterior wood entrance door is damaged and/or past its expected useful life.*

Description of Work: *Replace wood door.*

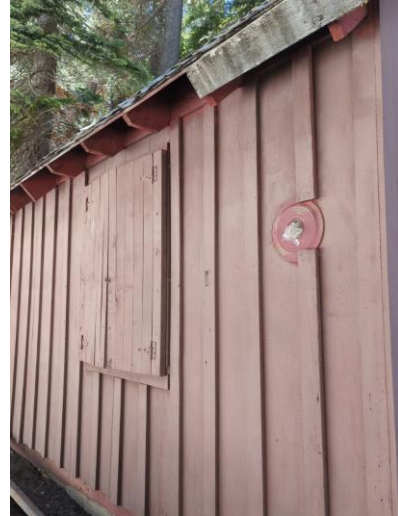
Record ID: 342
System: B2010 - EXTERIOR WALLS
Item No.: B2010.10.016
Priority: Immediate (0-1 Years)
Quantity/Unit of Measure: 700/SF
Total Deficiency Cost: \$17,640
Deficiency Description: *The exterior wood board siding is showing signs of age and wear.*

Description of Work: *Power wash and repaint existing wood board siding.*

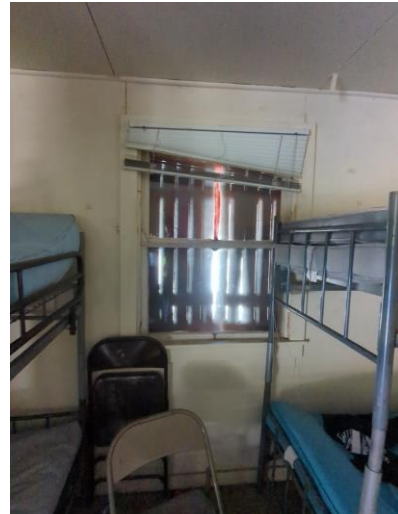
Record ID: 343
System: B2020 - EXTERIOR WINDOWS
Item No.: B2020.10.015
Priority: Immediate (0-1 Years)
Quantity/Unit of Measure: 45/SF
Total Deficiency Cost: \$23,460
Deficiency Description: *Windows are damaged and/or past their expected useful life.*

Description of Work: *Replace window.*

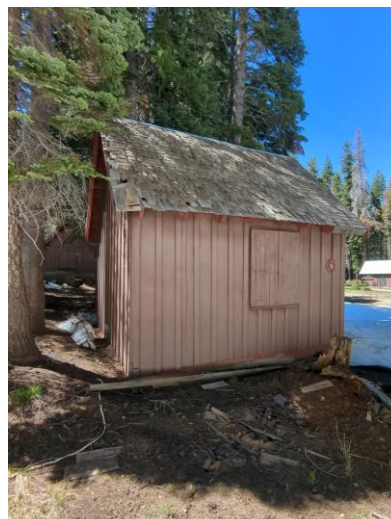
Record ID: 344
System: B3010 - ROOFING
Item No.: B3010.10.007
Priority: Immediate (0-1 Years)
Quantity/Unit of Measure: 200/SF
Total Deficiency Cost: \$7,720
Deficiency Description: *Wood shake roof is past its expected useful life.*

Description of Work: *Remove and replace wood shake roof and replace with metal roofing.*

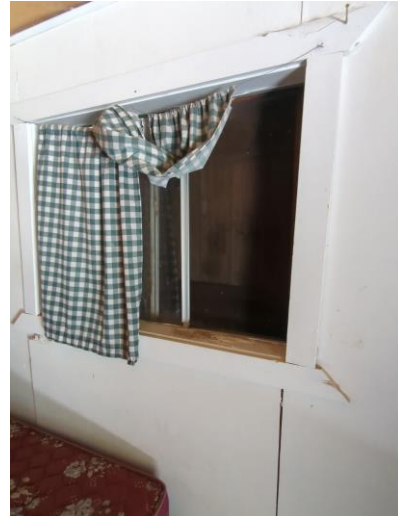
Record ID: 353
System: B2020 - EXTERIOR WINDOWS
Item No.: B2020.10.015
Priority: Immediate (0-1 Years)
Quantity/Unit of Measure: 45/SF
Total Deficiency Cost: \$23,460
Deficiency Description: *Windows are damaged and/or past their expected useful life.*

Description of Work: *Replace window.*

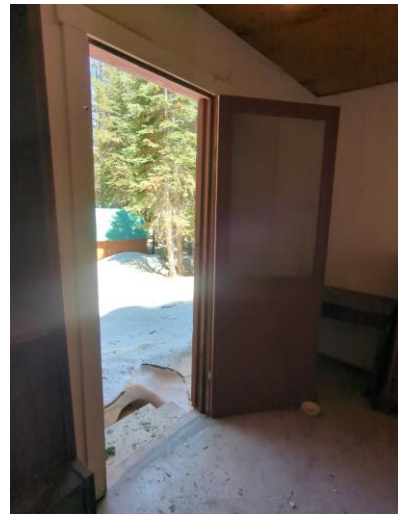
Record ID: 354
System: B2050 - EXTERIOR DOORS AND GRILLES
Item No.: B2050.10.001
Priority: Immediate (0-1 Years)
Quantity/Unit of Measure: 1/EA
Total Deficiency Cost: \$8,400
Deficiency Description: *Exterior wood entrance door is approaching the end of its useful life.*

Description of Work: *Replace wood door.*

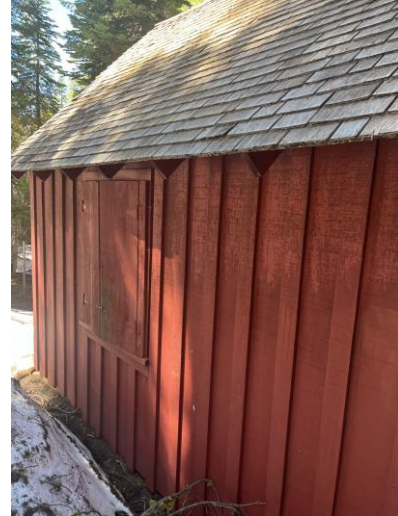
Record ID: 364
System: B2020 - EXTERIOR WINDOWS
Item No.: B2020.10.015
Priority: Immediate (0-1 Years)
Quantity/Unit of Measure: 45/SF
Total Deficiency Cost: \$23,460
Deficiency Description: *Windows are damaged and/or past their expected useful life.*

Description of Work: *Replace window.*

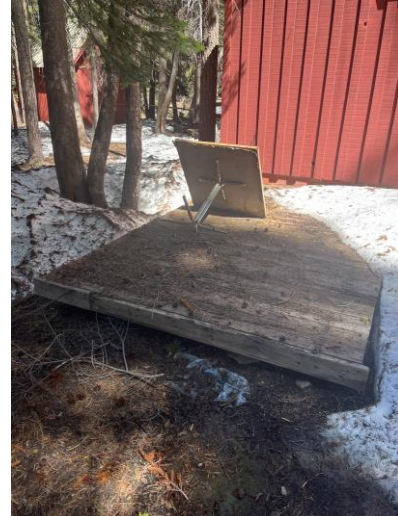
Record ID: 370
System: B1010 - FLOOR CONSTRUCTION
Item No.: B1010.20.005
Priority: Immediate (0-1 Years)
Quantity/Unit of Measure: 100/SF
Total Deficiency Cost: \$5,050
Deficiency Description: *Wood decking is approaching the end of its useful life.*
Description of Work: *Replace the wood deck.*
Comments:

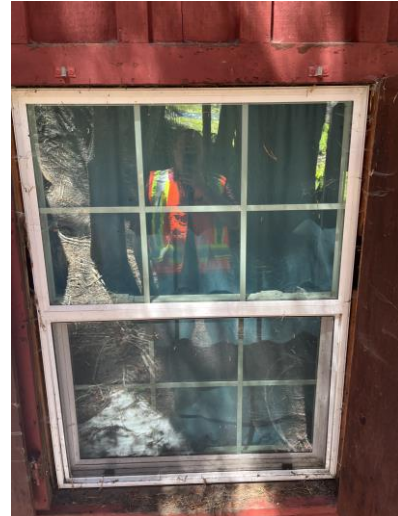
Record ID: 389
System: B2020 - EXTERIOR WINDOWS

Description of Work: *Replace window.*

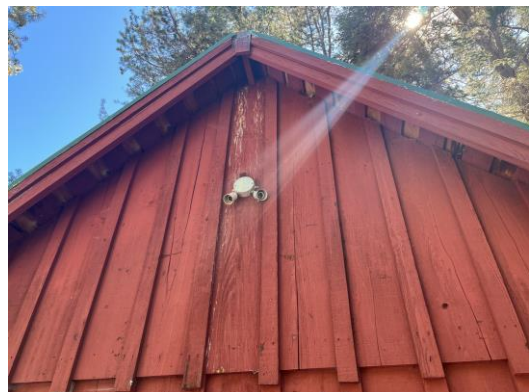
Record ID: 390
System: D5040 - LIGHTING

Description of Work: *Replace the existing wall mounted lighting fixture with an LED lighting fixture.*

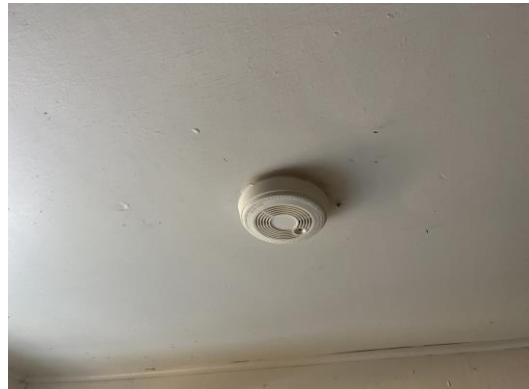
Record ID: 392
System: D7050 - DETECTION AND ALARM
Item No.: D7050.10.025
Priority: Immediate (0-1 Years)
Quantity/Unit of Measure: 1/EA
Total Deficiency Cost: \$680
Deficiency Description: *The smoke detector is past its expected useful life.*

Description of Work: *Replace the existing smoke detector with a new smoke detector.*

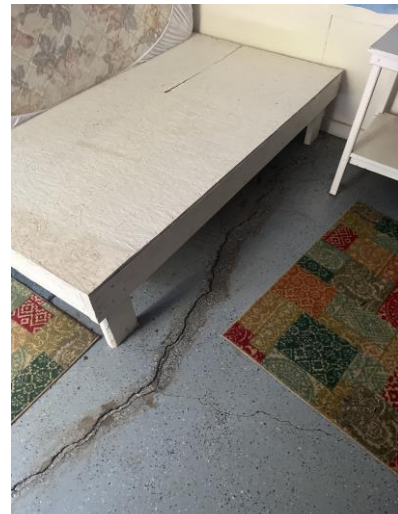
Record ID: 598
System: A4010 - STANDARD SLABS-ON-GRADE
Item No.: A4010.10.003
Priority: Immediate (0-1 Years)
Quantity/Unit of Measure: 150/SF
Total Deficiency Cost: \$5,900
Deficiency Description: *The concrete floor slab has major damage and cracks from uplift.*

Description of Work: *Replace the concrete slab.*

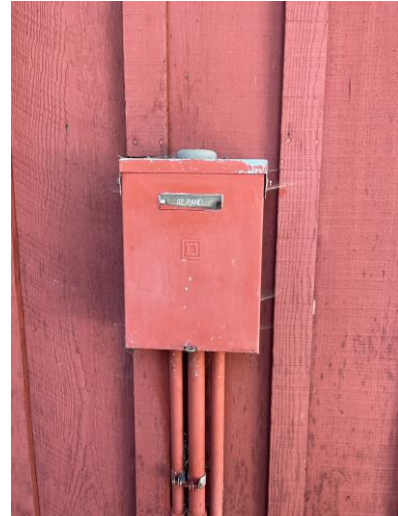
Record ID: 178
System: D5020 - ELECTRICAL SERVICE AND DISTRIBUTION
Item No.: D5020.30.9114
Priority: Immediate (0-1 Years)
Quantity/Unit of Measure: 1/EA
Total Deficiency Cost: \$6,750
Deficiency Description: *The outdoor load center is past its expected useful life.*

Description of Work: *Replace the existing load center with a new load center.*

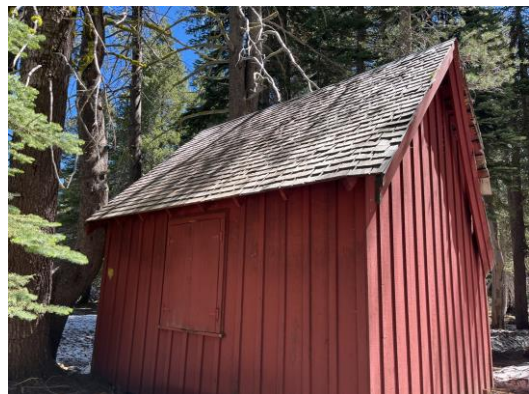
Record ID: 396
System: B2010 - EXTERIOR WALLS
Item No.: B2010.10.016
Priority: Immediate (0-1 Years)
Quantity/Unit of Measure: 700/SF
Total Deficiency Cost: \$17,640
Deficiency Description: *The exterior wood board siding is showing signs of age and wear.*

Description of Work: *Power wash and repaint existing wood board siding.*

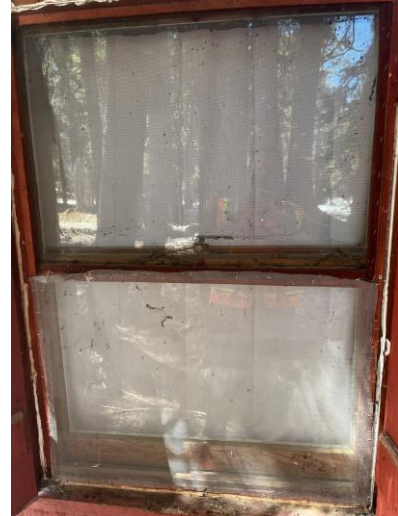
Record ID: 402
System: B2020 - EXTERIOR WINDOWS
Item No.: B2020.10.015
Priority: Immediate (0-1 Years)
Quantity/Unit of Measure: 45/SF
Total Deficiency Cost: \$23,460
Deficiency Description: *Windows are damaged and/or past their expected useful life.*

Description of Work: *Replace window.*

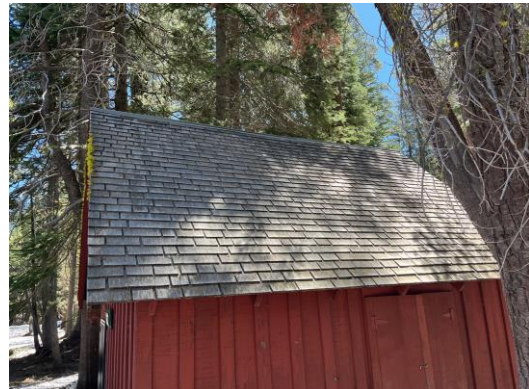
Record ID: 403
System: B3010 - ROOFING
Item No.: B3010.10.007
Priority: Immediate (0-1 Years)
Quantity/Unit of Measure: 200/SF
Total Deficiency Cost: \$7,720
Deficiency Description: *Wood shake roof is past its expected useful life.*

Description of Work: *Remove and replace wood shake roof and replace with metal roofing.*

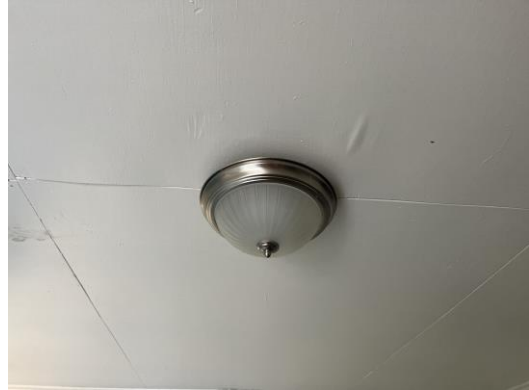
Record ID: 404
System: D5040 - LIGHTING
Item No.: D5040.50.421
Priority: Immediate (0-1 Years)
Quantity/Unit of Measure: 1/EA
Total Deficiency Cost: \$1,260
Deficiency Description: *The light fixture is past its expected useful life.*
Description of Work: *Replace existing incandescent fixtures with LED fixtures.*
Comments:

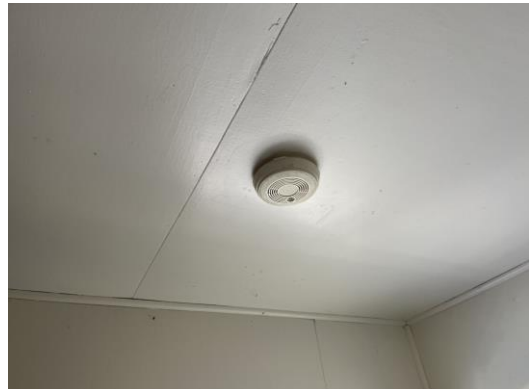
Record ID: 405
System: D7050 - DETECTION AND ALARM
Item No.: D7050.10.025
Priority: Immediate (0-1 Years)
Quantity/Unit of Measure: 1/EA
Total Deficiency Cost: \$680
Deficiency Description: *The smoke detector is past its expected useful life.*
Description of Work: *Replace the existing smoke detector with a new smoke detector.*
Comments:

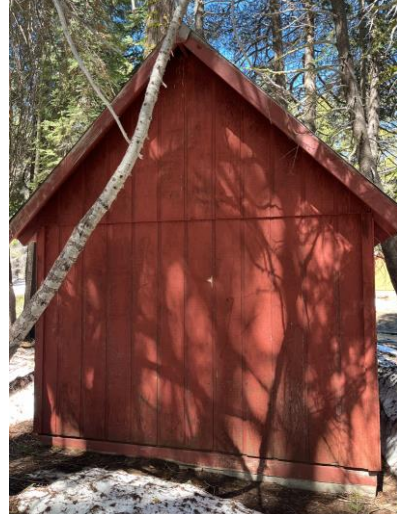
Record ID: 409
System: B2010 - EXTERIOR WALLS
Item No.: B2010.10.016
Priority: Immediate (0-1 Years)
Quantity/Unit of Measure: 700/SF
Total Deficiency Cost: \$17,640
Deficiency Description: *The exterior wood board siding is showing signs of age and wear.*

Description of Work: *Power wash and repaint existing wood board siding.*

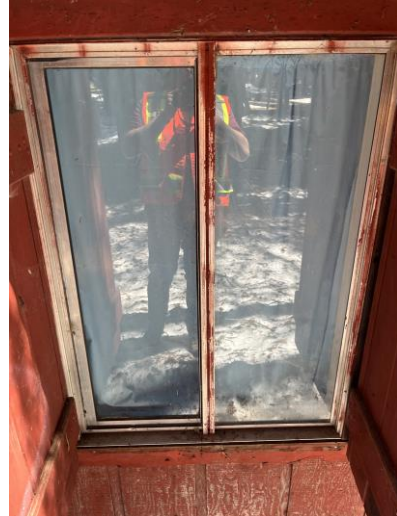
Record ID: 410
System: B2020 - EXTERIOR WINDOWS
Item No.: B2020.10.015
Priority: Immediate (0-1 Years)
Quantity/Unit of Measure: 30/SF
Total Deficiency Cost: \$15,620
Deficiency Description: *Windows are damaged and/or past their expected useful life.*

Description of Work: *Replace window.*

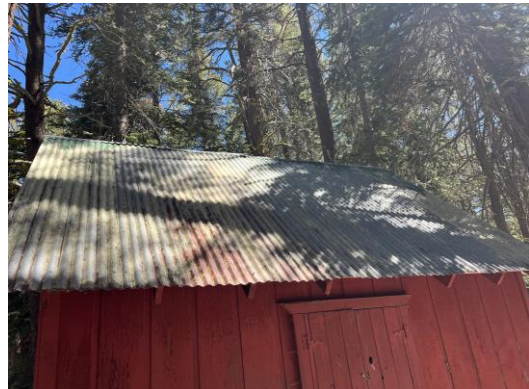
Record ID: 411
System: B3010 - ROOFING
Item No.: B3010.10.002
Priority: Immediate (0-1 Years)
Quantity/Unit of Measure: 200/SF
Total Deficiency Cost: \$7,720
Deficiency Description: *Metal Roofing is at or approaching end of expected useful service life.*

Description of Work: *Remove and replace metal roofing.*

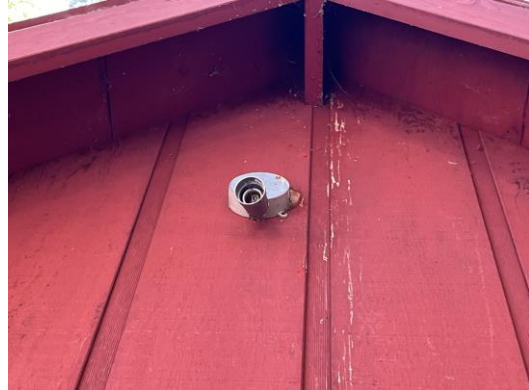
Record ID: 412
System: D5040 - LIGHTING
Item No.: D5040.50.420
Priority: Immediate (0-1 Years)
Quantity/Unit of Measure: 1/EA
Total Deficiency Cost: \$2,500
Deficiency Description: *The exterior wall mounted fixture is past its expected useful life.*

Description of Work: *Replace the existing wall mounted lighting fixture with an LED lighting fixture.*

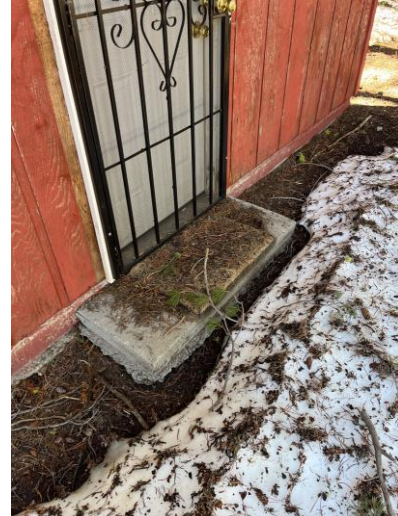
Record ID: 415
System: G2030 - PEDESTRIAN PLAZAS AND WALKWAYS
Item No.: G2030.30.038
Priority: Immediate (0-1 Years)
Quantity/Unit of Measure: 1/LFNS
Total Deficiency Cost: \$650
Deficiency Description: *Concrete steps are showing signs of age and wear.*

Description of Work: *Replace concrete steps.*

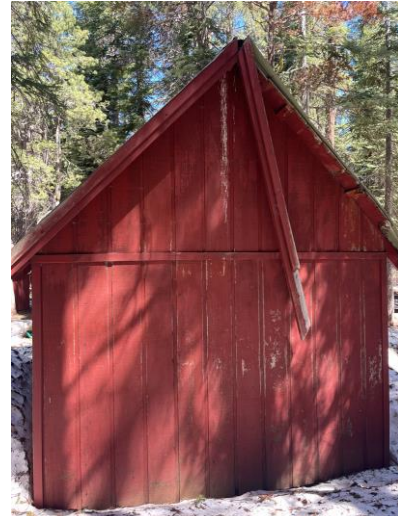
Record ID: 417
System: B2010 - EXTERIOR WALLS
Item No.: B2010.10.016
Priority: Immediate (0-1 Years)
Quantity/Unit of Measure: 700/SF
Total Deficiency Cost: \$17,640
Deficiency Description: *The exterior wood board siding is showing signs of age and wear.*
Description of Work: *Power wash and repaint existing wood board siding.*
Comments:

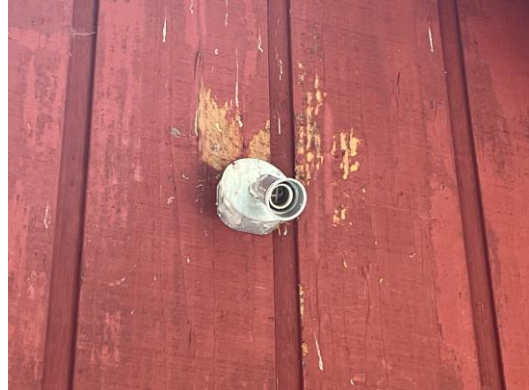
Record ID: 419
System: D5040 - LIGHTING
Item No.: D5040.50.420
Priority: Immediate (0-1 Years)
Quantity/Unit of Measure: 1/EA
Total Deficiency Cost: \$2,500
Deficiency Description: *The exterior wall mounted fixture is past its expected useful life.*

Description of Work: *Replace the existing wall mounted lighting fixture with an LED lighting fixture.*

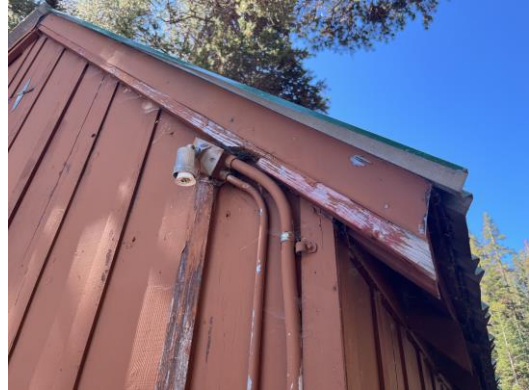
Record ID: 153
System: D5040 - LIGHTING
Item No.: D5040.50.420
Priority: Immediate (0-1 Years)
Quantity/Unit of Measure: 1/EA
Total Deficiency Cost: \$2,500
Deficiency Description: *The exterior wall mounted fixture is past its expected useful life.*

Description of Work: *Replace the existing wall mounted lighting fixture with an LED lighting fixture.*

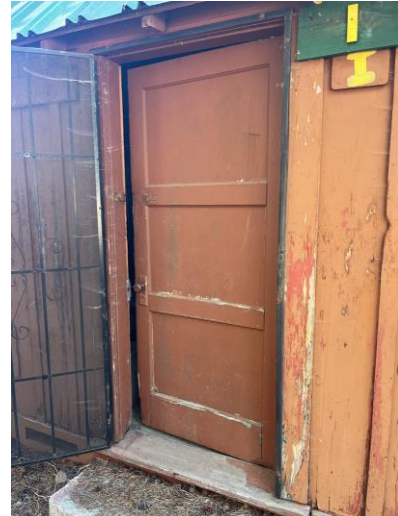
Record ID: 155
System: B2050 - EXTERIOR DOORS AND GRILLES
Item No.: B2050.10.001
Priority: Immediate (0-1 Years)
Quantity/Unit of Measure: 1/EA
Total Deficiency Cost: \$8,400
Deficiency Description: *Exterior wood entrance door is approaching the end of its useful life.*

Description of Work: *Replace wood door.*

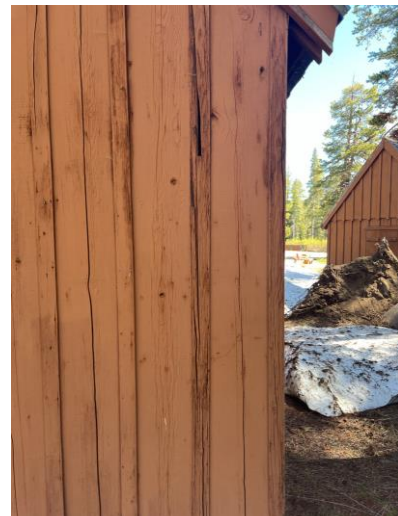
Record ID: 425
System: B2010 - EXTERIOR WALLS
Item No.: B2010.10.016
Priority: Immediate (0-1 Years)
Quantity/Unit of Measure: 700/SF
Total Deficiency Cost: \$17,640
Deficiency Description: *The exterior wood board siding is showing signs of age and wear.*

Description of Work: *Power wash and repaint existing wood board siding.*

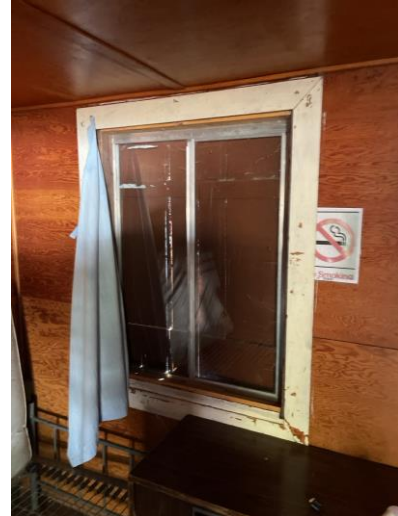
Record ID: 426
System: B2020 - EXTERIOR WINDOWS
Item No.: B2020.10.015
Priority: Immediate (0-1 Years)
Quantity/Unit of Measure: 45/SF
Total Deficiency Cost: \$23,460
Deficiency Description: *Windows are damaged and/or past their expected useful life.*

Description of Work: *Replace window.*

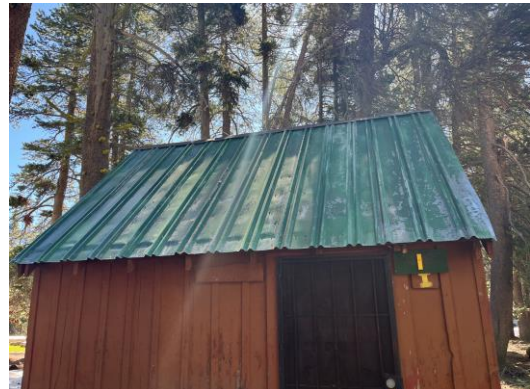
Record ID: 427
System: B3010 - ROOFING
Item No.: B3010.10.002
Priority: Immediate (0-1 Years)
Quantity/Unit of Measure: 200/SF
Total Deficiency Cost: \$7,720
Deficiency Description: *Metal Roofing is at or approaching end of expected useful service life.*

Description of Work: *Remove and replace metal roofing.*

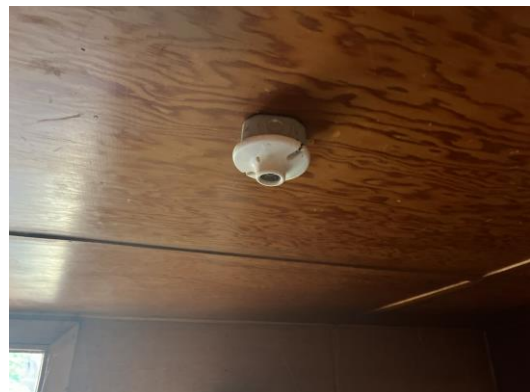
Record ID: 429
System: D5040 - LIGHTING
Item No.: D5040.50.421
Priority: Immediate (0-1 Years)
Quantity/Unit of Measure: 1/EA
Total Deficiency Cost: \$1,260
Deficiency Description: *The light fixture is past its expected useful life.*

Description of Work: *Replace existing incandescent fixtures with LED fixtures.*

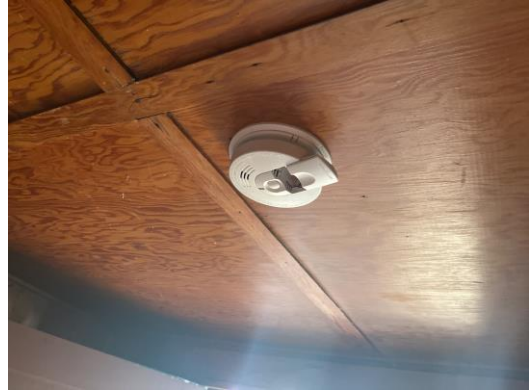
Record ID: 430
System: D7050 - DETECTION AND ALARM
Item No.: D7050.10.025
Priority: Immediate (0-1 Years)
Quantity/Unit of Measure: 1/EA
Total Deficiency Cost: \$680
Deficiency Description: *The smoke detector is past its expected useful life.*

Description of Work: *Replace the existing smoke detector with a new smoke detector.*

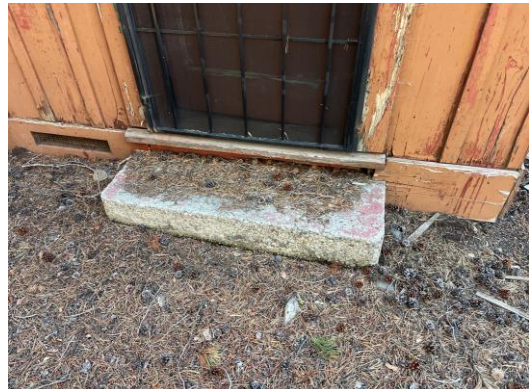
Record ID: 432
System: G2030 - PEDESTRIAN PLAZAS AND WALKWAYS
Item No.: G2030.30.038
Priority: Immediate (0-1 Years)
Quantity/Unit of Measure: 2/LFNS
Total Deficiency Cost: \$1,290
Deficiency Description: *Concrete steps are showing signs of age and wear.*

Description of Work: *Replace concrete steps.*

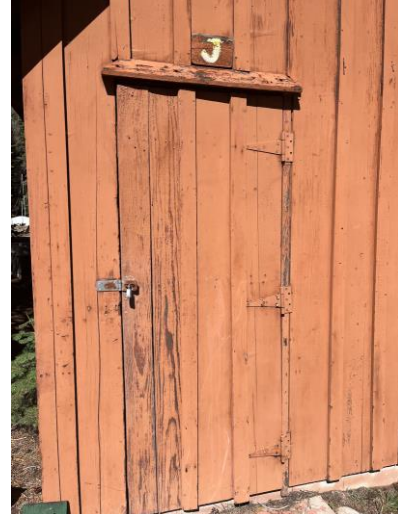
Deficiency Description: *Exterior wood entrance door is approaching the end of its useful life.*

Description of Work: *Replace wood door.*

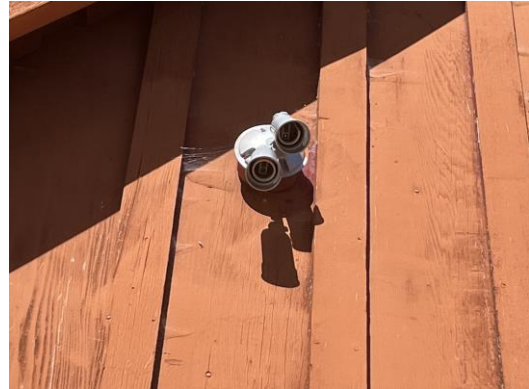
Deficiency Description: *The exterior wall mounted fixture is past its expected useful life.*

Description of Work: *Replace the existing wall mounted lighting fixture with an LED lighting fixture.*

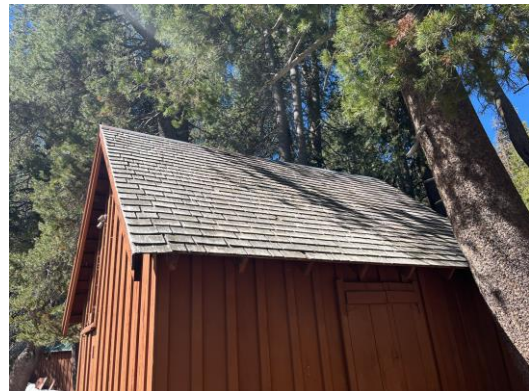
Deficiency Description: *Wood shake roof is past its expected useful life.*

Description of Work: *Remove and replace wood shake roof and replace with metal roofing.*

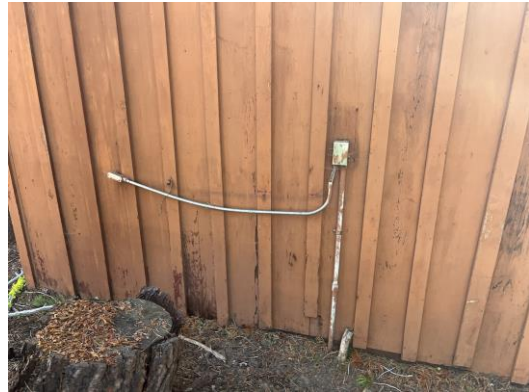
Priority: Immediate (0-1 Years)
Quantity/Unit of Measure: 1/EA
Total Deficiency Cost: \$380
Deficiency Description: *The wiring device (outlet box, junction box, receptacle, etc.) needs to be replaced.*

Description of Work: *Supply and install a new junction box and cover.*

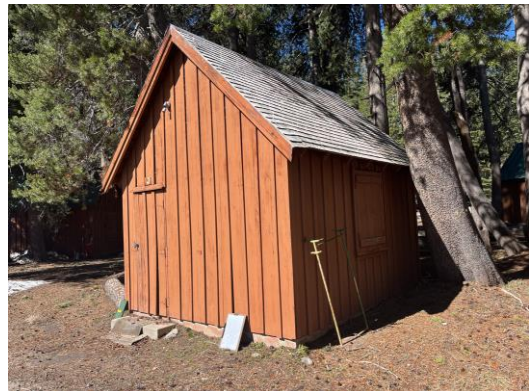
Priority: Immediate (0-1 Years)
Quantity/Unit of Measure: 700/SF
Total Deficiency Cost: \$17,640
Deficiency Description: *The exterior wood board siding is showing signs of age and wear.*

Description of Work: *Power wash and repaint existing wood board siding.*

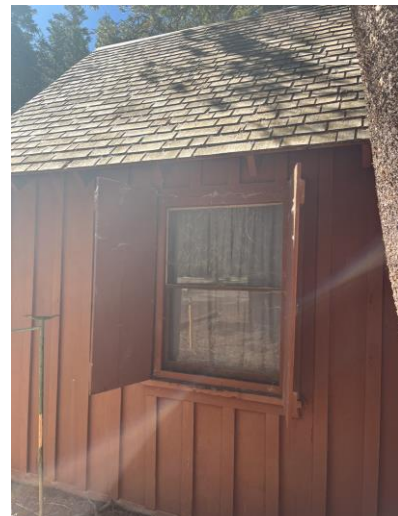
Priority: Immediate (0-1 Years)
Quantity/Unit of Measure: 30/SF
Total Deficiency Cost: \$15,620
Deficiency Description: *Windows are damaged and/or past their expected useful life.*

Description of Work: *Replace window.*

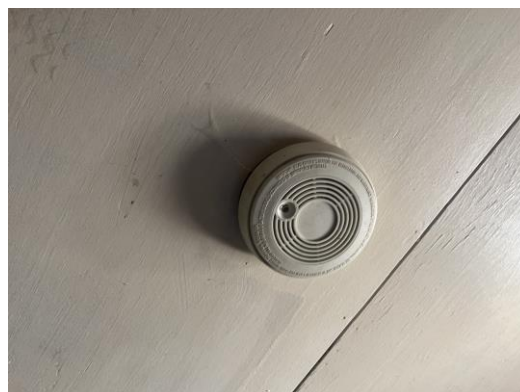
Record ID: 438
System: D7050 - DETECTION AND ALARM
Item No.: D7050.10.025
Priority: Immediate (0-1 Years)
Quantity/Unit of Measure: 1/EA
Total Deficiency Cost: \$680
Deficiency Description: *The smoke detector is past its expected useful life.*

Description of Work: *Replace the existing smoke detector with a new smoke detector.*

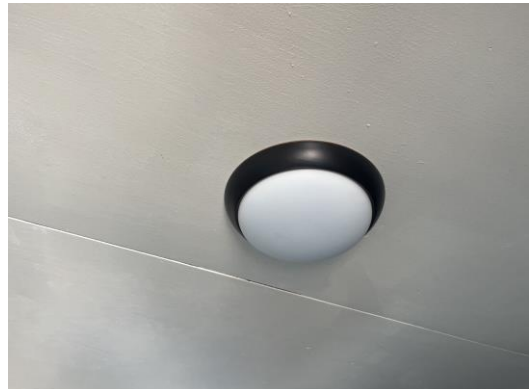
Record ID: 150
System: D5040 - LIGHTING
Item No.: D5040.50.421
Priority: Immediate (0-1 Years)
Quantity/Unit of Measure: 1/EA
Total Deficiency Cost: \$1,260
Deficiency Description: *The light fixture is past its expected useful life.*

Description of Work: *Replace existing incandescent fixtures with LED fixtures.*

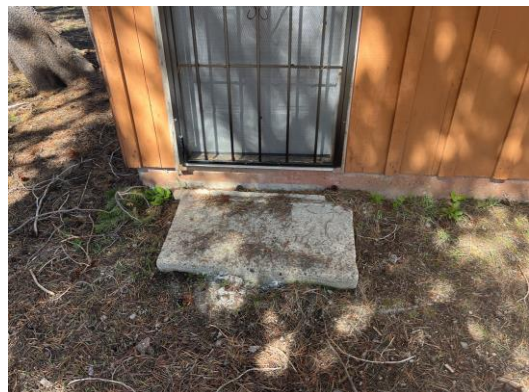
Record ID: 152
System: G2030 - PEDESTRIAN PLAZAS AND WALKWAYS
Item No.: G2030.30.038
Priority: Immediate (0-1 Years)
Quantity/Unit of Measure: 2/LFNS
Total Deficiency Cost: \$1,290
Deficiency Description: *Concrete steps are showing signs of age and wear.*

Description of Work: *Replace concrete steps.*

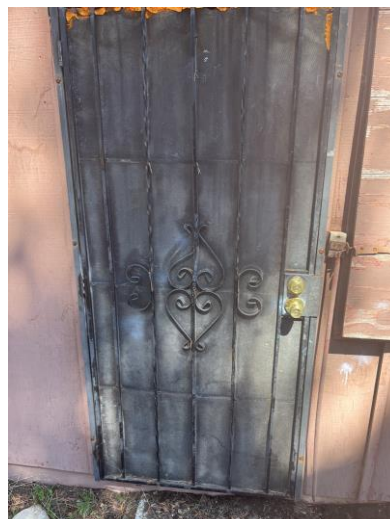
Record ID: 167
System: B2050 - EXTERIOR DOORS AND GRILLES
Item No.: B2050.10.006
Priority: Immediate (0-1 Years)
Quantity/Unit of Measure: 3/EA
Total Deficiency Cost: \$22,110
Deficiency Description: *Exterior aluminum entrance door, frame and hardware is approaching the end of its useful life.*
Description of Work: *Replace aluminum door, frame, and hardware.*
Comments:

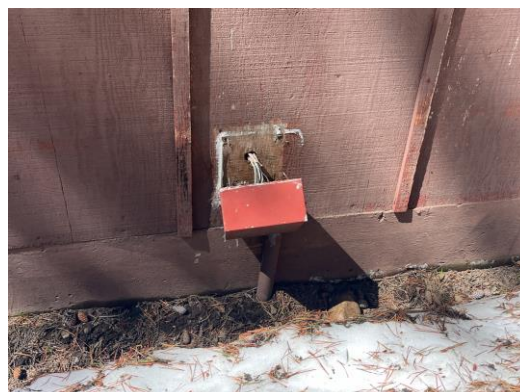
Record ID: 168
System: G4010 - SITE ELECTRIC DISTRIBUTION SYSTEMS
Item No.: G4010.10.001
Priority: Immediate (0-1 Years)
Quantity/Unit of Measure: 1/EA
Total Deficiency Cost: \$380
Deficiency Description: *The wiring device (outlet box, junction box, receptacle, etc.) needs to be replaced.*
Description of Work: *Supply and install a new junction box and cover.*
Comments:

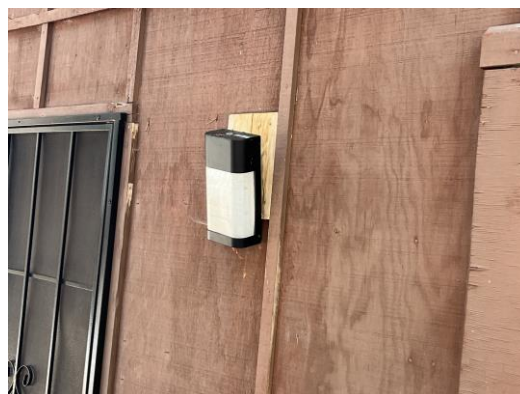
Record ID: 169
System: D5040 - LIGHTING
Item No.: D5040.50.420
Priority: Immediate (0-1 Years)
Quantity/Unit of Measure: 3/EA
Total Deficiency Cost: \$7,460
Deficiency Description: *The exterior wall mounted fixture is past its expected useful life.*
Description of Work: *Replace the existing wall mounted lighting fixture with an LED lighting fixture.*
Comments:

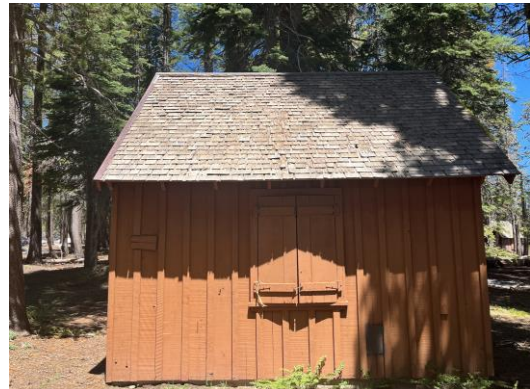
Record ID: 442
System: B3010 - ROOFING
Item No.: B3010.10.007
Priority: Immediate (0-1 Years)
Quantity/Unit of Measure: 200/SF
Total Deficiency Cost: \$7,720
Deficiency Description: *Wood shake roof is past its expected useful life.*

Description of Work: *Remove and replace wood shake roof and replace with metal roofing.*
