Silver Lake Campground Facility Condition Assessment

Final Report

August 16, 2024

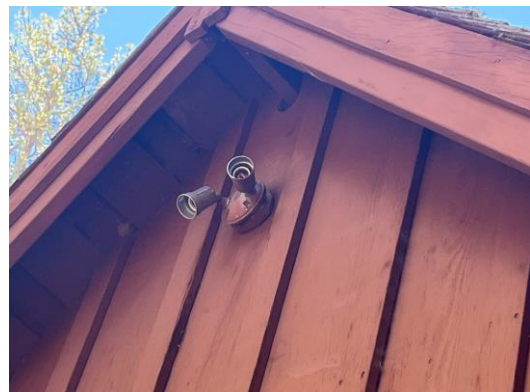
Record ID: 443
System: D5040 - LIGHTING
Item No.: D5040.50.420
Priority: Immediate (0-1 Years)
Quantity/Unit of Measure: 1/EA
Total Deficiency Cost: \$2,500
Deficiency Description: *The exterior wall mounted fixture is past its expected useful life.*

Description of Work: *Replace the existing wall mounted lighting fixture with an LED lighting fixture.*

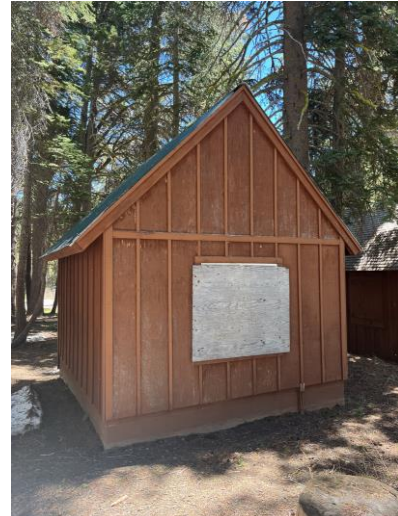
Record ID: 650
System: B2020 - EXTERIOR WINDOWS
Item No.: B2020.10.015
Priority: Immediate (0-1 Years)
Quantity/Unit of Measure: 45/SF
Total Deficiency Cost: \$23,460
Deficiency Description: *Windows are damaged and/or past their expected useful life.*

Description of Work: *Replace window.*

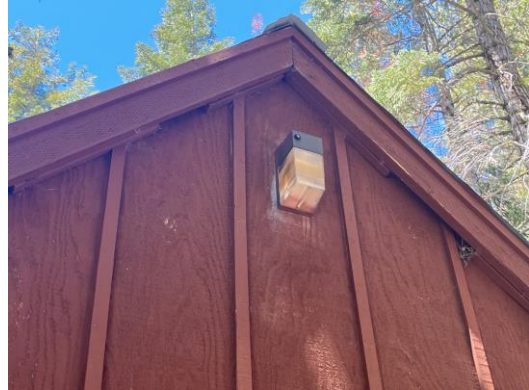
Record ID: 653
System: D5040 - LIGHTING
Item No.: D5040.50.421
Priority: Immediate (0-1 Years)
Quantity/Unit of Measure: 1/EA
Total Deficiency Cost: \$1,260
Deficiency Description: *The light fixture is past its expected useful life.*

Description of Work: *Replace existing fixtures with LED fixtures.*

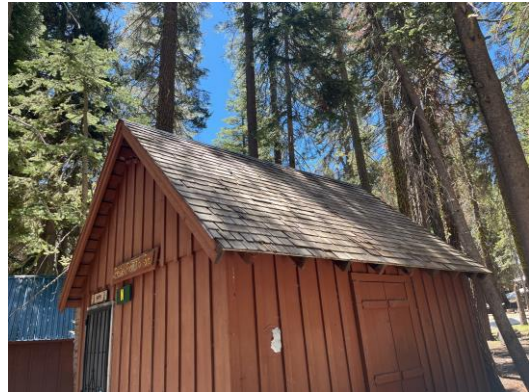
Priority: Immediate (0-1 Years)
Quantity/Unit of Measure: 200/SF
Total Deficiency Cost: \$7,720
Deficiency Description: *Wood shake roof is past its expected useful life.*

Description of Work: *Remove and replace wood shake roof and replace with metal roofing.*

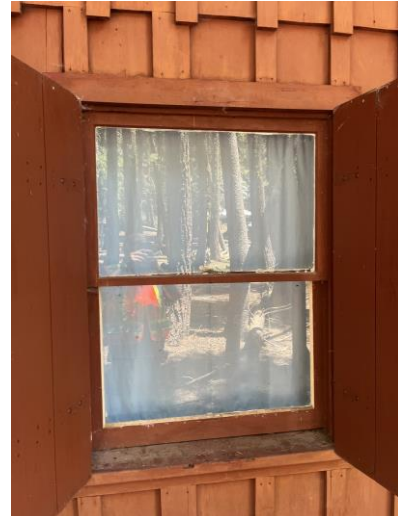
Record ID: 450
System: B2020 - EXTERIOR WINDOWS

Priority: Immediate (0-1 Years)
Quantity/Unit of Measure: 45/SF
Total Deficiency Cost: \$23,460
Deficiency Description: *Windows are damaged and/or past their expected useful life.*

Description of Work: *Replace window.*

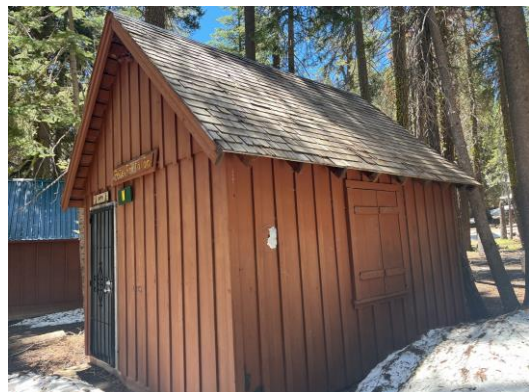
Record ID: 454
System: B2010 - EXTERIOR WALLS

Priority: Immediate (0-1 Years)
Quantity/Unit of Measure: 700/SF
Total Deficiency Cost: \$17,640
Deficiency Description: *The exterior wood board siding is showing signs of age and wear.*

Description of Work: *Power wash and repaint existing wood board siding.*

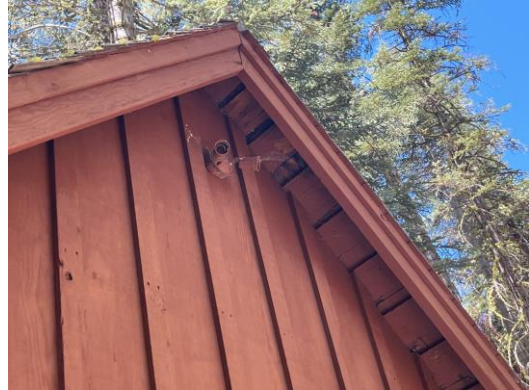
Record ID: 456
System: D5040 - LIGHTING
Item No.: D5040.50.420
Priority: Immediate (0-1 Years)
Quantity/Unit of Measure: 1/EA
Total Deficiency Cost: \$2,500
Deficiency Description: *The exterior wall mounted fixture is past its expected useful life.*

Description of Work: *Replace the existing wall mounted lighting fixture with an LED lighting fixture.*

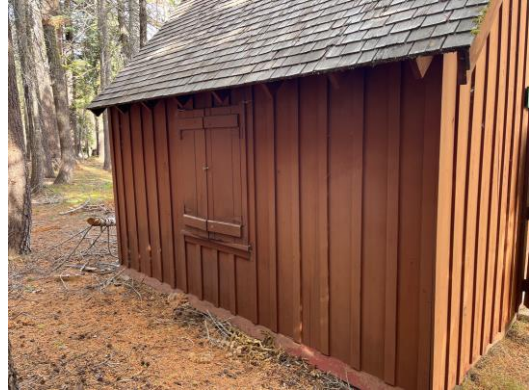
Priority: Immediate (0-1 Years)
Quantity/Unit of Measure: 700/SF
Total Deficiency Cost: \$17,640
Deficiency Description: *The exterior wood board siding is showing signs of age and wear.*

Description of Work: *Power wash and repaint existing wood board siding.*

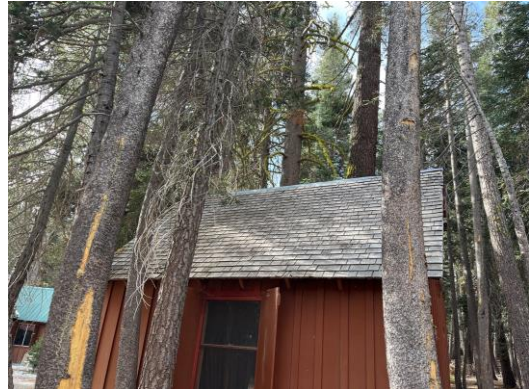
Record ID: 43
System: B3010 - ROOFING

Priority: Immediate (0-1 Years)
Quantity/Unit of Measure: 200/SF
Total Deficiency Cost: \$7,720
Deficiency Description: *Wood shake roof is past its expected useful life.*

Description of Work: *Remove and replace wood shake roof and replace with metal roofing.*

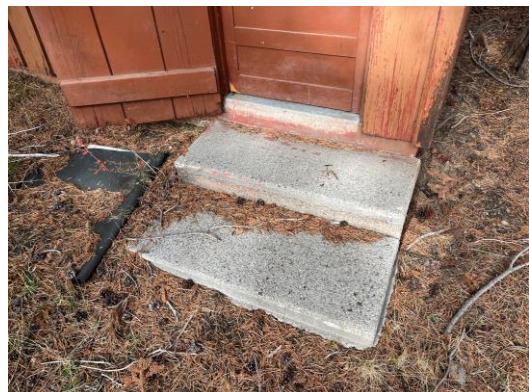
Record ID: 45
System: G2030 - PEDESTRIAN PLAZAS AND WALKWAYS

Priority: Immediate (0-1 Years)
Quantity/Unit of Measure: 3/LFNS
Total Deficiency Cost: \$1,940
Deficiency Description: *Concrete steps are showing signs of age and wear.*

Description of Work: *Replace concrete steps.*

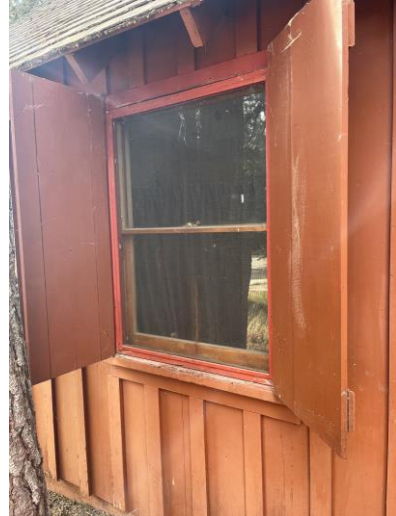
Record ID: 46
System: B2020 - EXTERIOR WINDOWS
Item No.: B2020.10.015
Priority: Immediate (0-1 Years)
Quantity/Unit of Measure: 45/SF
Total Deficiency Cost: \$23,460
Deficiency Description: *Windows are damaged and/or past their expected useful life.*

Description of Work: *Replace window.*

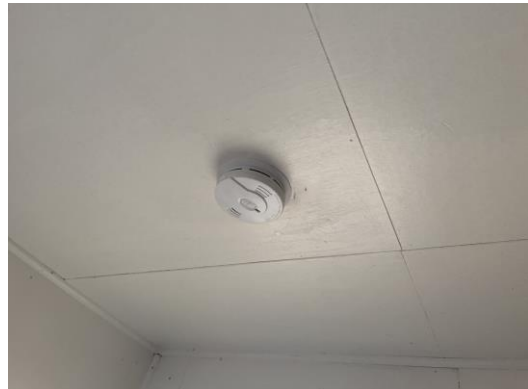
Record ID: 55
System: D7050 - DETECTION AND ALARM
Item No.: D7050.10.025
Priority: Immediate (0-1 Years)
Quantity/Unit of Measure: 1/EA
Total Deficiency Cost: \$680
Deficiency Description: *The smoke detector is past its expected useful life.*

Description of Work: *Replace the existing smoke detector with a new smoke detector.*

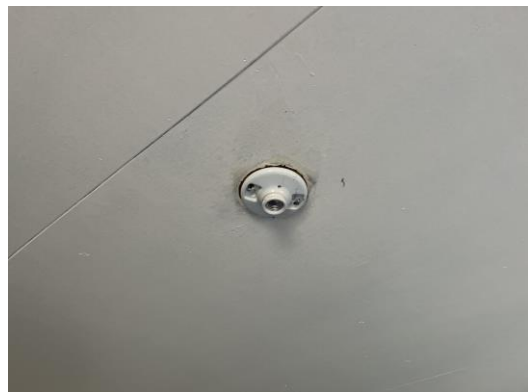
Record ID: 56
System: D5040 - LIGHTING
Item No.: D5040.50.421
Priority: Immediate (0-1 Years)
Quantity/Unit of Measure: 1/EA
Total Deficiency Cost: \$1,260
Deficiency Description: *The light fixture is past its expected useful life.*

Description of Work: *Replace existing incandescent fixtures with LED fixtures.*

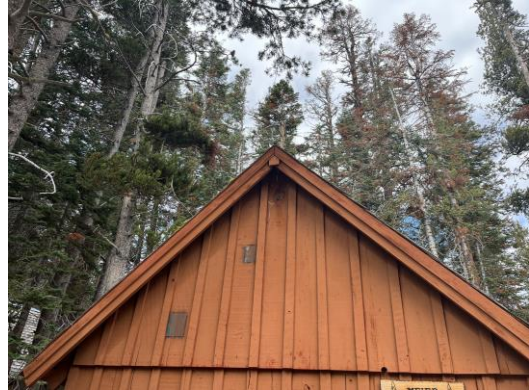
Record ID: 4
System: D5040 - LIGHTING
Item No.: D5040.50.420
Priority: Immediate (0-1 Years)
Quantity/Unit of Measure: 1/EA
Total Deficiency Cost: \$2,500
Deficiency Description: *The exterior wall mounted fixture is past its expected useful life.*

Comments: *The cable to the exterior light is routed from a nearby tree. The light fixture is hanging from the tree currently.*

Description of Work: *Replace the existing wall mounted lighting fixture with an LED lighting fixture.*

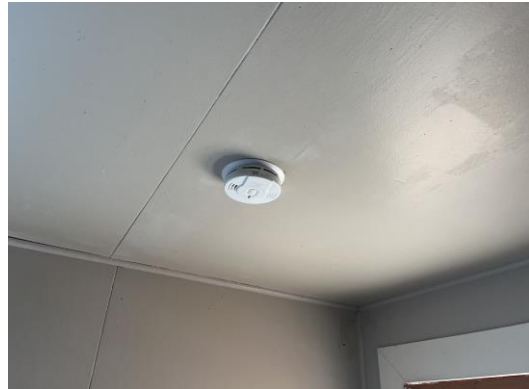
Record ID: 49
System: D7050 - DETECTION AND ALARM
Item No.: D7050.10.025
Priority: Immediate (0-1 Years)
Quantity/Unit of Measure: 1/EA
Total Deficiency Cost: \$680
Deficiency Description: *The smoke detector is past its expected useful life.*

Description of Work: *Replace the existing smoke detector with a new smoke detector.*

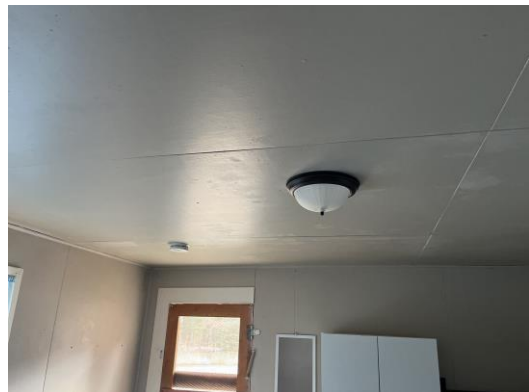
Record ID: 51
System: D5040 - LIGHTING
Item No.: D5040.50.421
Priority: Immediate (0-1 Years)
Quantity/Unit of Measure: 1/EA
Total Deficiency Cost: \$1,260
Deficiency Description: *The light fixture is past its expected useful life.*

Description of Work: *Replace existing incandescent fixtures with LED fixtures.*

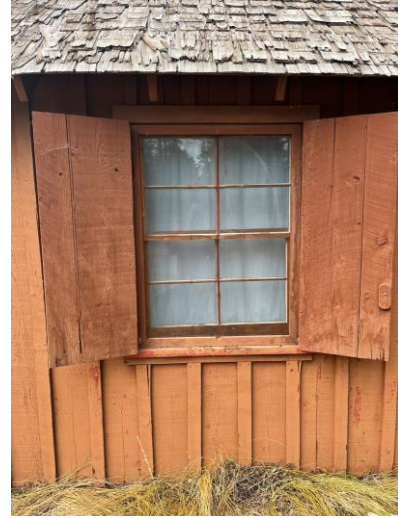
Record ID: 52
System: B2020 - EXTERIOR WINDOWS
Item No.: B2020.10.015
Priority: Immediate (0-1 Years)
Quantity/Unit of Measure: 45/SF
Total Deficiency Cost: \$23,460
Deficiency Description: *Windows are damaged and/or past their expected useful life.*

Description of Work: *Replace window.*

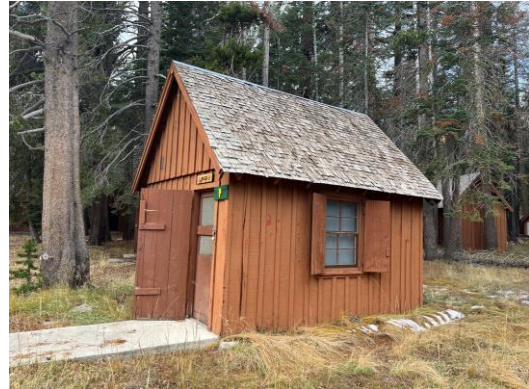
Record ID: 53
System: B3010 - ROOFING
Item No.: B3010.10.007
Priority: Immediate (0-1 Years)
Quantity/Unit of Measure: 200/SF
Total Deficiency Cost: \$7,720
Deficiency Description: *Wood shake roof is past its expected useful life.*

Comments: *Shake Roof*

Description of Work: *Remove and replace wood shake roof and replace with metal roofing.*

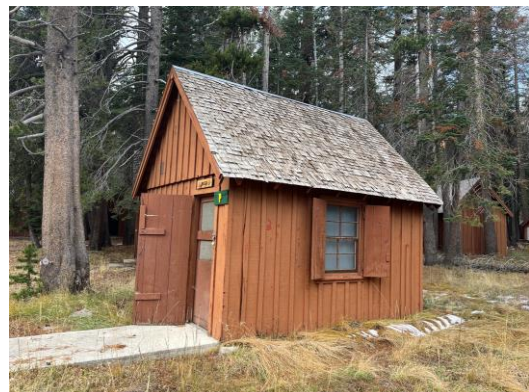
Record ID: 54
System: B2010 - EXTERIOR WALLS
Item No.: B2010.10.016
Priority: Immediate (0-1 Years)
Quantity/Unit of Measure: 700/SF
Total Deficiency Cost: \$17,640
Deficiency Description: *The exterior wood board siding is showing signs of age and wear.*

Description of Work: *Power wash and repaint existing wood board siding.*

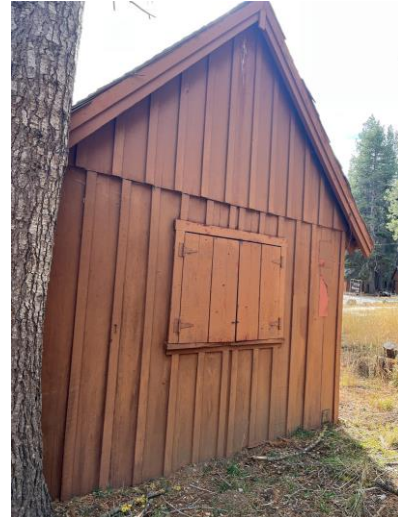
Priority: Immediate (0-1 Years)
Quantity/Unit of Measure: 700/SF
Total Deficiency Cost: \$17,640
Deficiency Description: *The exterior wood board siding is showing signs of age and wear.*

Description of Work: *Power wash and repaint existing wood board siding.*

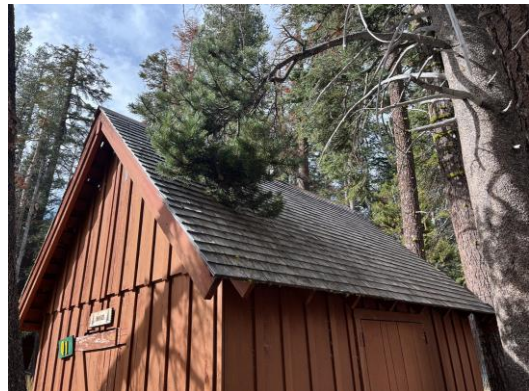
Record ID: 58
System: B3010 - ROOFING

Priority: Immediate (0-1 Years)
Quantity/Unit of Measure: 200/SF
Total Deficiency Cost: \$7,720
Deficiency Description: *Wood shake roof is past its expected useful life.*

Description of Work: *Remove and replace wood shake roof and replace with metal roofing.*

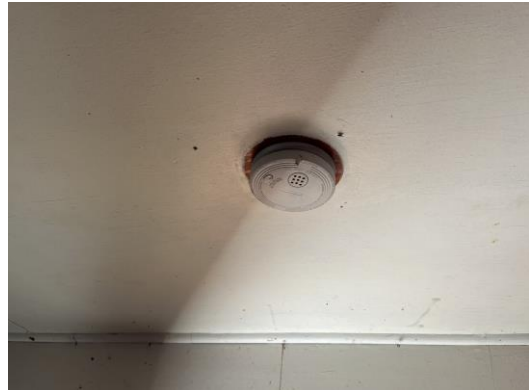
Record ID: 59
System: D7050 - DETECTION AND ALARM
Item No.: D7050.10.025
Priority: Immediate (0-1 Years)
Quantity/Unit of Measure: 1/EA
Total Deficiency Cost: \$680
Deficiency Description: *The smoke detector is past its expected useful life.*

Description of Work: *Replace the existing smoke detector with a new smoke detector.*

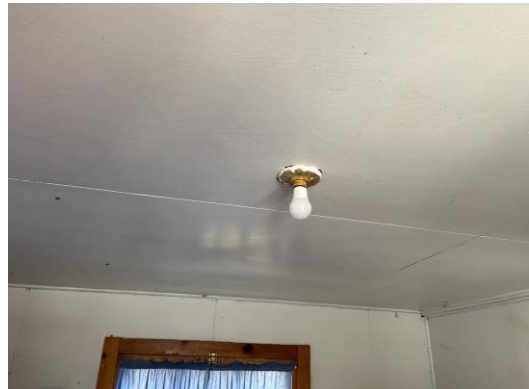
Record ID: 60
System: D5040 - LIGHTING
Item No.: D5040.50.421
Priority: Immediate (0-1 Years)
Quantity/Unit of Measure: 1/EA
Total Deficiency Cost: \$1,260
Deficiency Description: *The light fixture is past its expected useful life.*

Description of Work: *Replace existing incandescent fixtures with LED fixtures.*

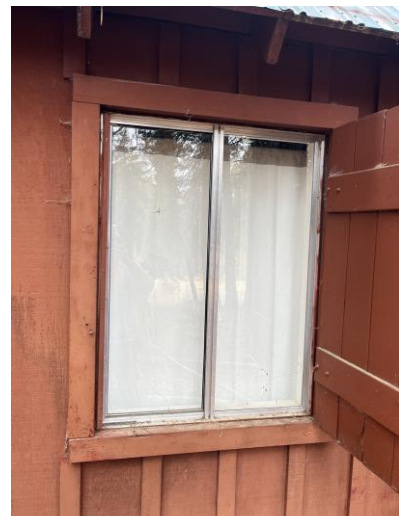
Record ID: 104
System: B2020 - EXTERIOR WINDOWS
Item No.: B2020.10.015
Priority: Immediate (0-1 Years)
Quantity/Unit of Measure: 45/SF
Total Deficiency Cost: \$23,460
Deficiency Description: *Windows are damaged and/or past their expected useful life.*

Description of Work: *Replace window.*

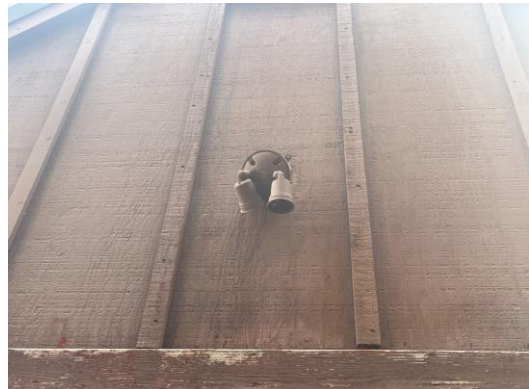
Record ID: 63
System: D5040 - LIGHTING
Item No.: D5040.50.420
Priority: Immediate (0-1 Years)
Quantity/Unit of Measure: 1/EA
Total Deficiency Cost: \$2,500
Deficiency Description: *The exterior wall mounted fixture is past its expected useful life.*

Description of Work: *Replace the existing wall mounted lighting fixture with an LED lighting fixture.*

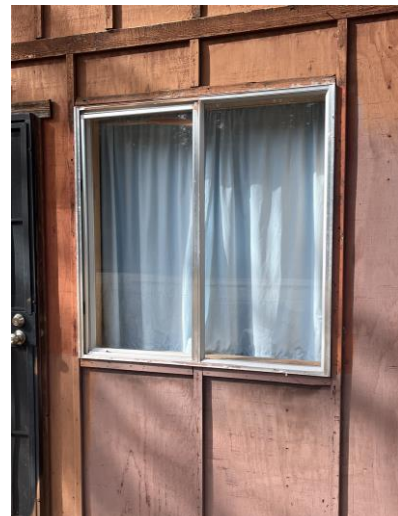
Record ID: 64
System: B2020 - EXTERIOR WINDOWS
Item No.: B2020.10.015
Priority: Immediate (0-1 Years)
Quantity/Unit of Measure: 45/SF
Total Deficiency Cost: \$23,460
Deficiency Description: *Windows are damaged and/or past their expected useful life.*

Description of Work: *Replace window.*

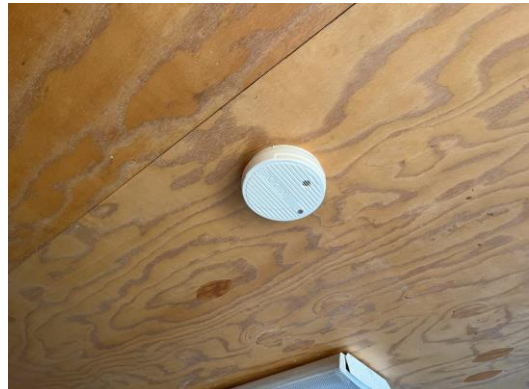
Record ID: 66
System: D7050 - DETECTION AND ALARM
Item No.: D7050.10.025
Priority: Immediate (0-1 Years)
Quantity/Unit of Measure: 1/EA
Total Deficiency Cost: \$680
Deficiency Description: *The smoke detector is past its expected useful life.*
Description of Work: *Replace the existing smoke detector with a new smoke detector.*
Comments:

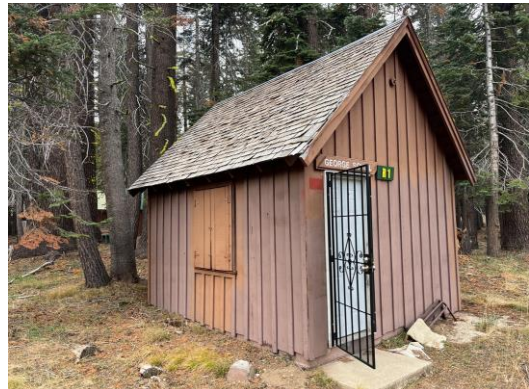
Record ID: 68
System: B3010 - ROOFING

Comments: *Shake Roof*

Description of Work: *Remove and replace wood shake roof and replace with metal roofing.*

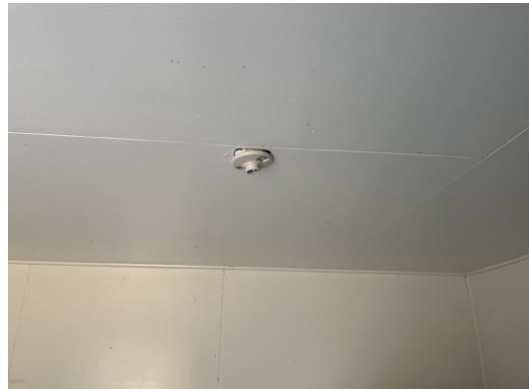
Record ID: 73
System: D5040 - LIGHTING
Item No.: D5040.50.421
Priority: Immediate (0-1 Years)
Quantity/Unit of Measure: 1/EA
Total Deficiency Cost: \$1,260
Deficiency Description: *The light fixture is past its expected useful life.*

Description of Work: *Replace existing incandescent fixtures with LED fixtures.*

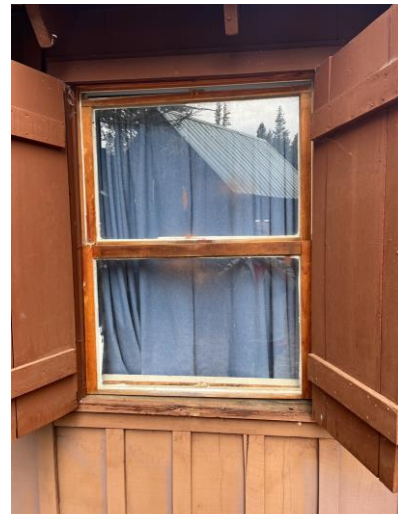
Record ID: 74
System: B2020 - EXTERIOR WINDOWS
Item No.: B2020.10.015
Priority: Immediate (0-1 Years)
Quantity/Unit of Measure: 45/SF
Total Deficiency Cost: \$23,460
Deficiency Description: *Windows are damaged and/or past their expected useful life.*

Description of Work: *Replace window.*

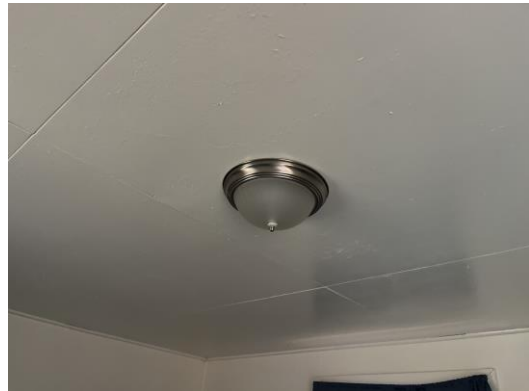
Record ID: 79
System: D5040 - LIGHTING
Item No.: D5040.50.421
Priority: Immediate (0-1 Years)
Quantity/Unit of Measure: 1/EA
Total Deficiency Cost: \$1,260
Deficiency Description: *The light fixture is past its expected useful life.*

Description of Work: *Replace existing incandescent fixtures with LED fixtures.*

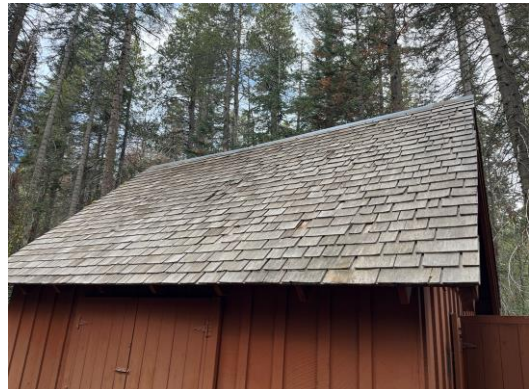
Record ID: 81
System: B3010 - ROOFING
Item No.: B3010.10.007
Priority: Immediate (0-1 Years)
Quantity/Unit of Measure: 200/SF
Total Deficiency Cost: \$7,720
Deficiency Description: *Wood shake roof is past its expected useful life.*

Description of Work: *Remove and replace wood shake roof and replace with metal roofing.*

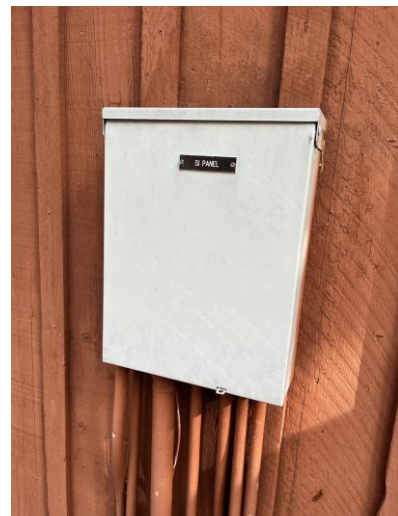
Priority: Immediate (0-1 Years)
Quantity/Unit of Measure: 1/EA
Total Deficiency Cost: \$6,750
Deficiency Description: *The outdoor load center is past its expected useful life.*

Description of Work: *Replace the existing load center with a new load center.*

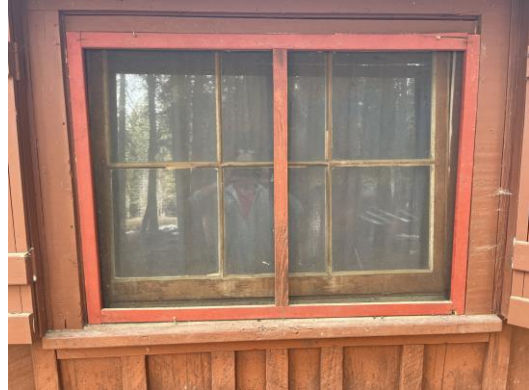
Record ID: 83
System: B2020 - EXTERIOR WINDOWS
Item No.: B2020.10.015
Priority: Immediate (0-1 Years)
Quantity/Unit of Measure: 45/SF
Total Deficiency Cost: \$23,460
Deficiency Description: *Windows are damaged and/or past their expected useful life.*

Description of Work: *Replace window.*

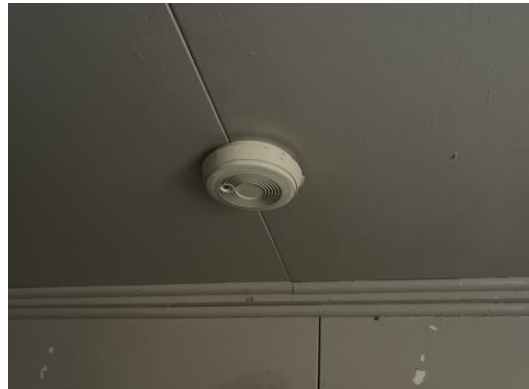
Record ID: 84
System: D7050 - DETECTION AND ALARM
Item No.: D7050.10.025
Priority: Immediate (0-1 Years)
Quantity/Unit of Measure: 1/EA
Total Deficiency Cost: \$680
Deficiency Description: *The smoke detector is past its expected useful life.*

Description of Work: *Replace the existing smoke detector with a new smoke detector.*

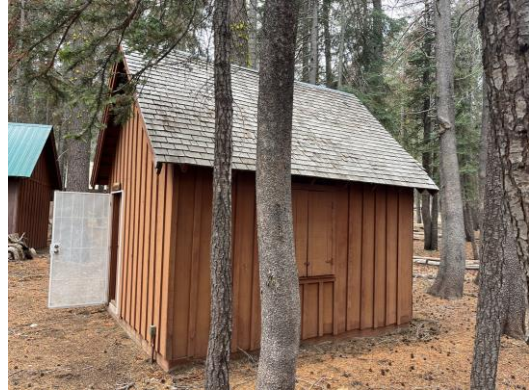
Priority: Immediate (0-1 Years)
Quantity/Unit of Measure: 200/SF
Total Deficiency Cost: \$7,720
Deficiency Description: *Wood shake roof is past its expected useful life.*

Comments: *Shake Roof*

Description of Work: *Remove and replace wood shake roof and replace with metal roofing.*

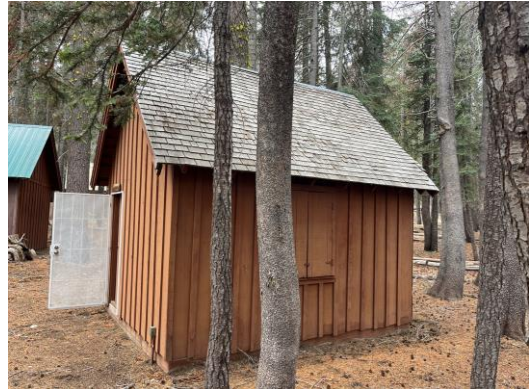
Record ID: 88
System: B2010 - EXTERIOR WALLS

Priority: Immediate (0-1 Years)
Quantity/Unit of Measure: 700/SF
Total Deficiency Cost: \$17,640
Deficiency Description: *The exterior wood board siding is showing signs of age and wear.*

Description of Work: *Power wash and repaint existing wood board siding.*

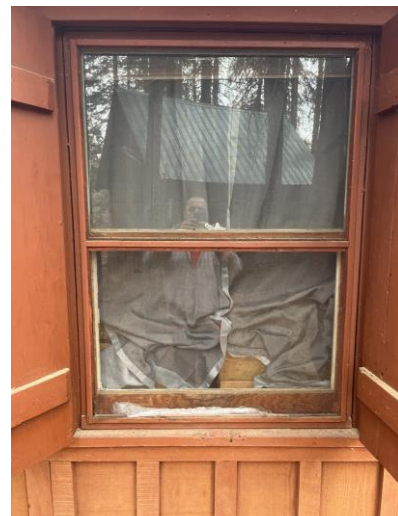
Record ID: 89
System: B2020 - EXTERIOR WINDOWS

Priority: Immediate (0-1 Years)
Quantity/Unit of Measure: 45/SF
Total Deficiency Cost: \$23,460
Deficiency Description: *Windows are damaged and/or past their expected useful life.*

Description of Work: *Replace window.*

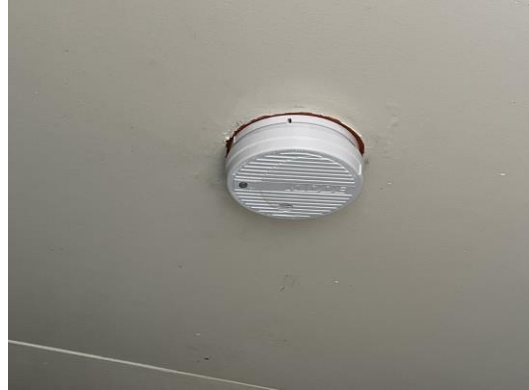
Record ID: 90
System: D7050 - DETECTION AND ALARM
Item No.: D7050.10.025
Priority: Immediate (0-1 Years)
Quantity/Unit of Measure: 1/EA
Total Deficiency Cost: \$680
Deficiency Description: *The smoke detector is past its expected useful life.*

Description of Work: *Replace the existing smoke detector with a new smoke detector.*

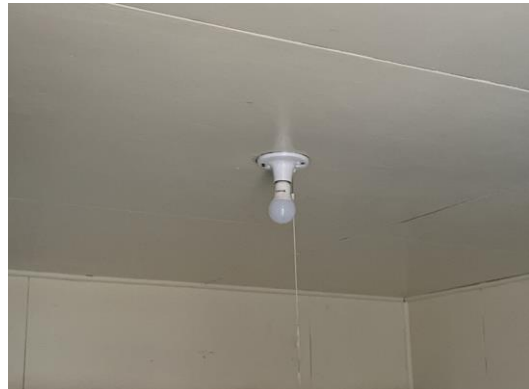
Record ID: 91
System: D5040 - LIGHTING
Item No.: D5040.50.421
Priority: Immediate (0-1 Years)
Quantity/Unit of Measure: 1/EA
Total Deficiency Cost: \$1,260
Deficiency Description: *The light fixture is past its expected useful life.*

Description of Work: *Replace existing incandescent fixtures with LED fixtures.*

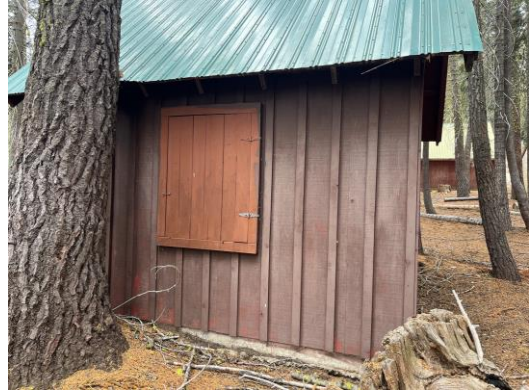
Priority: Immediate (0-1 Years)
Quantity/Unit of Measure: 700/SF
Total Deficiency Cost: \$17,640
Deficiency Description: *The exterior wood board siding is showing signs of age and wear.*

Description of Work: *Power wash and repaint existing wood board siding.*

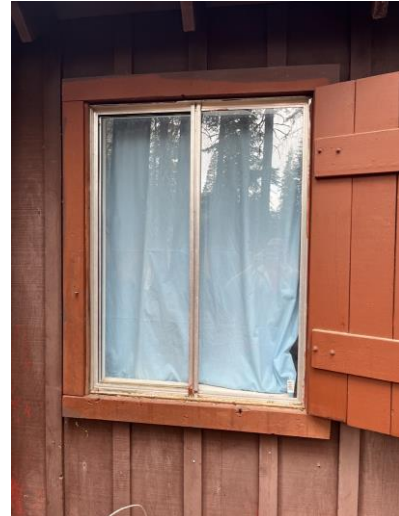
Record ID: 94
System: B2020 - EXTERIOR WINDOWS

Priority: Immediate (0-1 Years)
Quantity/Unit of Measure: 45/SF
Total Deficiency Cost: \$23,460
Deficiency Description: *Windows are damaged and/or past their expected useful life.*

Description of Work: *Replace window.*

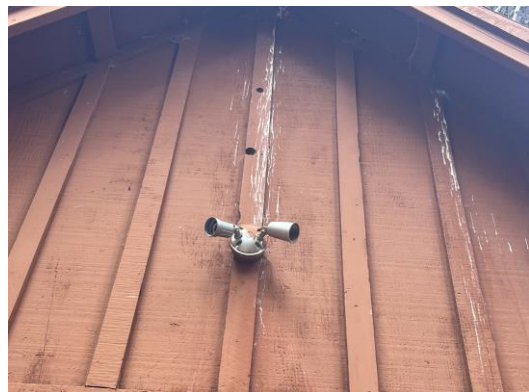
Record ID: 95
System: D5040 - LIGHTING

Priority: Immediate (0-1 Years)
Quantity/Unit of Measure: 1/EA
Total Deficiency Cost: \$2,500
Deficiency Description: *The exterior wall mounted fixture is past its expected useful life.*

Description of Work: *Replace the existing wall mounted lighting fixture with an LED lighting fixture.*

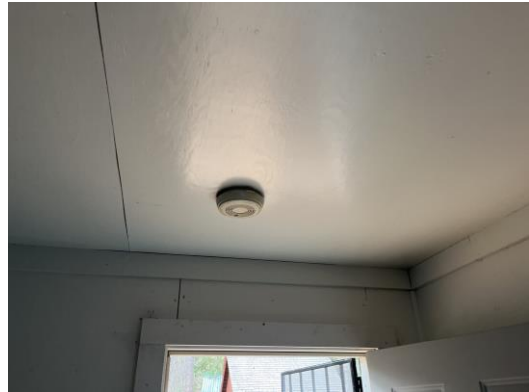
Record ID: 96
System: D7050 - DETECTION AND ALARM
Item No.: D7050.10.025
Priority: Immediate (0-1 Years)
Quantity/Unit of Measure: 1/EA
Total Deficiency Cost: \$680
Deficiency Description: *The smoke detector is past its expected useful life.*

Description of Work: *Replace the existing smoke detector with a new smoke detector.*

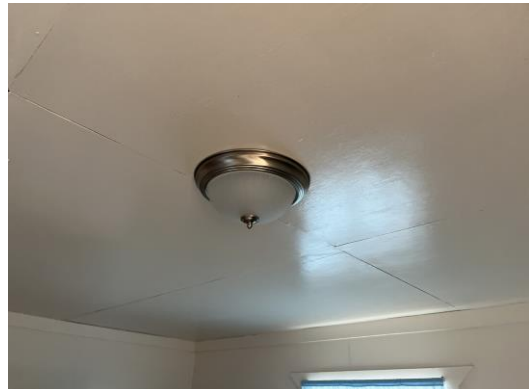
Record ID: 97
System: D5040 - LIGHTING
Item No.: D5040.50.421
Priority: Immediate (0-1 Years)
Quantity/Unit of Measure: 1/EA
Total Deficiency Cost: \$1,260
Deficiency Description: *The light fixture is past its expected useful life.*

Description of Work: *Replace existing incandescent fixtures with LED fixtures.*

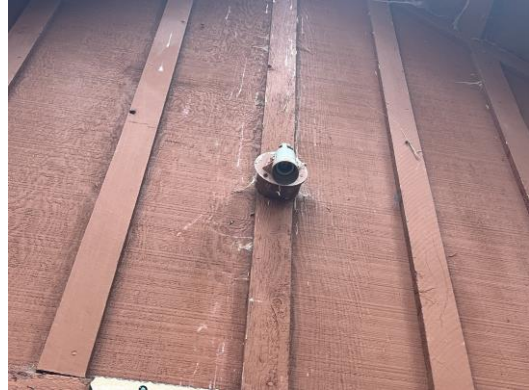
Record ID: 99
System: D5040 - LIGHTING
Item No.: D5040.50.420
Priority: Immediate (0-1 Years)
Quantity/Unit of Measure: 1/EA
Total Deficiency Cost: \$2,500
Deficiency Description: *The exterior wall mounted fixture is past its expected useful life.*

Description of Work: *Replace the existing wall mounted lighting fixture with an LED lighting fixture.*

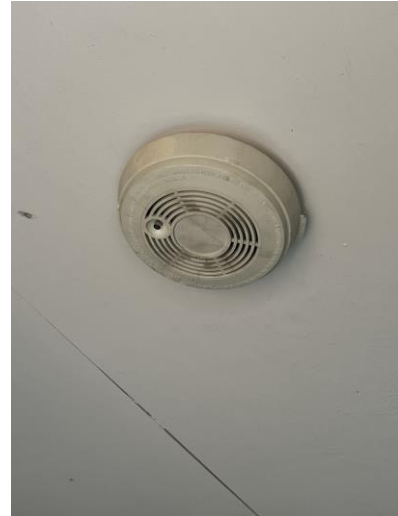
Record ID: 100
System: D7050 - DETECTION AND ALARM
Item No.: D7050.10.025
Priority: Immediate (0-1 Years)
Quantity/Unit of Measure: 1/EA
Total Deficiency Cost: \$680
Deficiency Description: *The smoke detector is past its expected useful life.*

Description of Work: *Replace the existing smoke detector with a new smoke detector.*

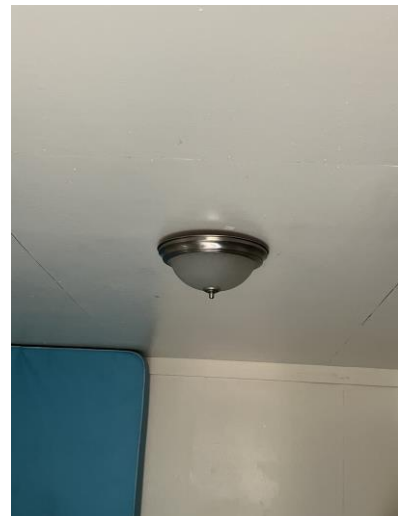
Record ID: 101
System: D5040 - LIGHTING
Item No.: D5040.50.421
Priority: Immediate (0-1 Years)
Quantity/Unit of Measure: 1/EA
Total Deficiency Cost: \$1,260
Deficiency Description: *The light fixture is past its expected useful life.*

Description of Work: *Replace existing incandescent fixtures with LED fixtures.*

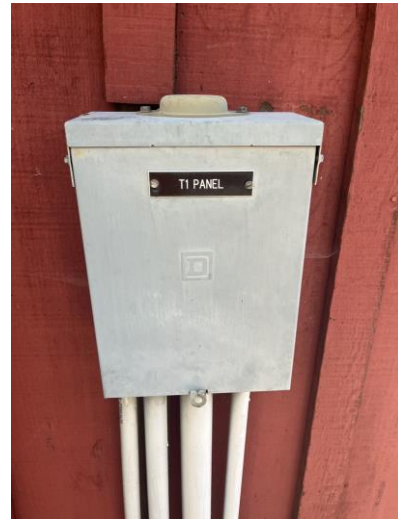
Priority: Immediate (0-1 Years)
Quantity/Unit of Measure: 1/EA
Total Deficiency Cost: \$6,750
Deficiency Description: *The outdoor load center is past its expected useful life.*

Description of Work: *Replace the existing load center with a new load center.*

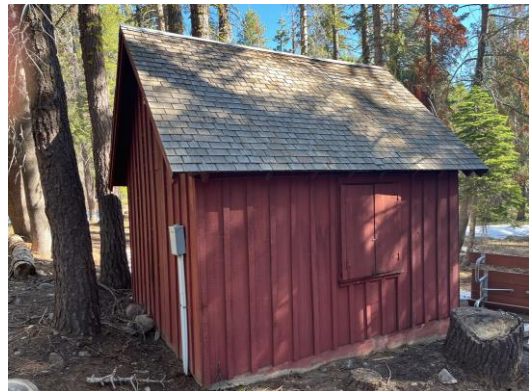
Record ID: 459
System: B2010 - EXTERIOR WALLS
Item No.: B2010.10.016

Priority: Immediate (0-1 Years)
Quantity/Unit of Measure: 700/SF
Total Deficiency Cost: \$17,640
Deficiency Description: *The exterior wood board siding is showing signs of age and wear.*

Description of Work: *Power wash and repaint existing wood board siding.*

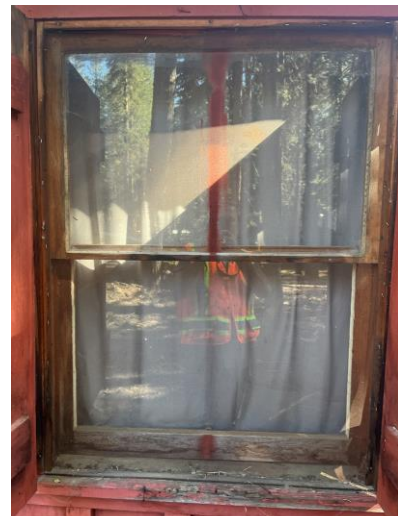
Record ID: 460
System: B2020 - EXTERIOR WINDOWS
Item No.: B2020.10.015

Priority: Immediate (0-1 Years)
Quantity/Unit of Measure: 45/SF
Total Deficiency Cost: \$23,460
Deficiency Description: *Windows are damaged and/or past their expected useful life.*

Description of Work: *Replace window.*

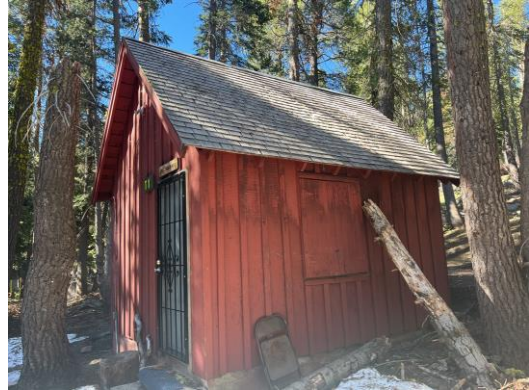
Record ID: 464
System: B3010 - ROOFING
Item No.: B3010.10.007
Priority: Immediate (0-1 Years)
Quantity/Unit of Measure: 150/SF
Total Deficiency Cost: \$5,810
Deficiency Description: *Wood shake roof is past its expected useful life.*
Description of Work: *Remove and replace wood shake roof and replace with metal roofing.*
Comments:

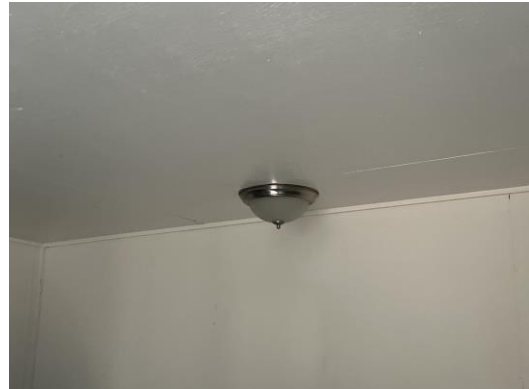
Record ID: 106
System: D5040 - LIGHTING
Item No.: D5040.50.421
Priority: Immediate (0-1 Years)
Quantity/Unit of Measure: /EA
Total Deficiency Cost:
Deficiency Description: *The light fixture is past its expected useful life.*

Description of Work: *Replace existing incandescent fixtures with LED fixtures.*

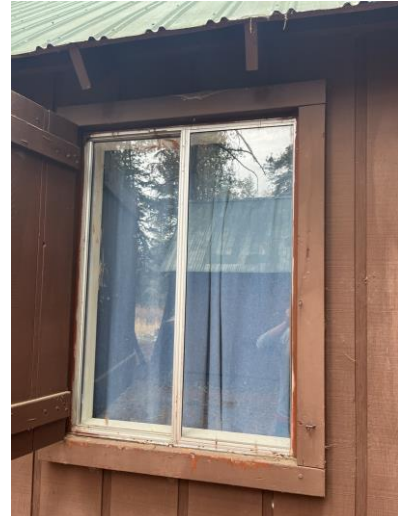
Record ID: 110
System: B2020 - EXTERIOR WINDOWS
Item No.: B2020.10.015
Priority: Immediate (0-1 Years)
Quantity/Unit of Measure: 45/SF
Total Deficiency Cost: \$23,460
Deficiency Description: *Windows are damaged and/or past their expected useful life.*

Description of Work: *Replace window.*

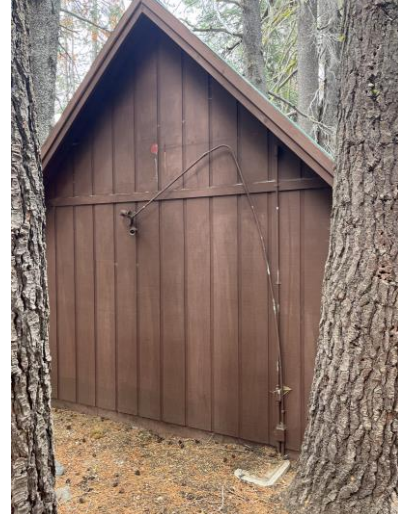
Comments: *Exterior light fixture and conduit is detached and hanging off the rear of cabin.*

Description of Work: *Replace the existing wall mounted lighting fixture with an LED lighting fixture.*

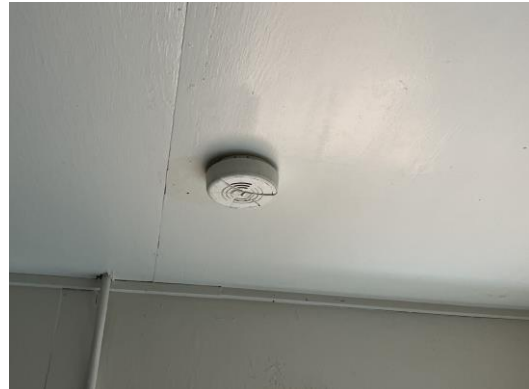
Record ID: 113
System: D7050 - DETECTION AND ALARM
Item No.: D7050.10.025
Priority: Immediate (0-1 Years)
Quantity/Unit of Measure: 1/EA
Total Deficiency Cost: \$680
Deficiency Description: *The smoke detector is past its expected useful life.*

Description of Work: *Replace the existing smoke detector with a new smoke detector.*

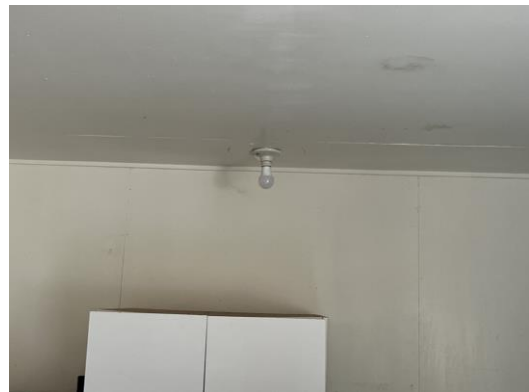
Record ID: 114
System: D5040 - LIGHTING
Item No.: D5040.50.421
Priority: Immediate (0-1 Years)
Quantity/Unit of Measure: 1/EA
Total Deficiency Cost: \$1,260
Deficiency Description: *The light fixture is past its expected useful life.*

Description of Work: *Replace existing incandescent fixtures with LED fixtures.*

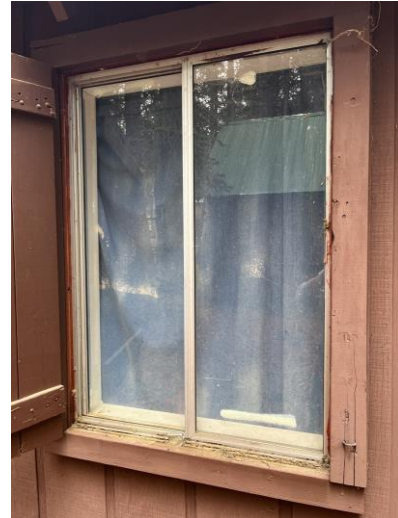
Record ID: 117
System: B2020 - EXTERIOR WINDOWS
Item No.: B2020.10.015
Priority: Immediate (0-1 Years)
Quantity/Unit of Measure: 45/SF
Total Deficiency Cost: \$23,460
Deficiency Description: *Windows are damaged and/or past their expected useful life.*

Description of Work: *Replace window.*

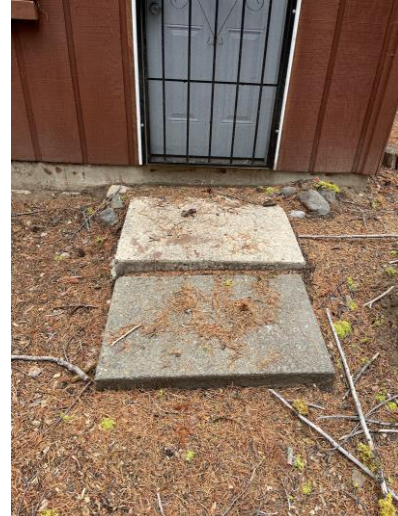
Record ID: 118
System: G2030 - PEDESTRIAN PLAZAS AND WALKWAYS
Item No.: G2030.30.038
Priority: Immediate (0-1 Years)
Quantity/Unit of Measure: 4/LFNS
Total Deficiency Cost: \$2,580
Deficiency Description: *Concrete steps are showing signs of age and wear.*

Description of Work: *Replace concrete steps.*

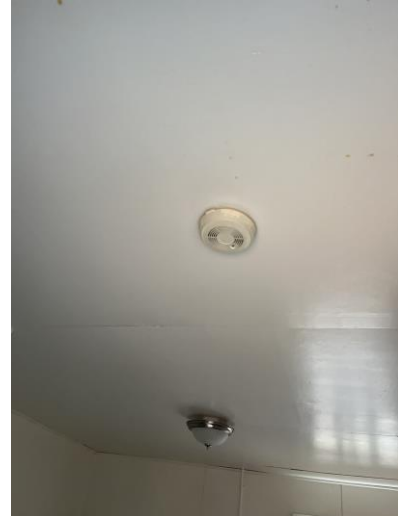
Record ID: 119
System: D7050 - DETECTION AND ALARM
Item No.: D7050.10.025
Priority: Immediate (0-1 Years)
Quantity/Unit of Measure: 1/EA
Total Deficiency Cost: \$680
Deficiency Description: *The smoke detector is past its expected useful life.*

Description of Work: *Replace the existing smoke detector with a new smoke detector.*

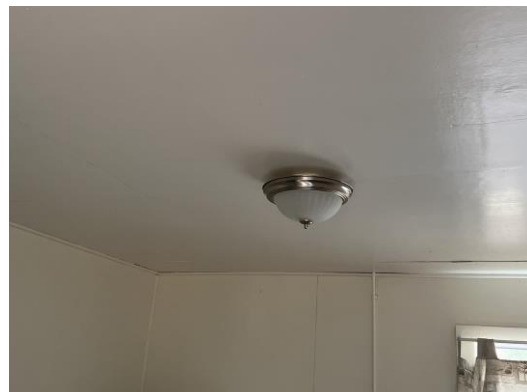
Record ID: 120
System: D5040 - LIGHTING
Item No.: D5040.50.421
Priority: Immediate (0-1 Years)
Quantity/Unit of Measure: 1/EA
Total Deficiency Cost: \$1,260
Deficiency Description: *The light fixture is past its expected useful life.*

Description of Work: *Replace existing incandescent fixtures with LED fixtures.*

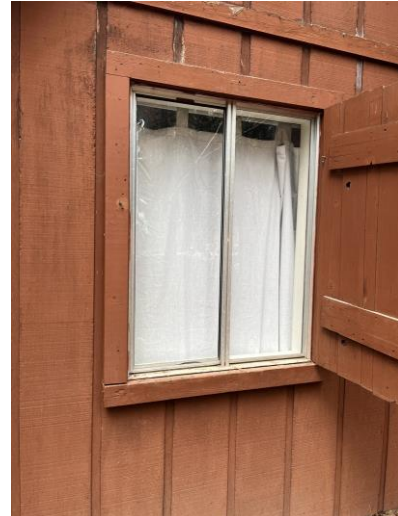
Record ID: 123
System: B2020 - EXTERIOR WINDOWS
Item No.: B2020.10.015
Priority: Immediate (0-1 Years)
Quantity/Unit of Measure: 45/SF
Total Deficiency Cost: \$23,460
Deficiency Description: *Windows are damaged and/or past their expected useful life.*

Description of Work: *Replace window.*

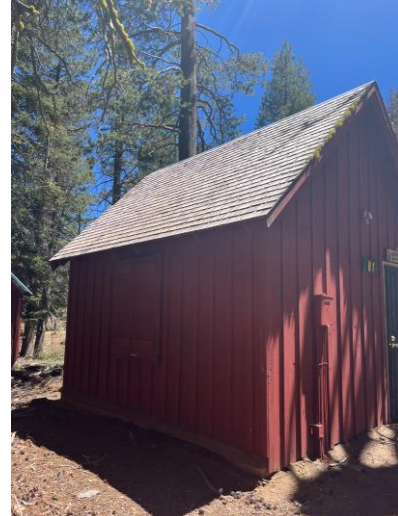
Record ID: 479
System: B2010 - EXTERIOR WALLS
Item No.: B2010.10.016
Priority: Immediate (0-1 Years)
Quantity/Unit of Measure: 700/SF
Total Deficiency Cost: \$17,640
Deficiency Description: *The exterior wood board siding is showing signs of age and wear.*

Description of Work: *Power wash and repaint existing wood board siding.*

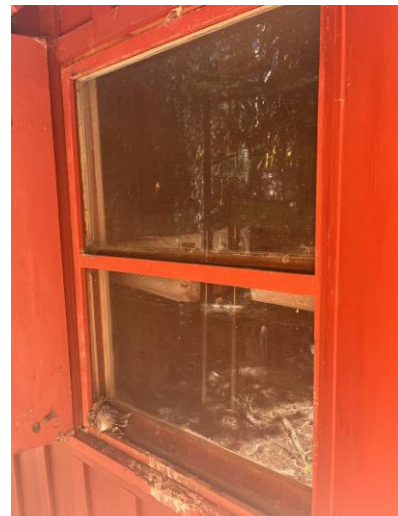
Record ID: 480
System: B2020 - EXTERIOR WINDOWS
Item No.: B2020.10.015
Priority: Immediate (0-1 Years)
Quantity/Unit of Measure: 45/SF
Total Deficiency Cost: \$23,460
Deficiency Description: *Windows are damaged and/or past their expected useful life.*

Description of Work: *Replace window.*

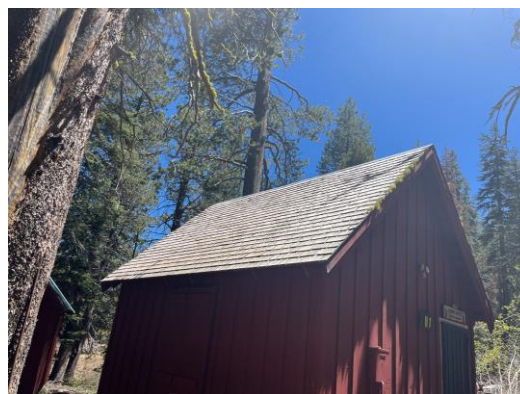
Record ID: 483
System: B3010 - ROOFING
Item No.: B3010.10.007
Priority: Immediate (0-1 Years)
Quantity/Unit of Measure: 200/SF
Total Deficiency Cost: \$7,720
Deficiency Description: *Wood shake roof is past its expected useful life.*

Description of Work: *Remove and replace wood shake roof and replace with metal roofing.*

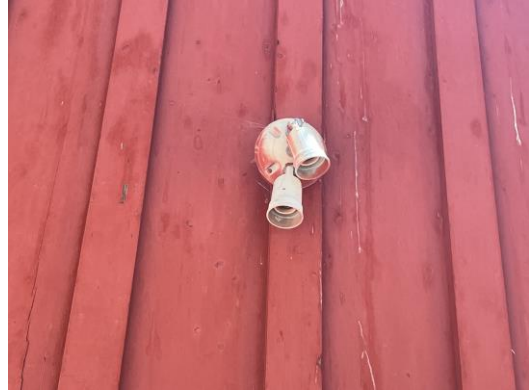
Deficiency Description: *The exterior wall mounted fixture is past its expected useful life.*

Description of Work: *Replace the existing wall mounted lighting fixture with an LED lighting fixture.*

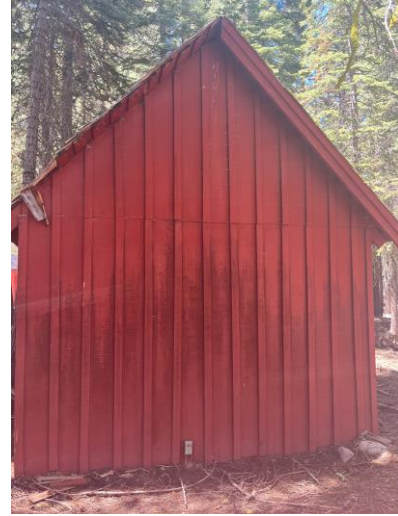
Record ID: 485
System: B2010 - EXTERIOR WALLS
Item No.: B2010.10.016
Priority: Immediate (0-1 Years)
Quantity/Unit of Measure: 700/SF
Total Deficiency Cost: \$17,640
Deficiency Description: *The exterior wood board siding is showing signs of age and wear.*

Description of Work: *Power wash and repaint existing wood board siding.*

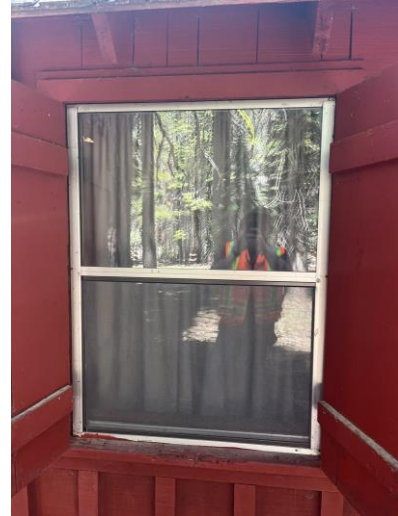
Record ID: 486
System: B2020 - EXTERIOR WINDOWS
Item No.: B2020.10.015
Priority: Immediate (0-1 Years)
Quantity/Unit of Measure: 45/SF
Total Deficiency Cost: \$23,460
Deficiency Description: *Windows are damaged and/or past their expected useful life.*

Description of Work: *Replace window.*

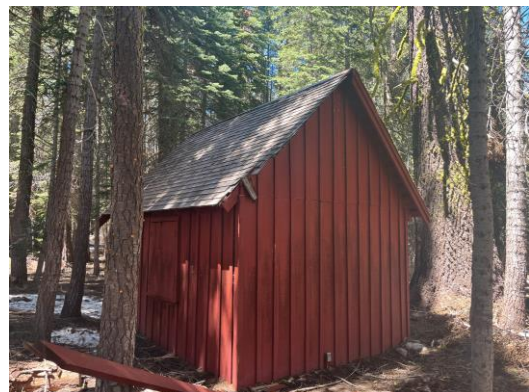
Record ID: 487
System: B3010 - ROOFING
Item No.: B3010.10.007
Priority: Immediate (0-1 Years)
Quantity/Unit of Measure: 200/SF
Total Deficiency Cost: \$7,720
Deficiency Description: *Wood shake roof is past its expected useful life.*

Description of Work: *Remove and replace wood shake roof and replace with metal roofing.*

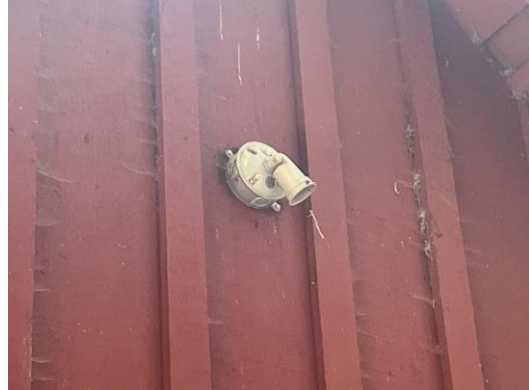
Record ID: 488
System: D5040 - LIGHTING
Item No.: D5040.50.420
Priority: Immediate (0-1 Years)
Quantity/Unit of Measure: 1/EA
Total Deficiency Cost: \$2,500
Deficiency Description: *The exterior wall mounted fixture is past its expected useful life.*

Description of Work: *Replace the existing wall mounted lighting fixture with an LED lighting fixture.*

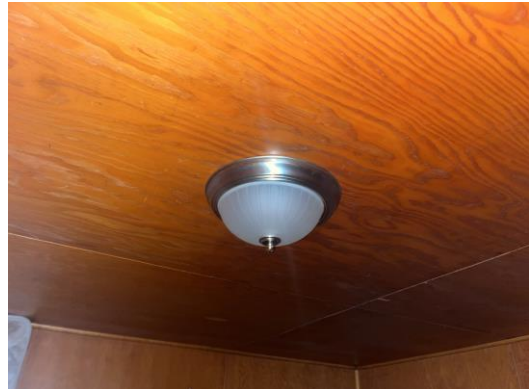
Record ID: 489
System: D5040 - LIGHTING
Item No.: D5040.50.421
Priority: Immediate (0-1 Years)
Quantity/Unit of Measure: 1/EA
Total Deficiency Cost: \$1,260
Deficiency Description: *The light fixture is past its expected useful life.*

Description of Work: *Replace existing incandescent fixtures with LED fixtures.*

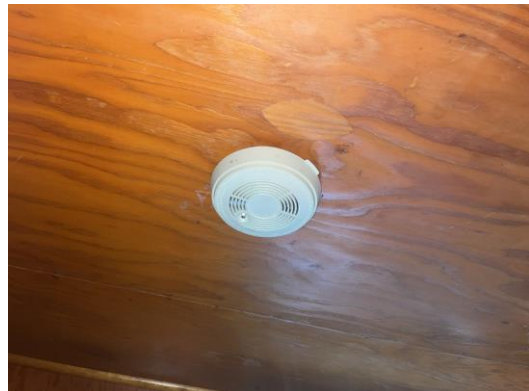
Record ID: 490
System: D7050 - DETECTION AND ALARM
Item No.: D7050.10.025
Priority: Immediate (0-1 Years)
Quantity/Unit of Measure: 1/EA
Total Deficiency Cost: \$680
Deficiency Description: *The smoke detector is past its expected useful life.*

Description of Work: *Replace the existing smoke detector with a new smoke detector.*

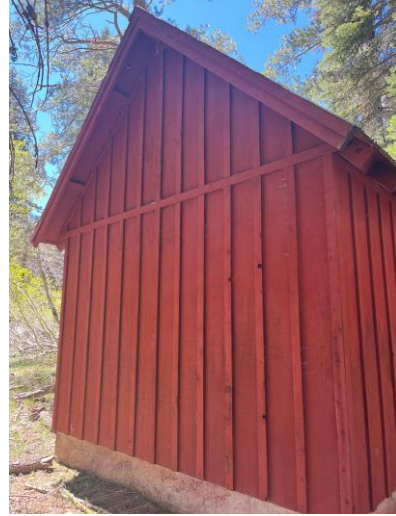
Record ID: 491
System: B2010 - EXTERIOR WALLS
Item No.: B2010.10.016
Priority: Immediate (0-1 Years)
Quantity/Unit of Measure: 700/SF
Total Deficiency Cost: \$17,640
Deficiency Description: *The exterior wood board siding is showing signs of age and wear.*

Description of Work: *Power wash and repaint existing wood board siding.*

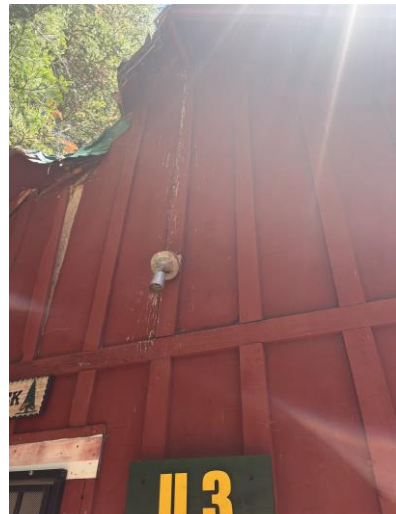
Record ID: 493
System: D5040 - LIGHTING
Item No.: D5040.50.420
Priority: Immediate (0-1 Years)
Quantity/Unit of Measure: 1/EA
Total Deficiency Cost: \$2,500
Deficiency Description: *The exterior wall mounted fixture is past its expected useful life.*

Description of Work: *Replace the existing wall mounted lighting fixture with an LED lighting fixture.*

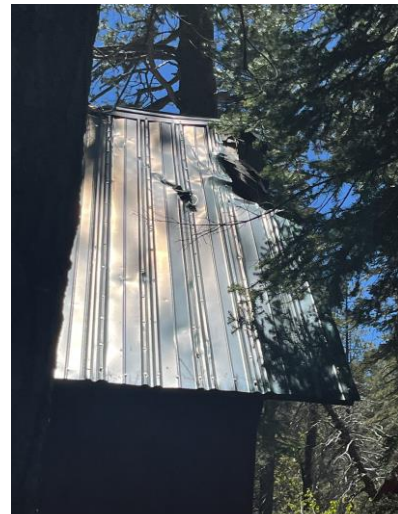
Record ID: 498
System: B3010 - ROOFING
Item No.: B3010.10.002
Priority: Immediate (0-1 Years)
Quantity/Unit of Measure: 200/SF
Total Deficiency Cost: \$7,720
Deficiency Description: *Metal Roofing is at or approaching end of expected useful service life.*

Description of Work: *Remove and replace metal roofing.*

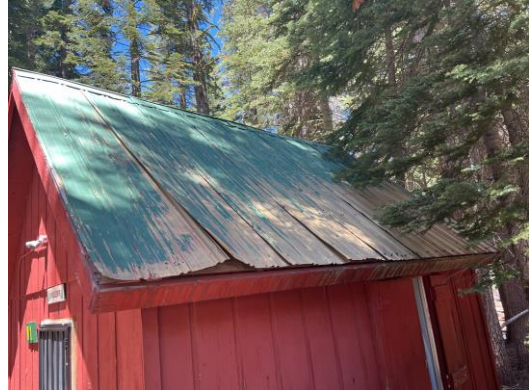
Priority: Immediate (0-1 Years)
Quantity/Unit of Measure: 200/SF
Total Deficiency Cost: \$7,720
Deficiency Description: *Metal Roofing is at or approaching end of expected useful service life.*

Description of Work: *Remove and replace metal roofing.*

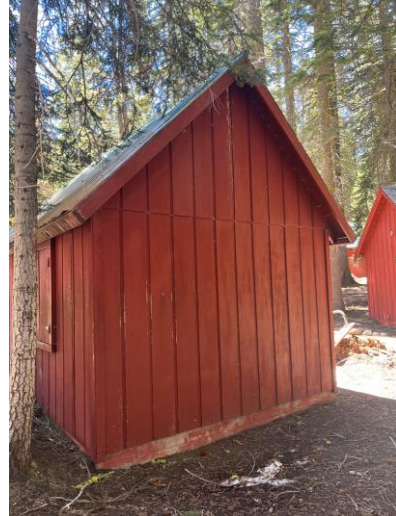
Priority: Immediate (0-1 Years)
Quantity/Unit of Measure: 700/SF
Total Deficiency Cost: \$17,640
Deficiency Description: *The exterior wood board siding is showing signs of age and wear.*

Description of Work: *Power wash and repaint existing wood board siding.*
