Silver Lake Campground Facility Condition Assessment

Final Report

August 16, 2024

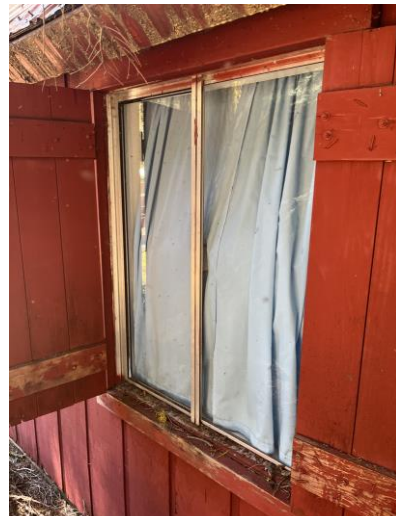
Priority: Immediate (0-1 Years)
Quantity/Unit of Measure: 30/SF
Total Deficiency Cost: \$15,620
Deficiency Description: *Windows are damaged and/or past their expected useful life.*

Description of Work: *Replace window.*

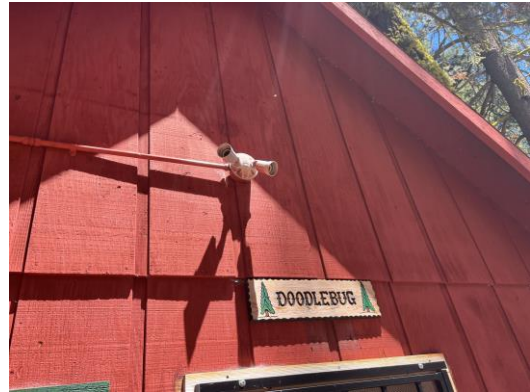
Deficiency Description: *The exterior wall mounted fixture is past its expected useful life.*

Description of Work: *Replace the existing wall mounted lighting fixture with an LED lighting fixture.*

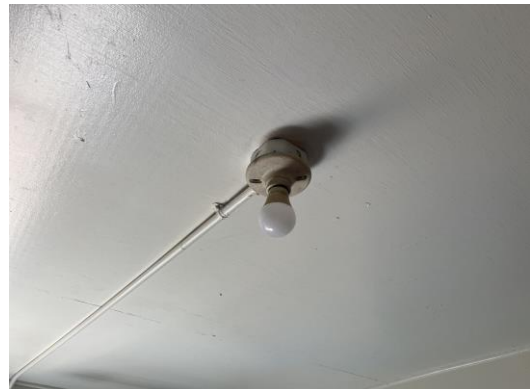
Deficiency Description: *The light fixture is past its expected useful life.*

Description of Work: *Replace existing incandescent fixtures with LED fixtures.*

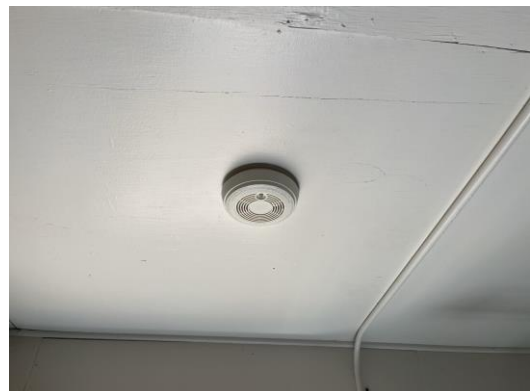
Deficiency Description: *The smoke detector is past its expected useful life.*

Description of Work: *Replace the existing smoke detector with a new smoke detector.*

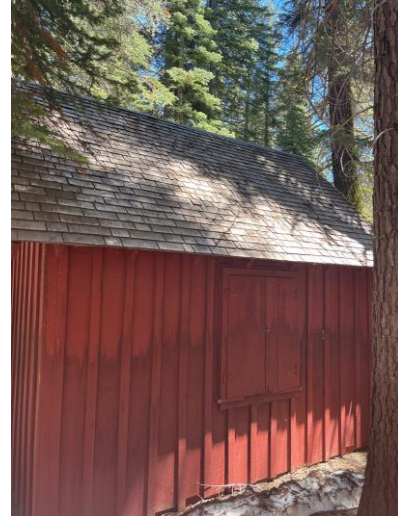
Record ID: 505
System: B3010 - ROOFING
Item No.: B3010.10.007
Priority: Immediate (0-1 Years)
Quantity/Unit of Measure: 200/SF
Total Deficiency Cost: \$7,720
Deficiency Description: *Wood shake roof is past its expected useful life.*

Description of Work: *Remove and replace wood shake roof and replace with metal roofing.*

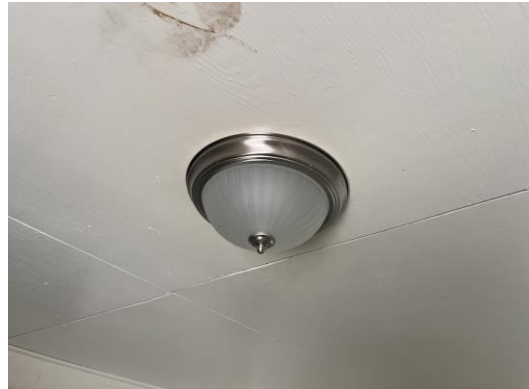
Record ID: 509
System: D5040 - LIGHTING
Item No.: D5040.50.421
Priority: Immediate (0-1 Years)
Quantity/Unit of Measure: 1/EA
Total Deficiency Cost: \$1,260
Deficiency Description: *The light fixture is past its expected useful life.*

Description of Work: *Replace existing incandescent fixtures with LED fixtures.*

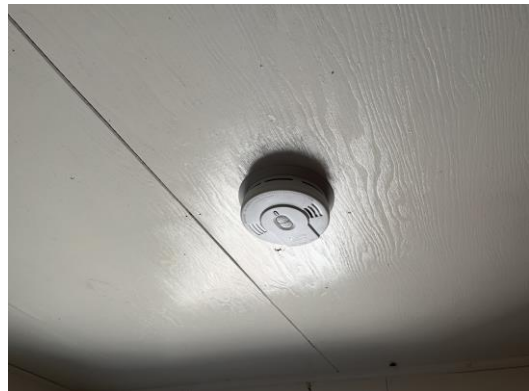
Record ID: 510
System: D7050 - DETECTION AND ALARM
Item No.: D7050.10.025
Priority: Immediate (0-1 Years)
Quantity/Unit of Measure: 1/EA
Total Deficiency Cost: \$680
Deficiency Description: *The smoke detector is past its expected useful life.*

Description of Work: *Replace the existing smoke detector with a new smoke detector.*

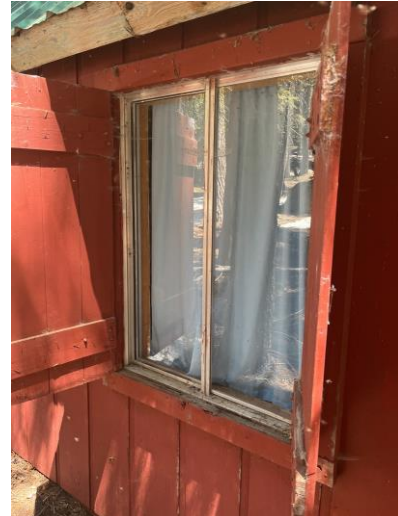
Record ID: 512
System: B2020 - EXTERIOR WINDOWS
Item No.: B2020.10.015
Priority: Immediate (0-1 Years)
Quantity/Unit of Measure: 30/SF
Total Deficiency Cost: \$15,620
Deficiency Description: *Windows are damaged and/or past their expected useful life.*

Description of Work: *Replace window.*

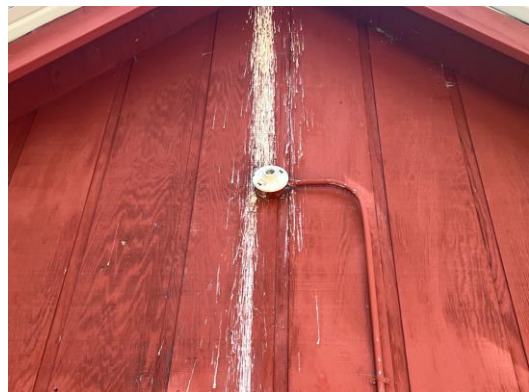
Record ID: 513
System: D5040 - LIGHTING
Item No.: D5040.50.420
Priority: Immediate (0-1 Years)
Quantity/Unit of Measure: 1/EA
Total Deficiency Cost: \$2,500
Deficiency Description: *The exterior wall mounted fixture is past its expected useful life.*

Description of Work: *Replace the existing wall mounted lighting fixture with an LED lighting fixture.*

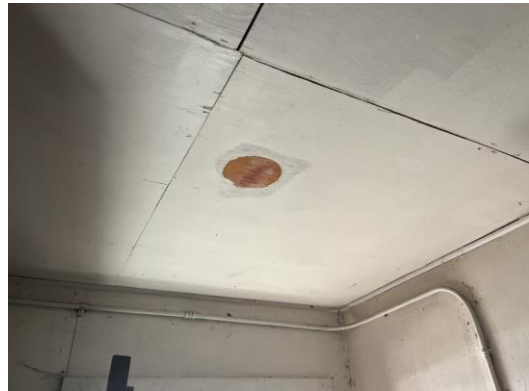
Record ID: 515
System: D7050 - DETECTION AND ALARM
Item No.: D7050.10.025
Priority: Immediate (0-1 Years)
Quantity/Unit of Measure: 1/EA
Total Deficiency Cost: \$680
Deficiency Description: *The smoke detector is past its expected useful life.*

Description of Work: *Replace the existing smoke detector with a new smoke detector.*

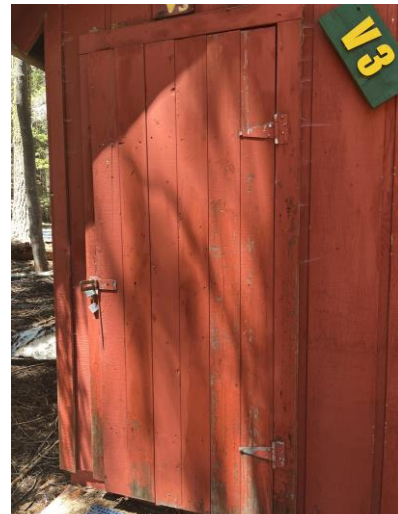
Record ID: 516
System: B2050 - EXTERIOR DOORS AND GRILLES
Item No.: B2050.10.001
Priority: Immediate (0-1 Years)
Quantity/Unit of Measure: 1/EA
Total Deficiency Cost: \$8,400
Deficiency Description: *Exterior wood entrance door is approaching the end of its useful life.*

Description of Work: *Replace wood door.*

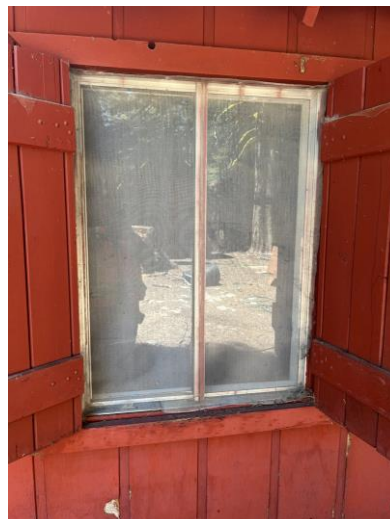
Record ID: 519
System: B2020 - EXTERIOR WINDOWS
Item No.: B2020.10.015
Priority: Immediate (0-1 Years)
Quantity/Unit of Measure: 30/SF
Total Deficiency Cost: \$15,620
Deficiency Description: *Windows are damaged and/or past their expected useful life.*

Description of Work: *Replace window.*

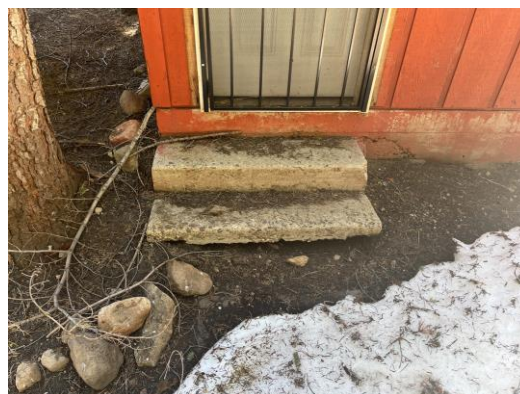
Record ID: 520
System: G2030 - PEDESTRIAN PLAZAS AND WALKWAYS
Item No.: G2030.30.038
Priority: Immediate (0-1 Years)
Quantity/Unit of Measure: 1/LFNS
Total Deficiency Cost: \$650
Deficiency Description: *Concrete steps are showing signs of age and wear.*

Description of Work: *Replace concrete steps.*

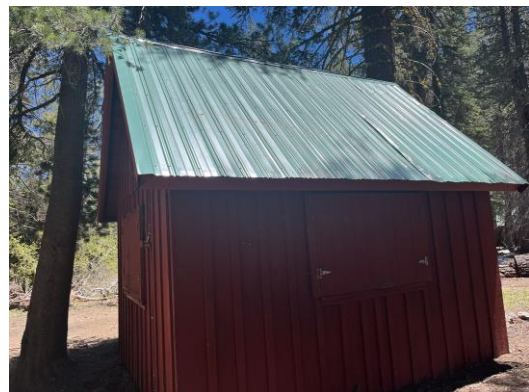
Record ID: 527
System: B3010 - ROOFING
Item No.: B3010.10.002
Priority: Immediate (0-1 Years)
Quantity/Unit of Measure: 200/SF
Total Deficiency Cost: \$7,720
Deficiency Description: *Metal Roofing is at or approaching end of expected useful service life.*

Description of Work: *Remove and replace metal roofing.*

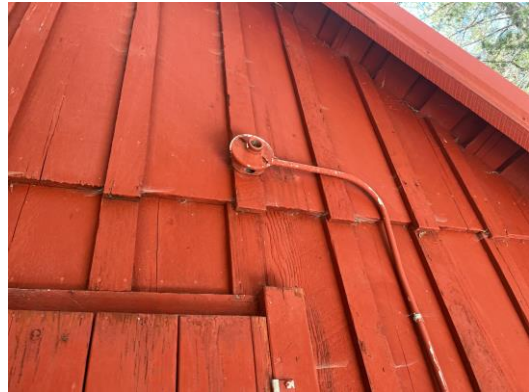
Record ID: 529
System: D5040 - LIGHTING
Item No.: D5040.50.420
Priority: Immediate (0-1 Years)
Quantity/Unit of Measure: 1/EA
Total Deficiency Cost: \$2,500
Deficiency Description: *The exterior wall mounted fixture is past its expected useful life.*

Description of Work: *Replace the existing wall mounted lighting fixture with an LED lighting fixture.*

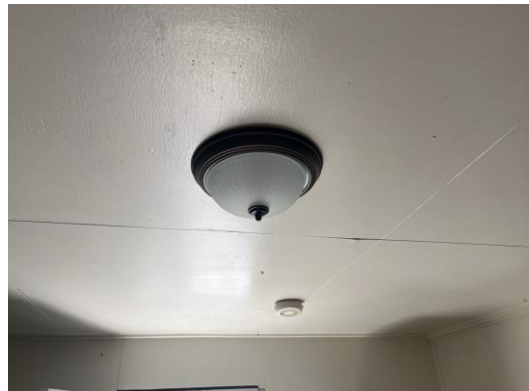
Record ID: 530
System: D5040 - LIGHTING
Item No.: D5040.50.421
Priority: Immediate (0-1 Years)
Quantity/Unit of Measure: 1/EA
Total Deficiency Cost: \$1,260
Deficiency Description: *The light fixture is past its expected useful life.*

Description of Work: *Replace existing incandescent fixtures with LED fixtures.*

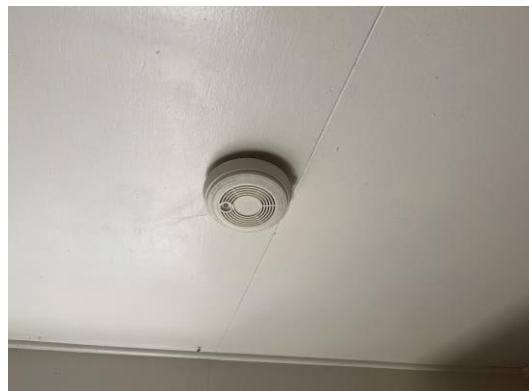
Record ID: 531
System: D7050 - DETECTION AND ALARM
Item No.: D7050.10.025
Priority: Immediate (0-1 Years)
Quantity/Unit of Measure: 1/EA
Total Deficiency Cost: \$680
Deficiency Description: *The smoke detector is past its expected useful life.*

Description of Work: *Replace the existing smoke detector with a new smoke detector.*

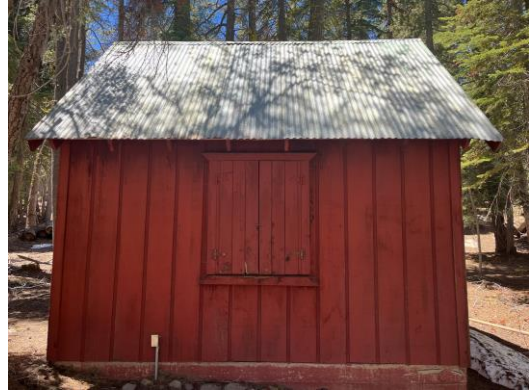
Priority: Immediate (0-1 Years)
Quantity/Unit of Measure: 700/SF
Total Deficiency Cost: \$17,640
Deficiency Description: *The exterior wood board siding is showing signs of age and wear.*

Description of Work: *Power wash and repaint existing wood board siding.*

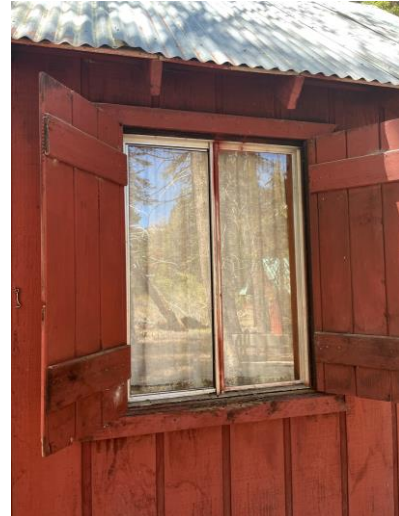
Priority: Immediate (0-1 Years)
Quantity/Unit of Measure: 30/SF
Total Deficiency Cost: \$15,620
Deficiency Description: *Windows are damaged and/or past their expected useful life.*

Description of Work: *Replace window.*

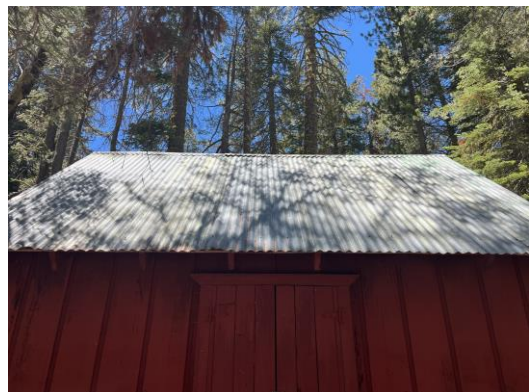
Priority: Immediate (0-1 Years)
Quantity/Unit of Measure: 200/SF
Total Deficiency Cost: \$7,720
Deficiency Description: *Metal Roofing is at or approaching end of expected useful service life.*

Description of Work: *Remove and replace metal roofing.*

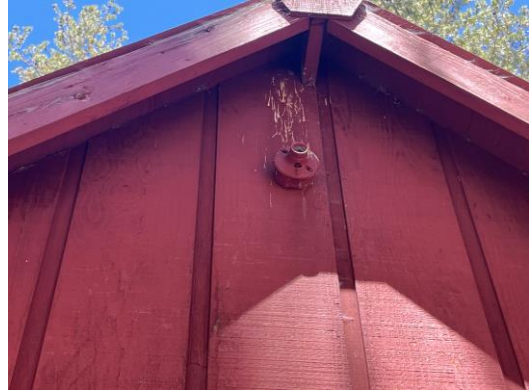
Record ID: 535
System: D5040 - LIGHTING
Item No.: D5040.50.420
Priority: Immediate (0-1 Years)
Quantity/Unit of Measure: 1/EA
Total Deficiency Cost: \$2,500
Deficiency Description: *The exterior wall mounted fixture is past its expected useful life.*

Description of Work: *Replace the existing wall mounted lighting fixture with an LED lighting fixture.*

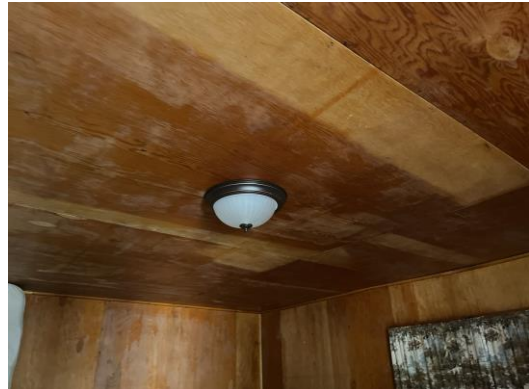
Record ID: 536
System: D5040 - LIGHTING
Item No.: D5040.50.421
Priority: Immediate (0-1 Years)
Quantity/Unit of Measure: 1/EA
Total Deficiency Cost: \$1,260
Deficiency Description: *The light fixture is past its expected useful life.*

Description of Work: *Replace existing incandescent fixtures with LED fixtures.*

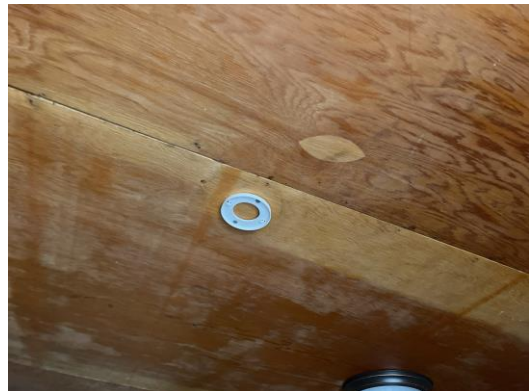
Record ID: 537
System: D7050 - DETECTION AND ALARM
Item No.: D7050.10.025
Priority: Immediate (0-1 Years)
Quantity/Unit of Measure: 1/EA
Total Deficiency Cost: \$680
Deficiency Description: *The smoke detector is past its expected useful life.*

Description of Work: *Replace the existing smoke detector with a new smoke detector.*

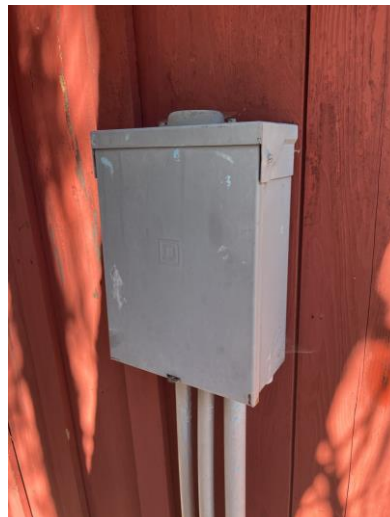
Priority: Immediate (0-1 Years)
Quantity/Unit of Measure: 1/EA
Total Deficiency Cost: \$6,750
Deficiency Description: *The outdoor load center is past its expected useful life.*

Description of Work: *Replace the existing load center with a new load center.*

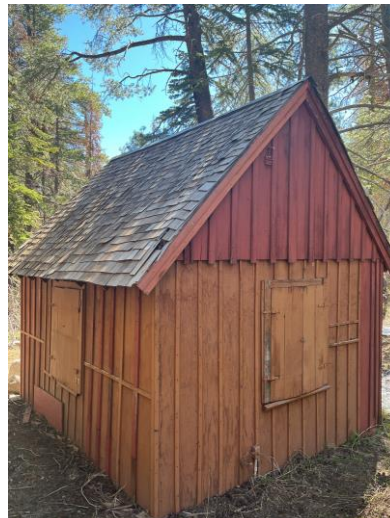
Priority: Immediate (0-1 Years)
Quantity/Unit of Measure: 700/SF
Total Deficiency Cost: \$17,640
Deficiency Description: *The exterior wood board siding is showing signs of age and wear.*

Description of Work: *Power wash and repaint existing wood board siding.*

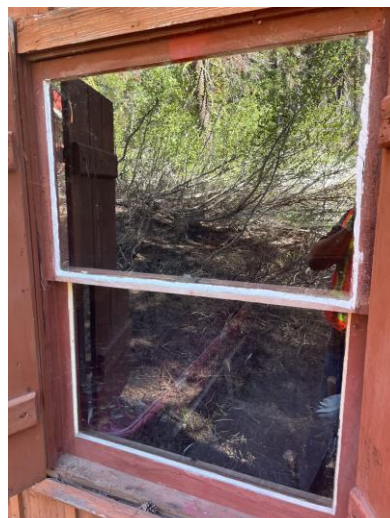
Priority: Immediate (0-1 Years)
Quantity/Unit of Measure: 45/SF
Total Deficiency Cost: \$23,460
Deficiency Description: *Windows are damaged and/or past their expected useful life.*

Description of Work: *Replace window.*

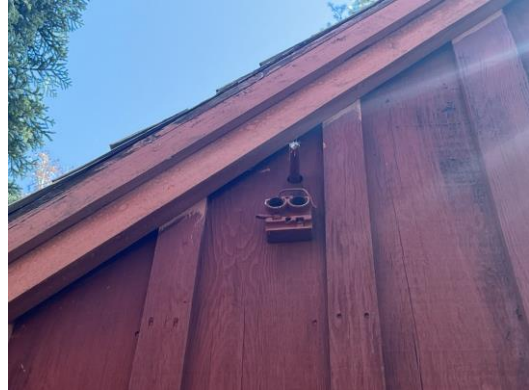
Record ID: 542
System: D5040 - LIGHTING
Item No.: D5040.50.420
Priority: Immediate (0-1 Years)
Quantity/Unit of Measure: 2/EA
Total Deficiency Cost: \$4,960
Deficiency Description: *The exterior wall mounted fixture is past its expected useful life.*

Description of Work: *Replace the existing wall mounted lighting fixture with an LED lighting fixture.*

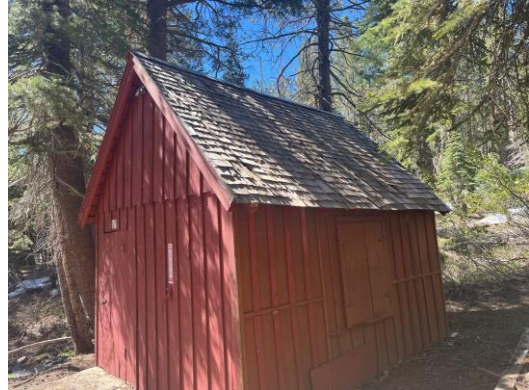
Record ID: 545
System: B3010 - ROOFING
Item No.: B3010.10.007
Priority: Immediate (0-1 Years)
Quantity/Unit of Measure: 200/SF
Total Deficiency Cost: \$7,720
Deficiency Description: *Wood shake roof is past its expected useful life.*

Description of Work: *Remove and replace wood shake roof and replace with metal roofing.*

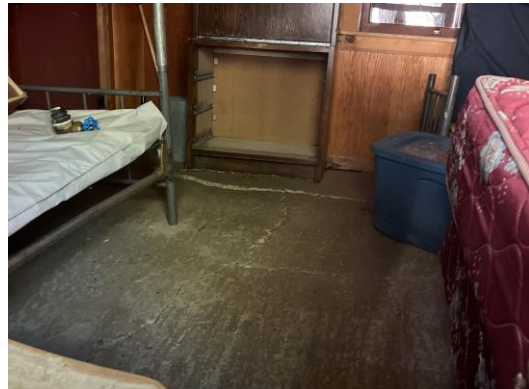
Record ID: 546
System: A4010 - STANDARD SLABS-ON-GRADE
Item No.: A4010.10.003
Priority: Immediate (0-1 Years)
Quantity/Unit of Measure: 150/SF
Total Deficiency Cost: \$5,900
Deficiency Description: *The concrete floor slab has major damage and cracks from uplift.*

Description of Work: *Replace the concrete slab.*

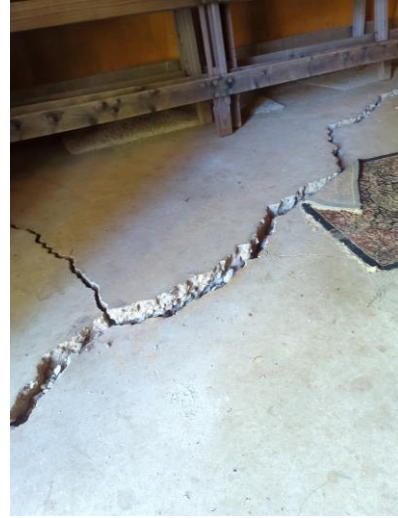
Priority: Immediate (0-1 Years)
Quantity/Unit of Measure: 150/SF
Total Deficiency Cost: \$5,900
Deficiency Description: *The concrete floor slab has major damage and cracks from uplift.*

Description of Work: *Replace the concrete slab.*

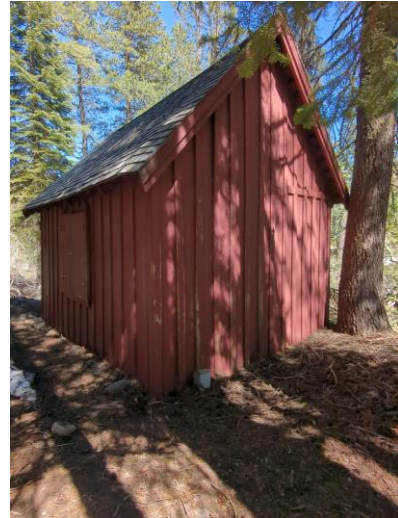
Priority: Immediate (0-1 Years)
Quantity/Unit of Measure: 700/SF
Total Deficiency Cost: \$17,640
Deficiency Description: *The exterior wood board siding is showing signs of age and wear.*

Description of Work: *Power wash and repaint existing wood board siding.*

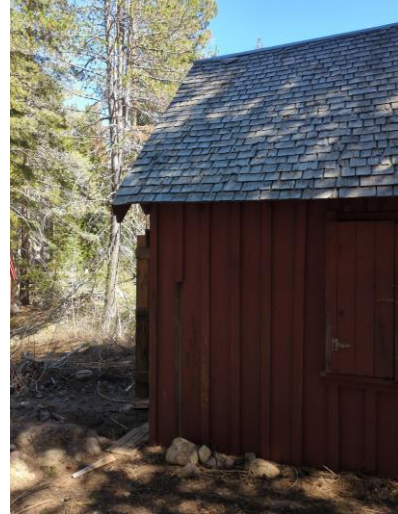
Record ID: 550
System: B3010 - ROOFING
Item No.: B3010.10.007
Priority: Immediate (0-1 Years)
Quantity/Unit of Measure: 200/SF
Total Deficiency Cost: \$7,720
Deficiency Description: *Wood shake roof is past its expected useful life.*

Description of Work: *Remove and replace wood shake roof and replace with metal roofing.*

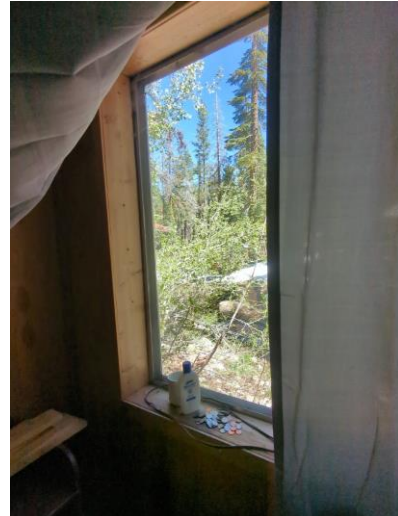
Record ID: 556
System: B2020 - EXTERIOR WINDOWS
Item No.: B2020.10.015
Priority: Immediate (0-1 Years)
Quantity/Unit of Measure: 15/SF
Total Deficiency Cost: \$7,810
Deficiency Description: *Windows are damaged and/or past their expected useful life.*

Description of Work: *Replace window.*

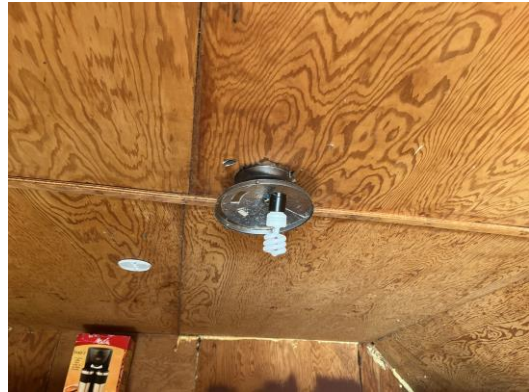
Record ID: 564
System: D5040 - LIGHTING
Item No.: D5040.50.421
Priority: Immediate (0-1 Years)
Quantity/Unit of Measure: 1/EA
Total Deficiency Cost: \$1,260
Deficiency Description: *The light fixture is past its expected useful life.*
Description of Work: *Replace existing incandescent fixtures with LED fixtures.*
Comments:

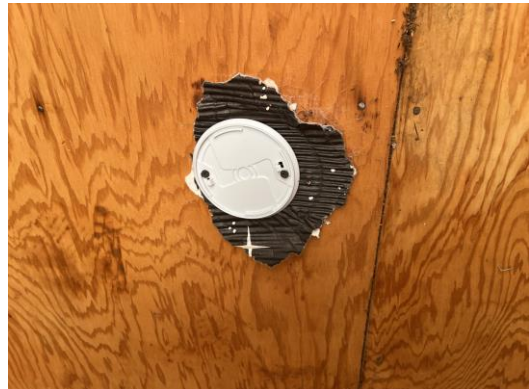
Record ID: 565
System: D7050 - DETECTION AND ALARM
Item No.: D7050.10.025
Priority: Immediate (0-1 Years)
Quantity/Unit of Measure: 1/EA
Total Deficiency Cost: \$680
Deficiency Description: *The smoke detector is past its expected useful life.*
Description of Work: *Replace the existing smoke detector with a new smoke detector.*
Comments:

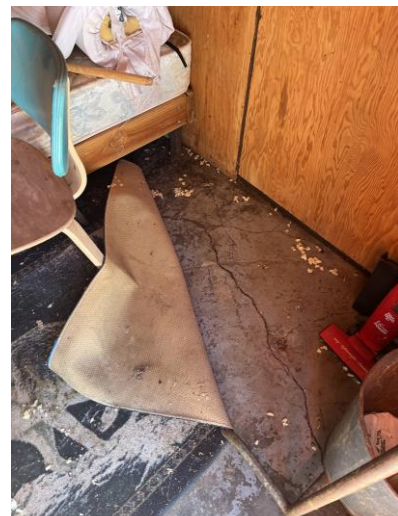
Record ID: 566
System: A4010 - STANDARD SLABS-ON-GRADE
Item No.: A4010.10.003
Priority: Immediate (0-1 Years)
Quantity/Unit of Measure: 150/SF
Total Deficiency Cost: \$5,900
Deficiency Description: *The concrete floor slab has major damage and cracks from uplift.*
Description of Work: *Replace the concrete slab.*
Comments:

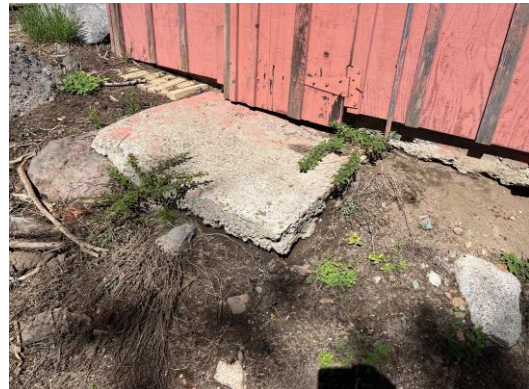
Record ID: 569
System: G2030 - PEDESTRIAN PLAZAS AND WALKWAYS
Item No.: G2030.30.038
Priority: Immediate (0-1 Years)
Quantity/Unit of Measure: 2/LFNS
Total Deficiency Cost: \$1,290
Deficiency Description: *Concrete steps are showing signs of age and wear.*

Description of Work: *Replace concrete steps.*

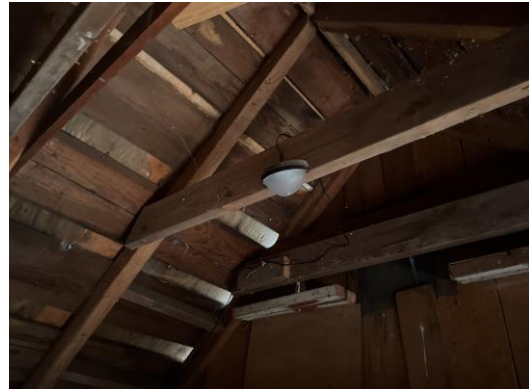
Priority: Immediate (0-1 Years)
Quantity/Unit of Measure: 1/EA
Total Deficiency Cost: \$1,260
Deficiency Description: *The light fixture is past its expected useful life.*

Description of Work: *Replace existing incandescent fixtures with LED fixtures.*

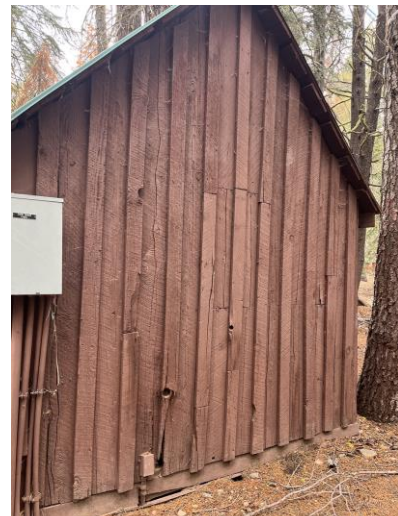
Priority: Immediate (0-1 Years)
Quantity/Unit of Measure: 400/SF
Total Deficiency Cost: \$10,100
Deficiency Description: *The exterior wood board siding is showing signs of age and wear.*

Comments: *Wood board siding is in poor condition.*

Description of Work: *Power wash and repaint existing wood board siding.*

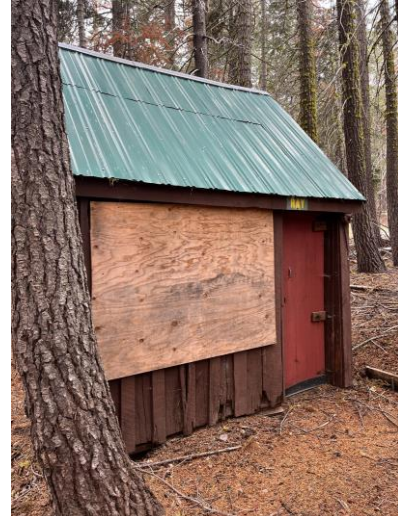
Comments: *Windows missing.*

Description of Work: *Replace window.*

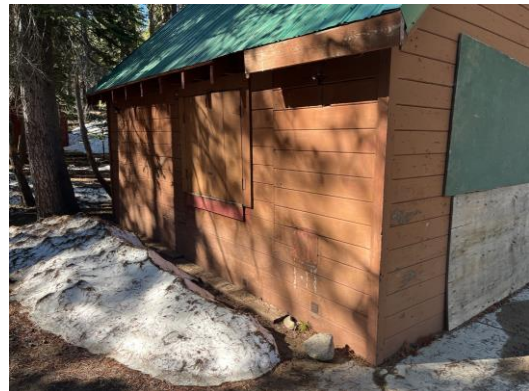
Priority: Immediate (0-1 Years)
Quantity/Unit of Measure: 800/SF
Total Deficiency Cost: \$20,170
Deficiency Description: *The exterior wood board siding is showing signs of age and wear.*

Description of Work: *Power wash and repaint existing wood board siding.*

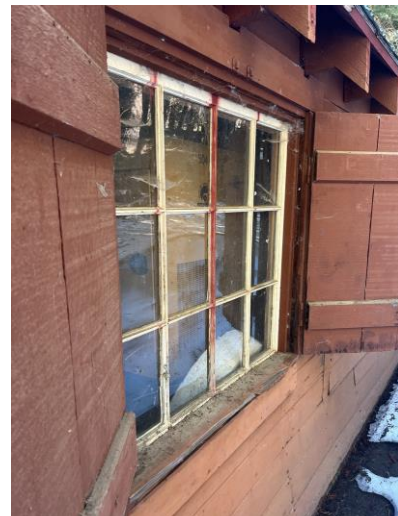
Priority: Immediate (0-1 Years)
Quantity/Unit of Measure: 45/SF
Total Deficiency Cost: \$23,460
Deficiency Description: *Windows are damaged and/or past their expected useful life.*

Description of Work: *Replace window.*

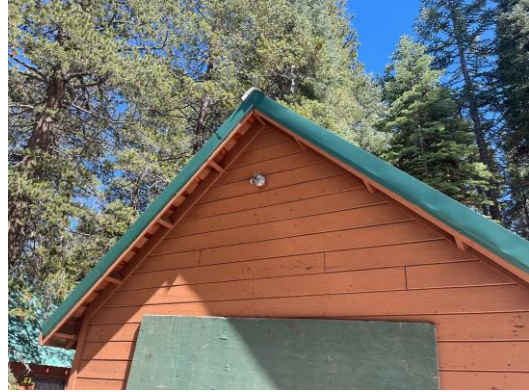
Record ID: 582
System: D5040 - LIGHTING
Item No.: D5040.50.420
Priority: Immediate (0-1 Years)
Quantity/Unit of Measure: 2/EA
Total Deficiency Cost: \$4,960
Deficiency Description: *The exterior wall mounted fixture is past its expected useful life.*
Description of Work: *Replace the existing wall mounted lighting fixture with an LED lighting fixture.*
Comments:

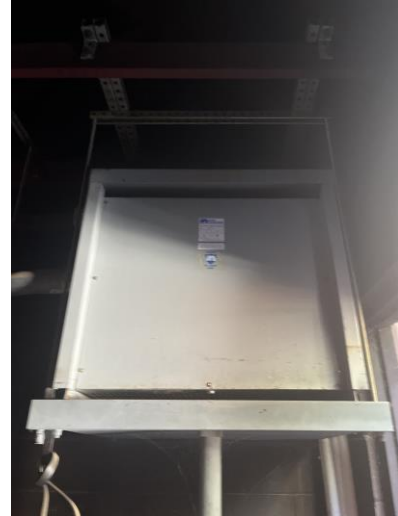
Priority: Immediate (0-1 Years)
Quantity/Unit of Measure: 1/EA
Total Deficiency Cost: \$22,140
Deficiency Description: *The 112.5kVA transformer (3P dry-type, 480-120/208V) is approaching the end of its expected useful life.*

Description of Work: *Replace the existing transformer with a new transformer.*

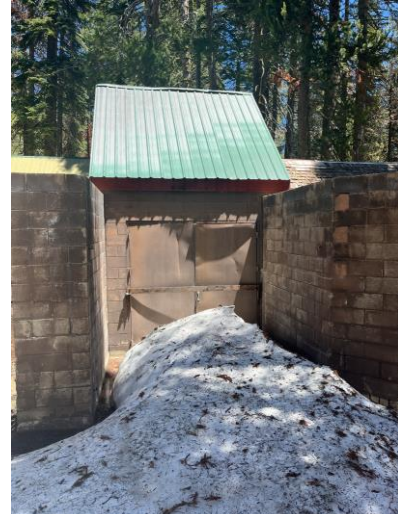
Record ID: 587
System: B2050 - EXTERIOR DOORS AND GRILLES
Item No.: B2050.20.003

Priority: Immediate (0-1 Years)
Quantity/Unit of Measure: 2/EA
Total Deficiency Cost: \$23,550
Deficiency Description: *Exterior doors, frames and hardware are approaching the end of their useful life.*

Description of Work: *Replace the exterior doors, frames and hardware.*

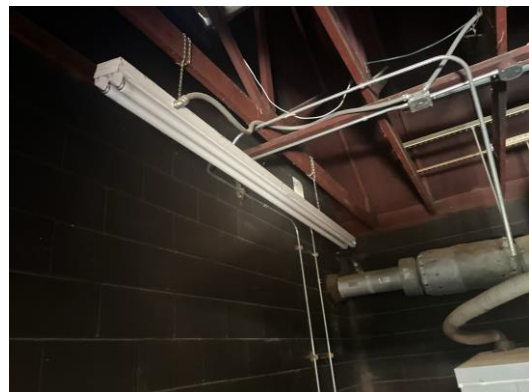
Record ID: 588
System: D5040 - LIGHTING
Item No.: D5040.50.421

Priority: Immediate (0-1 Years)
Quantity/Unit of Measure: 2/EA
Total Deficiency Cost: \$2,520
Deficiency Description: *The light fixture is past its expected useful life.*

Description of Work: *Replace existing incandescent fixtures with LED fixtures.*

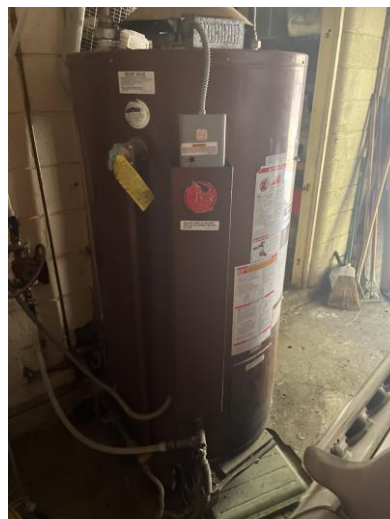
Deficiency Description: *Gas fired water heater more than 75 Gal is approaching the end of its expected useful life.*

Description of Work: *Provide equipment replacement and installation.*

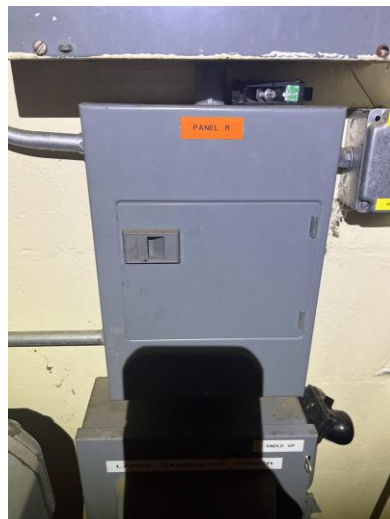
Record ID: 327
System: D5020 - ELECTRICAL SERVICE AND DISTRIBUTION

Deficiency Description: *The 100A (18 ckts, 20A plug-in breakers, 1P) load center is approaching the end of its expected useful life.*

Description of Work: *Replace the existing load center with a new load center.*

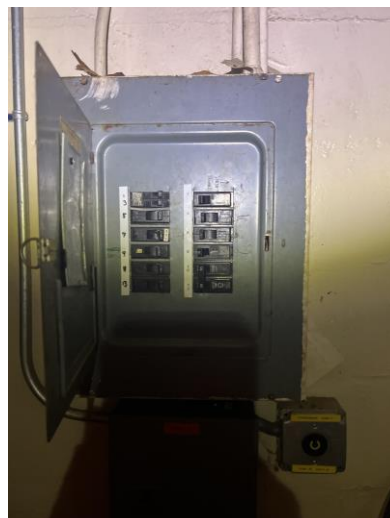
Record ID: 328
System: D5020 - ELECTRICAL SERVICE AND DISTRIBUTION

Deficiency Description: *The 100A (18 ckts, 20A plug-in breakers, 1P) load center is approaching the end of its expected useful life.*

Description of Work: *Replace the existing load center with a new load center.*

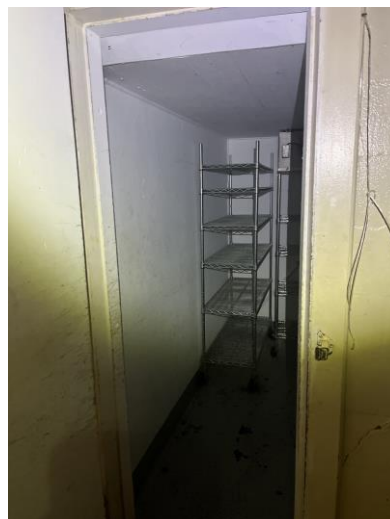
Priority: Immediate (0-1 Years)
Quantity/Unit of Measure: 100/SF
Total Deficiency Cost: \$7,050
Deficiency Description: *Walk-in cooler and freezer are at or approaching the end of its expected useful service life.*

Description of Work: *Provide equipment replacement and installation.*

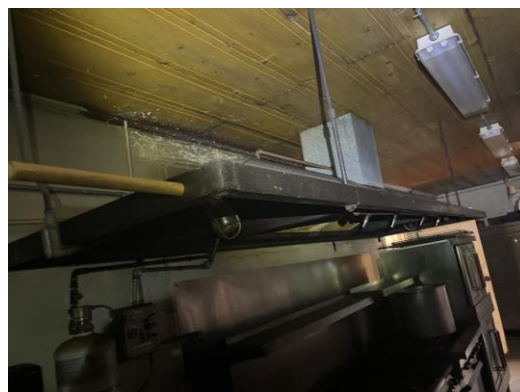
Record ID: 330
System: D4010 - FIRE SUPPRESSION

Priority: Immediate (0-1 Years)
Quantity/Unit of Measure: 100/cubic-feet of natural gas
Total Deficiency Cost: \$2,700
Deficiency Description: *Ansul fire suppression system with halon tank and controller is approaching the end of its expected useful life.*

Description of Work: *Provide equipment replacement and installation.*

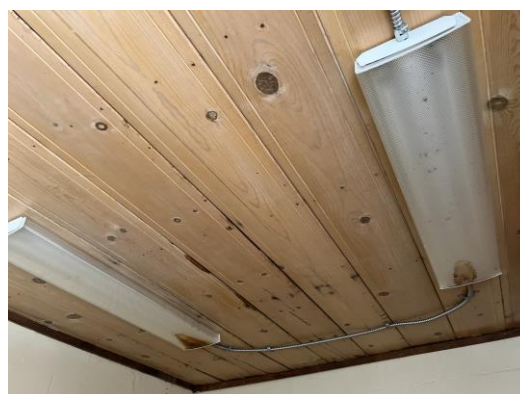
Record ID: 331
System: D5040 - LIGHTING

Priority: Immediate (0-1 Years)
Quantity/Unit of Measure: 8/EA
Total Deficiency Cost: \$10,040
Deficiency Description: *The light fixture is past its expected useful life.*

Description of Work: *Replace existing incandescent fixtures with LED fixtures.*

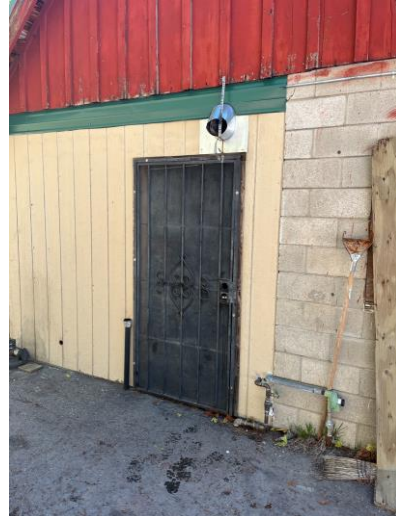
Record ID: 589
System: B2050 - EXTERIOR DOORS AND GRILLES
Item No.: B2050.10.006
Priority: Immediate (0-1 Years)
Quantity/Unit of Measure: 5/EA
Total Deficiency Cost: \$36,850
Deficiency Description: *Exterior aluminum entrance door, frame and hardware is approaching the end of its useful life.*
Description of Work: *Replace aluminum door, frame, and hardware.*
Comments:

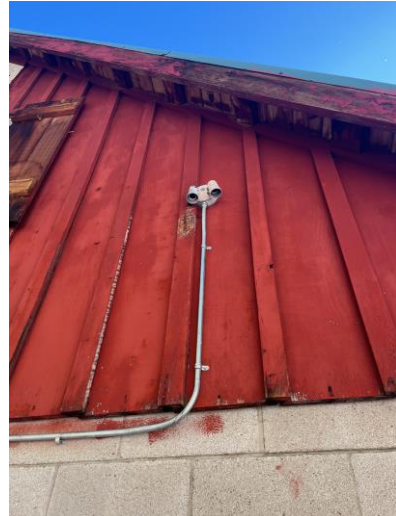
Record ID: 590
System: D5040 - LIGHTING
Item No.: D5040.50.420
Priority: Immediate (0-1 Years)
Quantity/Unit of Measure: 3/EA
Total Deficiency Cost: \$7,460
Deficiency Description: *The exterior wall mounted fixture is past its expected useful life.*
Description of Work: *Replace the existing wall mounted lighting fixture with an LED lighting fixture.*
Comments:

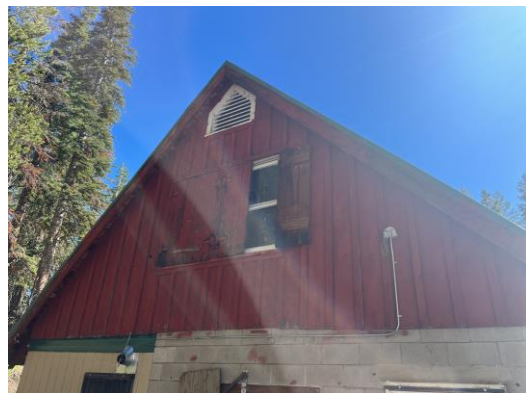
Record ID: 591
System: B2010 - EXTERIOR WALLS
Item No.: B2010.10.016
Priority: Immediate (0-1 Years)
Quantity/Unit of Measure: 500/SF
Total Deficiency Cost: \$12,600
Deficiency Description: *The exterior wood board siding is showing signs of age and wear.*
Description of Work: *Power wash and repaint existing wood board siding.*
Comments:

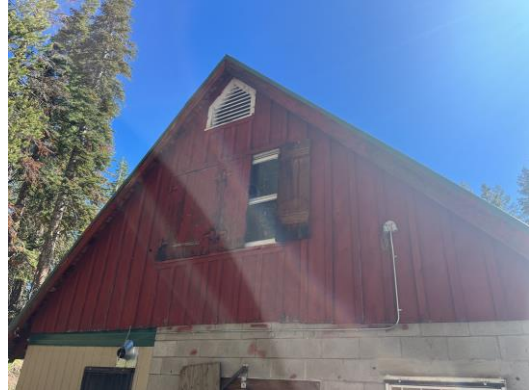
Record ID: 592
System: B2020 - EXTERIOR WINDOWS
Item No.: B2020.10.015
Priority: Immediate (0-1 Years)
Quantity/Unit of Measure: 100/SF
Total Deficiency Cost: \$52,110
Deficiency Description: *Windows are damaged and/or past their expected useful life.*
Description of Work: *Replace window.*
Comments:

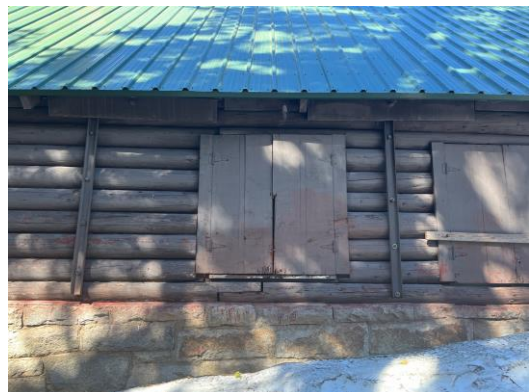
Record ID: 597
System: B2020 - EXTERIOR WINDOWS
Item No.: B2020.10.015
Priority: Immediate (0-1 Years)
Quantity/Unit of Measure: 300/SF
Total Deficiency Cost: \$156,310
Deficiency Description: *Windows are damaged and/or past their expected useful life.*

Description of Work: *Replace window.*

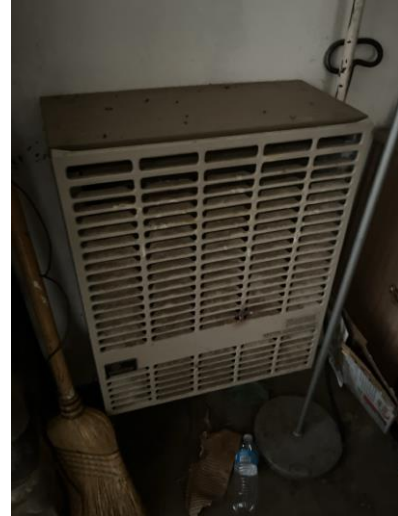
Record ID: 186
System: D3020 - HEATING SYSTEMS
Item No.: D3020.10.019
Priority: Immediate (0-1 Years)
Quantity/Unit of Measure: 1/EA
Total Deficiency Cost: \$3,700
Deficiency Description: Gas-fired furnace 15 Mbh is past its expected useful life.
Description of Work: Provide equipment replacement and installation.
Comments:

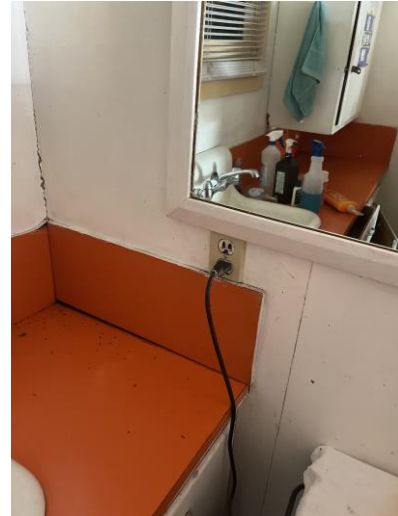
Record ID: 187
System: D5030 - GENERAL PURPOSE ELECTRICAL POWER
Item No.: D5030.50.010
Priority: Immediate (0-1 Years)
Quantity/Unit of Measure: 1/EA
Total Deficiency Cost: \$260
Deficiency Description: A 20A duplex GFCI receptacle, 120V, grounded, should exist in the place of a normal receptacle neighboring a sink.
Description of Work: Replace the existing receptacle with a GFCI receptacle.
Comments:

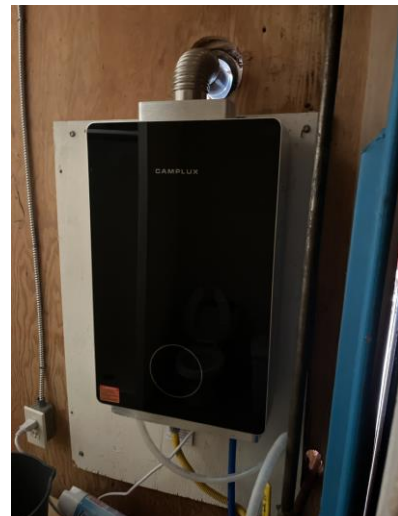
Record ID: 188
System: D2010 - DOMESTIC WATER DISTRIBUTION
Item No.: D2010.20.028
Priority: Immediate (0-1 Years)
Quantity/Unit of Measure: 1/EA
Total Deficiency Cost: \$6,720
Deficiency Description: Tankless water heater is past its expected useful life.
Description of Work: Provide equipment replacement and installation.
Comments:

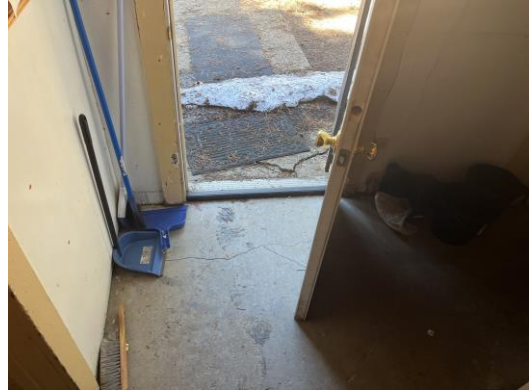
Comments: *Door does not fully open due to foundation cracking and settlement.*

Description of Work: *Replace wood door.*

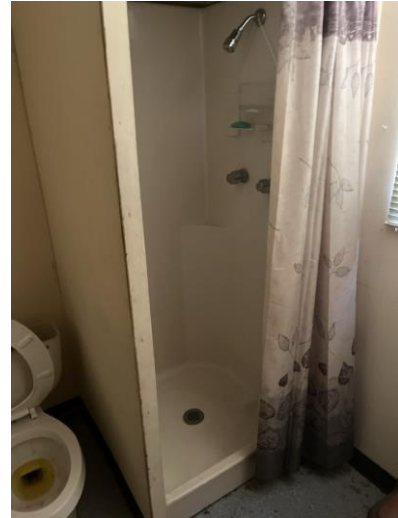
Record ID: 608
System: D2010 - DOMESTIC WATER DISTRIBUTION
Item No.: D2010.60.037
Priority: Immediate (0-1 Years)
Quantity/Unit of Measure: 1/EA
Total Deficiency Cost: \$1,670
Deficiency Description: *Shower station is at or approaching the end of its useful life.*

Description of Work: *Provide equipment replacement and installation.*

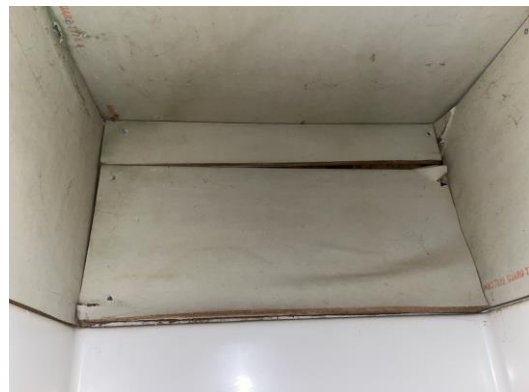
Record ID: 609
System: C2010 - WALL FINISHES
Item No.: C2010.70.001
Priority: Immediate (0-1 Years)
Quantity/Unit of Measure: 40/SF
Total Deficiency Cost: \$850
Deficiency Description: *Painted gypsum wallboard is showing signs of wear.*

Description of Work: *Patch and paint the gypsum wallboard.*

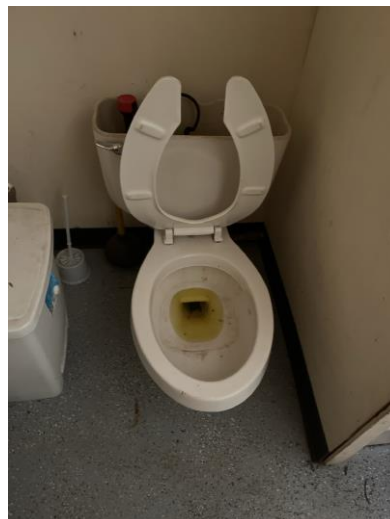
Record ID: 614
System: D2010 - DOMESTIC WATER DISTRIBUTION
Item No.: D2010.60.004
Priority: Immediate (0-1 Years)
Quantity/Unit of Measure: /EA
Total Deficiency Cost:
Deficiency Description: *Floor mounted, flush tank water closet is approaching the end of its expected useful life.*

Description of Work: *Provide equipment replacement and installation.*

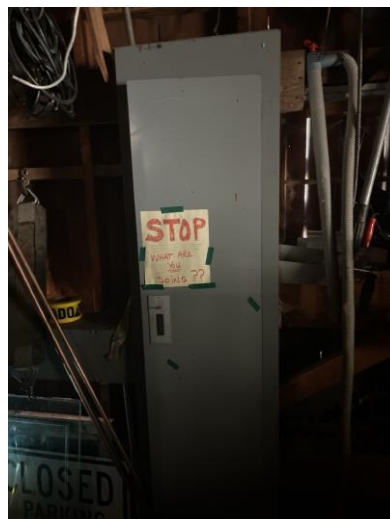
Priority: Immediate (0-1 Years)
Quantity/Unit of Measure: 1/EA
Total Deficiency Cost: \$19,440
Deficiency Description: *The 225A (42 ckts, 120/208, 3P) panelboard is approaching the end of its expected useful life.*

Description of Work: *Replace the existing panelboard with a new panelboard.*

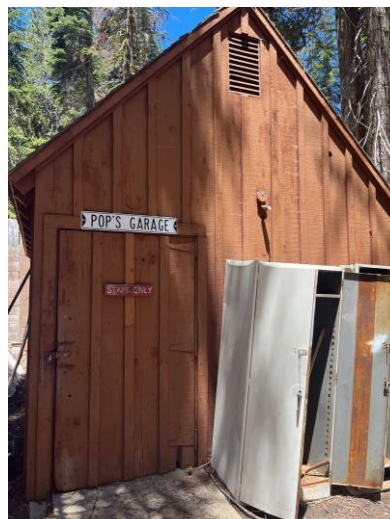
Record ID: 615
System: B2010 - EXTERIOR WALLS
Item No.: B2010.10.016

Priority: Immediate (0-1 Years)
Quantity/Unit of Measure: 700/SF
Total Deficiency Cost: \$17,640
Deficiency Description: *The exterior wood board siding and/or wall finish is showing signs of age and wear.*

Description of Work: *Power wash and repaint existing wood board siding and/or wall finish.*

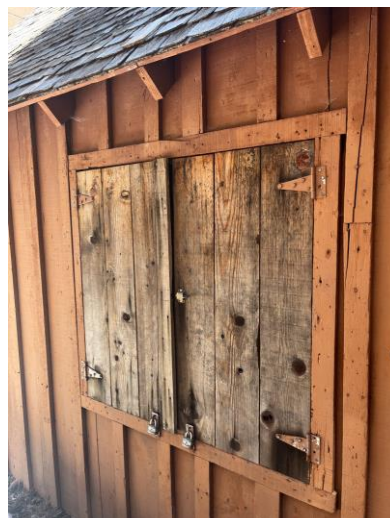
Record ID: 616
System: B2020 - EXTERIOR WINDOWS
Item No.: B2020.10.015

Priority: Immediate (0-1 Years)
Quantity/Unit of Measure: 45/SF
Total Deficiency Cost: \$23,460
Deficiency Description: *Windows are damaged and/or past their expected useful life.*

Description of Work: *Replace window.*

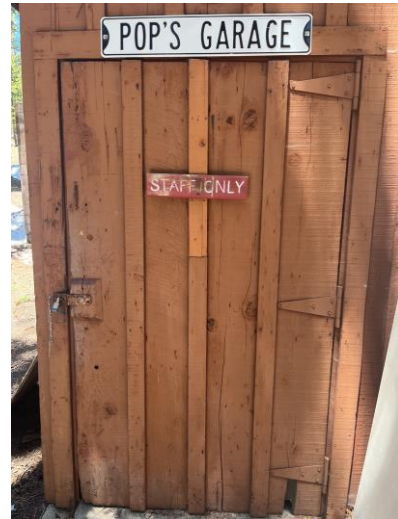
Deficiency Description: *Exterior wood entrance door is damaged and/or past its expected useful life.*

Description of Work: *Replace wood door.*

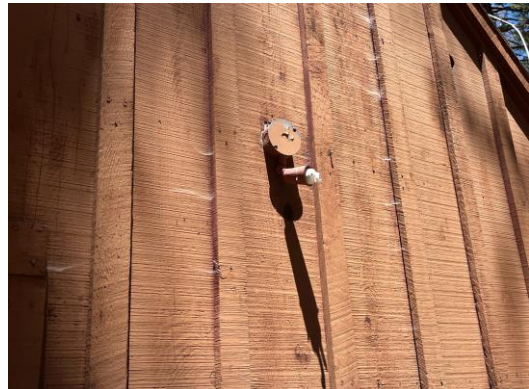
Record ID: 618
System: D5040 - LIGHTING

Deficiency Description: *The exterior wall mounted fixture is past its expected useful life.*

Description of Work: *Replace the existing wall mounted lighting fixture with an LED lighting fixture.*

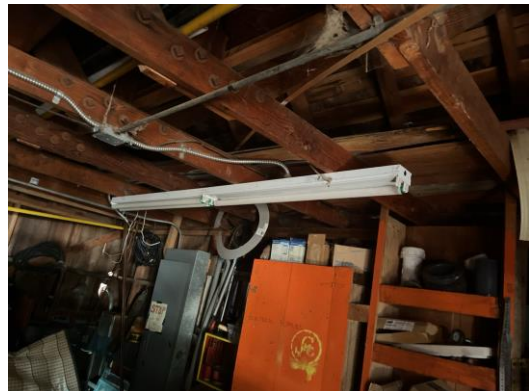
Record ID: 619
System: D5040 - LIGHTING

Deficiency Description: *The light fixture is past its expected useful life.*

Description of Work: *Replace existing incandescent fixtures with LED fixtures.*

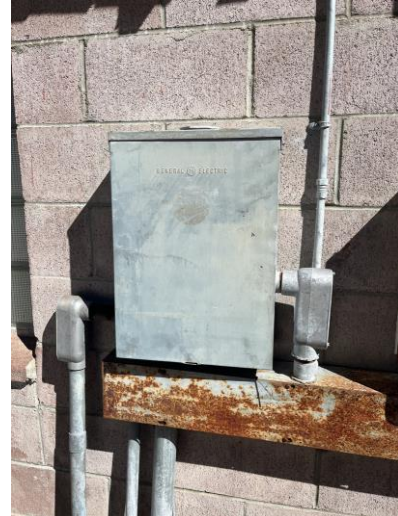
Priority: Immediate (0-1 Years)
Quantity/Unit of Measure: 1/EA
Total Deficiency Cost: \$6,750
Deficiency Description: *The outdoor load center is past its expected useful life.*

Description of Work: *Replace the existing load center with a new load center.*

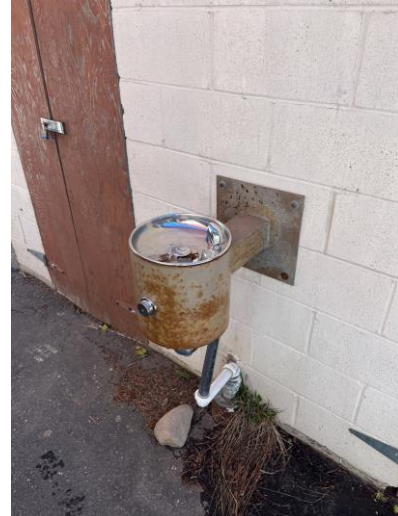
Record ID: 262
System: G3010 - WATER UTILITIES
Item No.: G3010.10.004

Priority: Immediate (0-1 Years)
Quantity/Unit of Measure: 1/EA
Total Deficiency Cost: \$16,150
Deficiency Description: *Drinking fountain is past its expected useful life.*

Description of Work: *Replace drinking fountain.*

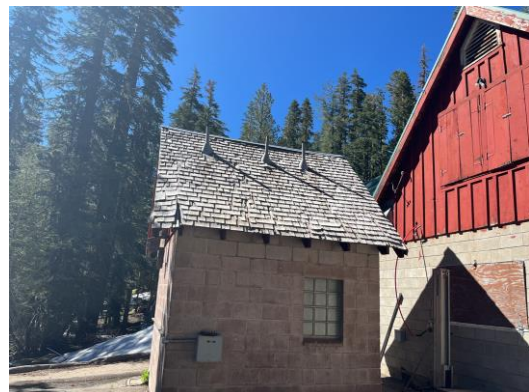
Record ID: 620
System: B3010 - ROOFING
Item No.: B3010.10.007

Priority: Immediate (0-1 Years)
Quantity/Unit of Measure: 100/SF
Total Deficiency Cost: \$3,880
Deficiency Description: *Wood shake roof is past its expected useful life.*

Description of Work: *Remove and replace wood shake roof and replace with metal roofing.*

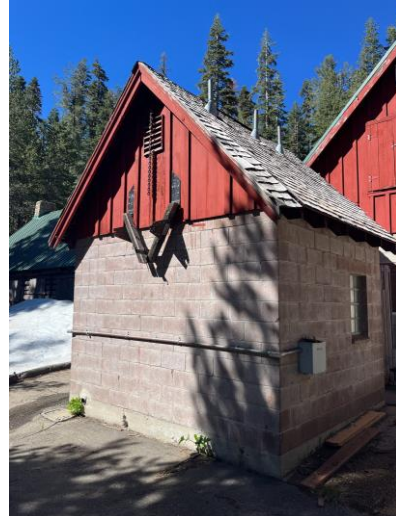
Record ID: 621
System: B2010 - EXTERIOR WALLS
Item No.: B2010.10.016
Priority: Immediate (0-1 Years)
Quantity/Unit of Measure: 80/SF
Total Deficiency Cost: \$2,030
Deficiency Description: *The exterior wood board siding and/or wall finish is showing signs of age and wear.*

Description of Work: *Power wash and repaint existing wood board siding and/or wall finish.*

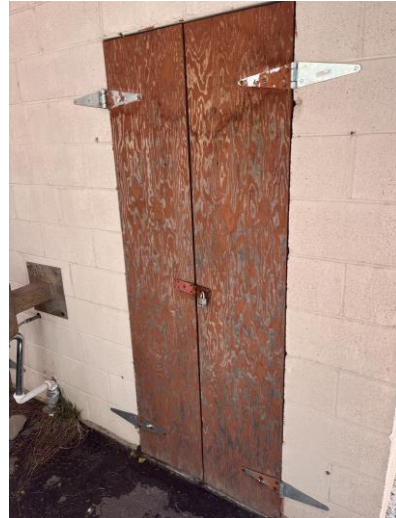
Record ID: 622
System: B2050 - EXTERIOR DOORS AND GRILLES
Item No.: B2050.10.001
Priority: Immediate (0-1 Years)
Quantity/Unit of Measure: 2/EA
Total Deficiency Cost: \$16,790
Deficiency Description: *Exterior wood entrance door is damaged and/or past its expected useful life.*

Description of Work: *Replace wood door.*

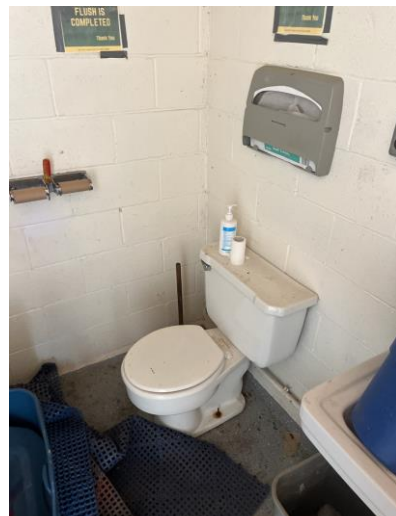
Record ID: 623
System: D2010 - DOMESTIC WATER DISTRIBUTION
Item No.: D2010.60.004
Priority: Immediate (0-1 Years)
Quantity/Unit of Measure: 2/EA
Total Deficiency Cost: \$500
Deficiency Description: *Floor mounted, flush tank water closet is approaching the end of its expected useful life.*

Description of Work: *Provide equipment replacement and installation.*

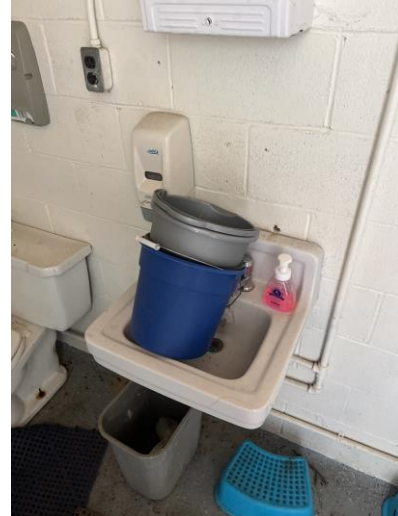
Deficiency Description: *Porcelain sink is approaching the end of its expected useful life.*

Description of Work: *Provide equipment replacement and installation.*

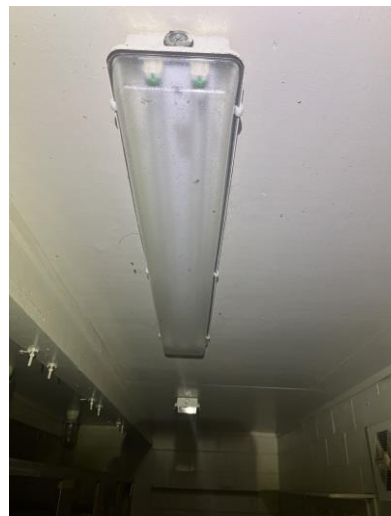
Record ID: 631
System: D5040 - LIGHTING

Comments: *Includes assumed quantities for Men's Restroom.*

Description of Work: *Replace existing fixtures with LED fixtures.*

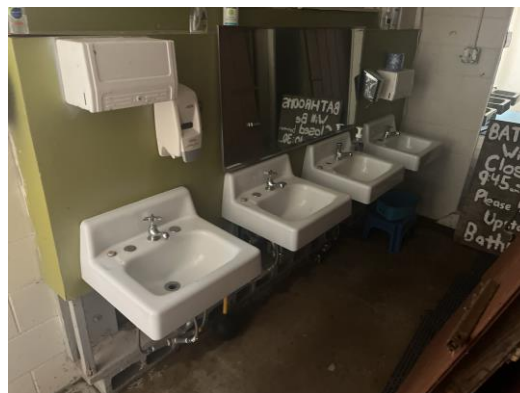
Comments: Includes assumed quantities for Men's Restroom.

Description of Work: Provide equipment replacement and installation.
