Silver Lake Campground Facility Condition Assessment

Final Report

August 16, 2024

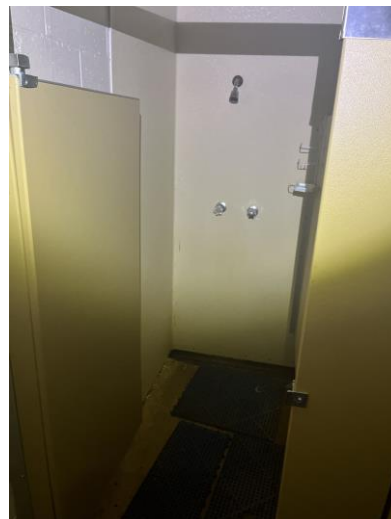
Record ID: 633
System: D2010 - DOMESTIC WATER DISTRIBUTION

Comments: Includes assumed quantities for Men's Restroom.

Description of Work: Provide equipment replacement and installation.

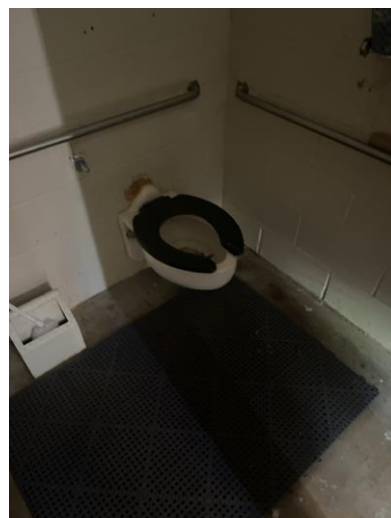
Record ID: 634
System: D2010 - DOMESTIC WATER DISTRIBUTION

Comments: Includes assumed quantities for Men's Restroom.

Description of Work: Provide equipment replacement and installation.

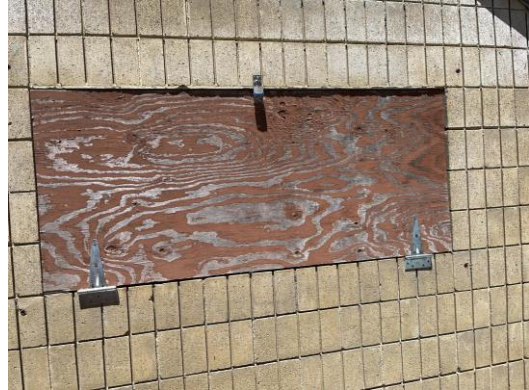
Comments: *Includes second floor windows.*

Description of Work: *Replace window.*

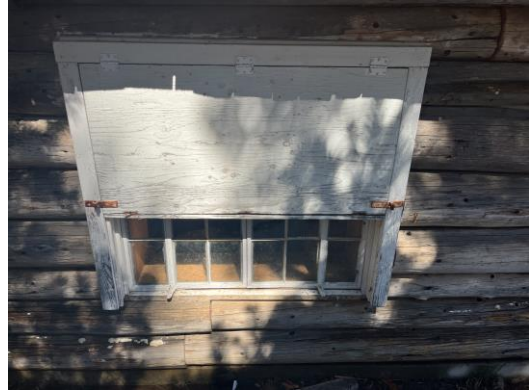
Record ID: 639
System: B2020 - EXTERIOR WINDOWS
Item No.: B2020.10.015
Priority: Immediate (0-1 Years)
Quantity/Unit of Measure: 75/SF
Total Deficiency Cost: \$39,080
Deficiency Description: *Windows are damaged and/or past their expected useful life.*
Description of Work: *Replace window.*
Comments:

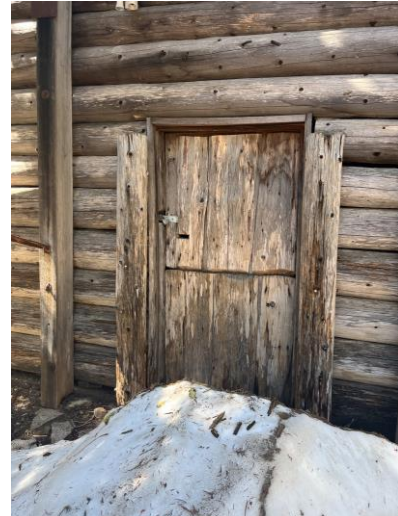
Record ID: 640
System: B2050 - EXTERIOR DOORS AND GRILLES
Item No.: B2050.10.005
Priority: Immediate (0-1 Years)
Quantity/Unit of Measure: 1/EA
Total Deficiency Cost: \$5,050
Deficiency Description: *Exterior wood entrance door, frame and hardware is approaching the end of its useful life.*
Description of Work: *Replace wood door, frame, and hardware.*
Comments:

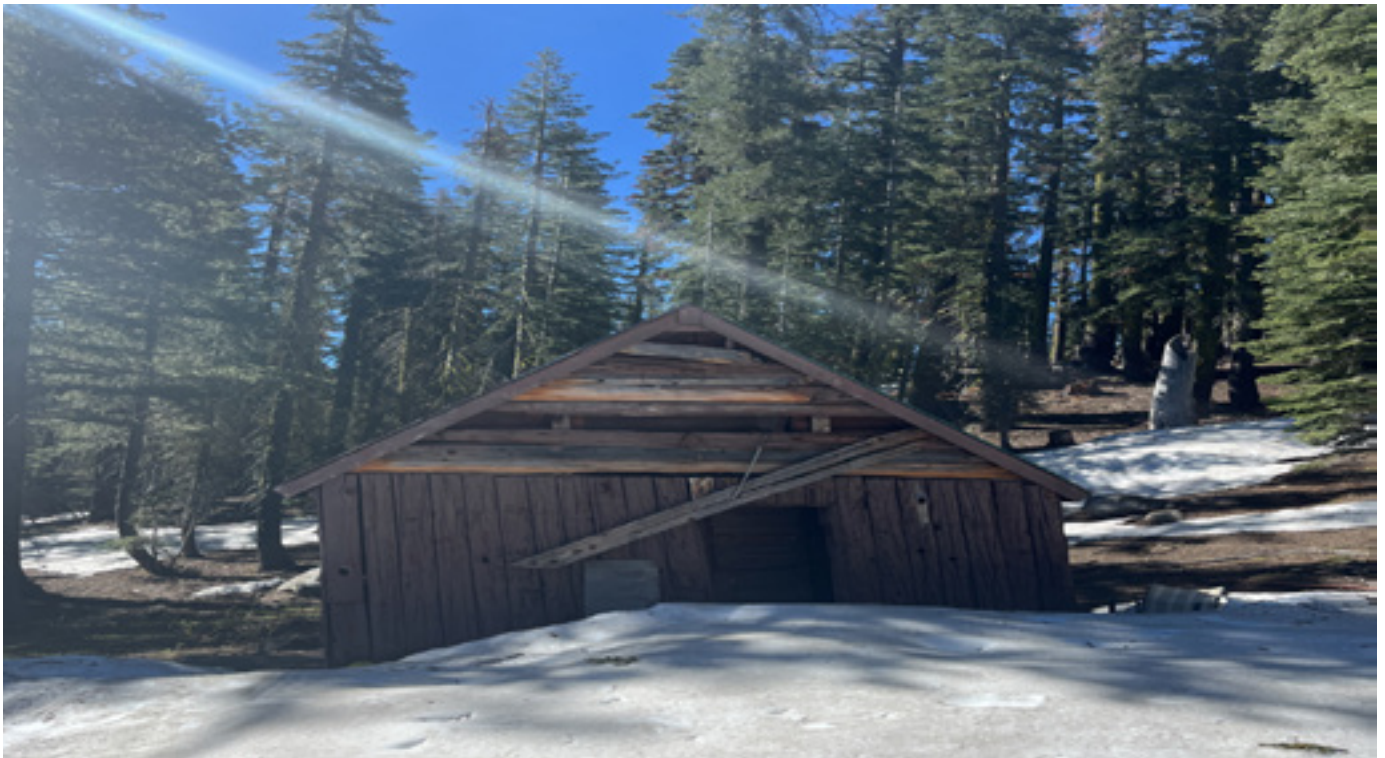
Storage 2 is an approximately 150 square foot wood structure with a metal roof on a concrete foundation. The structure is showing signs of structural damage due to the concrete foundation failure. The structure appeared to be leaning downslope and the access door could not be fully opened to allow entrance.

A full demolition and replacement of the Storage 2 building is recommended.

Due to the condition of Storage 2, it is recommended the structure be fully replaced. The estimated cost for the replacement is \$69,000.

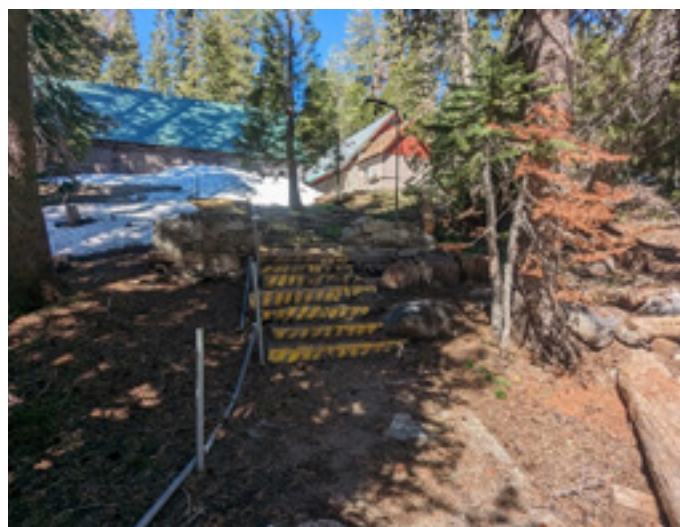
Figure 2: Exterior Stairs East of Lodge Shown on Left. Fire Pit is On Right Side of View

the Manager's Office east to the Nurse cabin is compliant for surface slopes. The remaining portions of the loop walk west of Cabin J to the Restroom and Showers building has deficiencies in cross slope and slope in direction of travel. The north loop from the Manager's Office to the Restroom and Showers building has significant barriers with excessive surface slopes and steps to reach the entrance doors. There is no improved path to the Crafts cabin, Lodge, Kitchen, Reynold's Memorial Museum, nor any recreational activity areas. Exterior stairs east of the Lodge have unequal risers and lack handrails for accessibility. Unevenness of the stair riser height is a safety risk for normal bodied persons as well. The Lodge stairs should be replaced with concrete stairways and handrails.

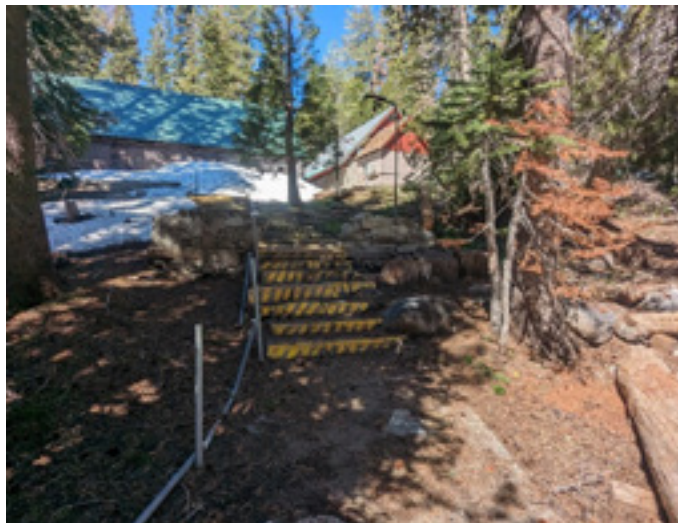
Figure 5: Cabin P Exterior with Manager's Office at Left

Approximately 65 cabins are provided at Silver Lake, and Cabin P has been designated by the camp as the sole accessible unit. ABAAS defines the cabin as a Camp Shelter used for camping for weather protection and does not contain plumbing fixtures or kitchen applies. For approximately 65 units provided at the Silver Lake Campground a minimum number of four camping units with mobility features should be provided per ABAAS F244.2. Significant barriers exist at the cabin entrance door as the opening width is less than the standards, and the concrete pavement at the door does not provide full maneuvering access space at the door for entry. Inside the cabin, the mounting height of the light switch, receptacle, and window latch does not meet the standards. Four new purpose-built accessible cabins are recommended in lieu of correcting the existing cabins.

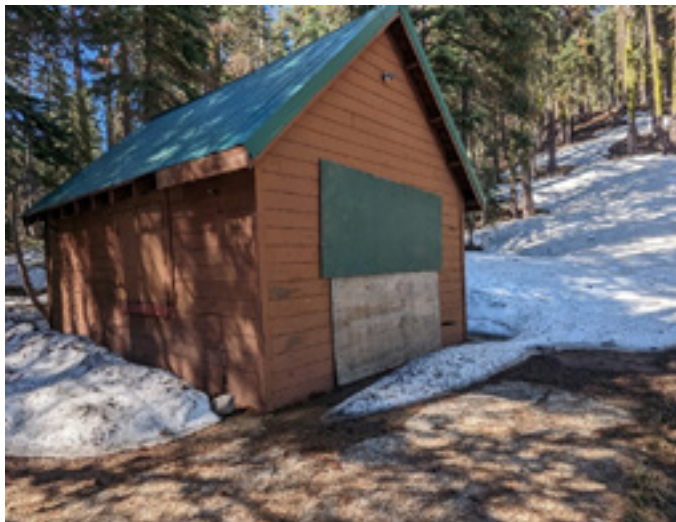
Figure 9: Crafts Cabin

Kitchell could not evaluate the accessibility of the Crafts cabin as the entrance door was covered with plywood. The existing concrete pavement stoop at three sides of the cabin does not have an improved surface for connection to the site path of travel about the camp.
