**SUBJECT: REQUEST FOR BUDGET AMENDMENT FOR COMPREHENSIVE  
WELL EVALUATION WATER OF WELL NO. 33 - PROJECT NO. UH22005**

## **Well No. 33 Evaluation Work Plan**

### **City of Stockton**

# WATER WELL VIDEO REPORT

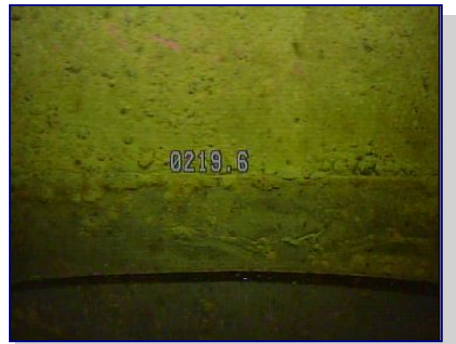
Depth: 219.6 Feet

219.8 Ft.	18-inch x 20-inch Casing Reduction
 	222.3 Ft.	Top of Sounding Box
 	229.3 Ft.	Bottom of Sounding Box
	264.8 Ft.	Perforations, Top of Wire Wrapped Stainless Steel Screen
