RE: Letter on Demolition of 625-33 East Market

Resource Name or #: (Assigned by recorder) 633 E. Market Street

BUILDING, STRUCTURE, AND OBJECT RECORD

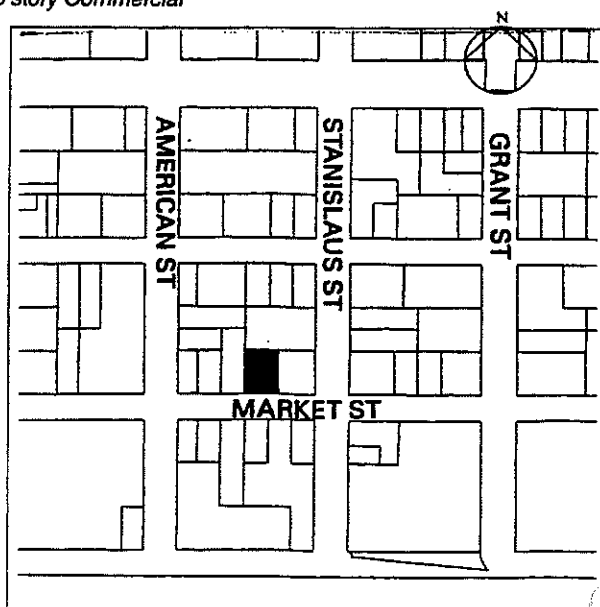
This is a one-story building located on the north side of E. Market Street. The brick building has a flat roof with a low arched parapet wall with small decorative scroll brackets on either side. Just below the roof line are three rectangular panels of colored, patterned tile. A continuous row of multi-paned windows runs just below the tile. Entrances consist of a large roll-up door and a set of double doors with top lites. The lower portion of the facade has been refaced with stucco. The building appears to have been modified over the years to accommodate different tenants and uses. The exterior of the building appears to be in good condition.

Photo looking northeast.

Constructed in 1922. Alterations include plaster over lower portion of front facade, replacement of pedestrian and steel rolling doors.
