PRIMARY RECORD

Resource Name or #: (Assigned by recorder) *Curved Needle- Building 015*P1. Other Identifier: *Stockton Developmental Center - Curved Needle- Building 015*P2. Location: ☐ Not for Publication ☒ Unrestricted a. County *San Joaquin*

Stockton Developmental Center Site Cultural Resources Inventory

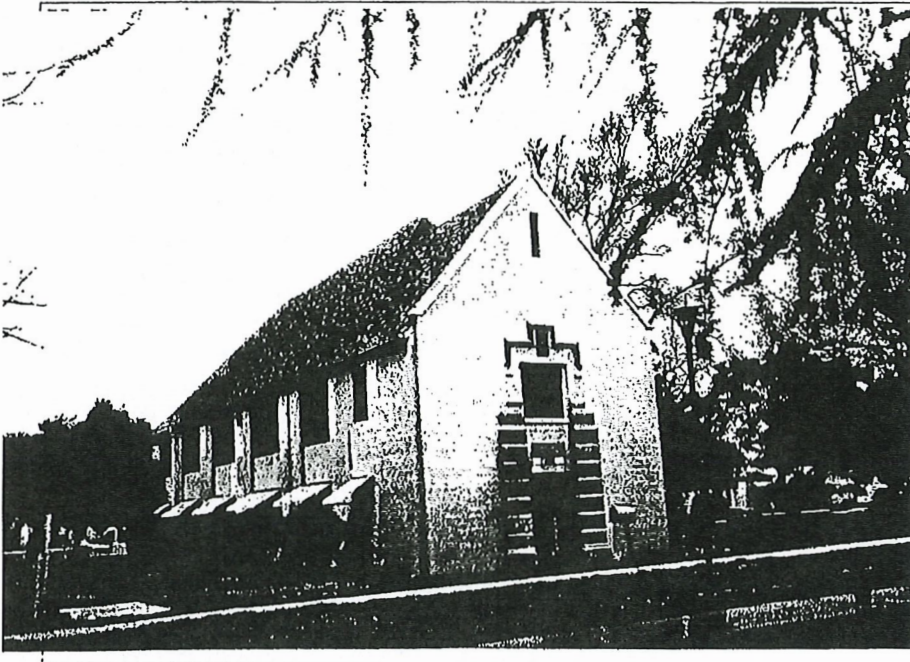
This stucco clad building is located on the southeastern corner of N. Grant and E. Rose Streets. The structure is a two-story building with a steep gable roof covered with tile. The north side of the roof has a hipped dormer with two attic vents. Large multi-paned windows create a symmetrical fenestration. The first floor windows have awnings. The main entrance is at the southern side of the building. The entrance is recessed into the building with large concrete blocks surrounding the opening. Above the entrance is a large multi-paned awning window with geometric plaster work. The building is irregular in plan with 6,192 square feet and appears to be in good condition.

P3b. Resource Attributes: (List attributes and codes) *HP41 - Hospital*P4. Resources Present ☒ Building ☐ Structure ☐ Object ☐ Site ☐ District ☐ Element of District ☐ Other (Isolates, etc.)P5b. Description of Photo: (View, date, accession #)
*North*P6. Date Constructed/Age and Sources:
☐ Prehistoric ☒ Historic ☐ Both*Constructed 1929.*
